RE: Bledsoe Coal Corporation
ID No. LRL-2004-00202

Bledsoe Coal Corp. #866-0272 Off Site Mitigation
Monitoring Report Summary

KDNR Permit No. 866-0272
COE & PCN 2011 Report
LRL-2004-00202
Photos

Off-Site Mitigation Representative Stream
 Plan, Profile, Cross-Section

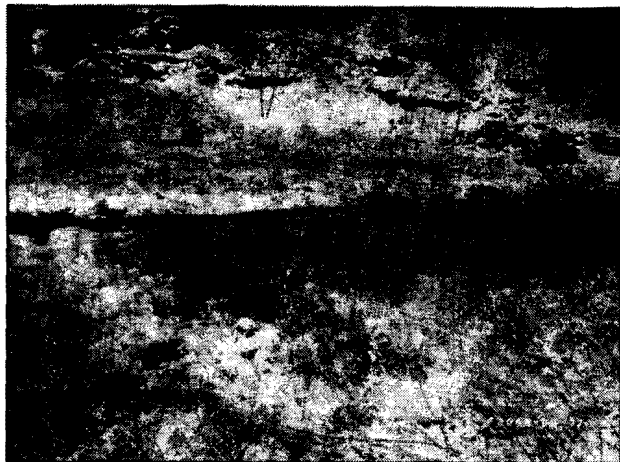
Standing at road looking downstream
showing valley

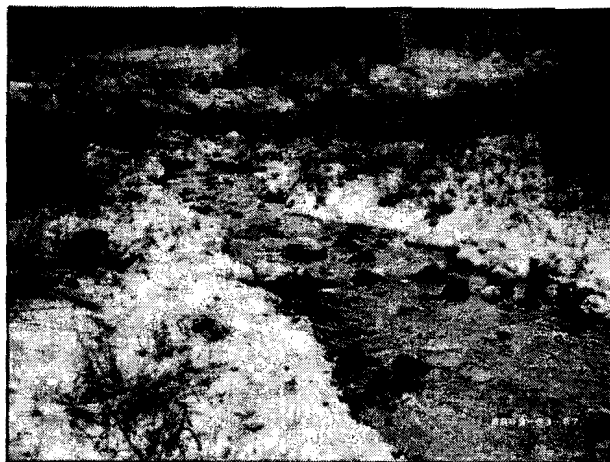
Looking Upstream

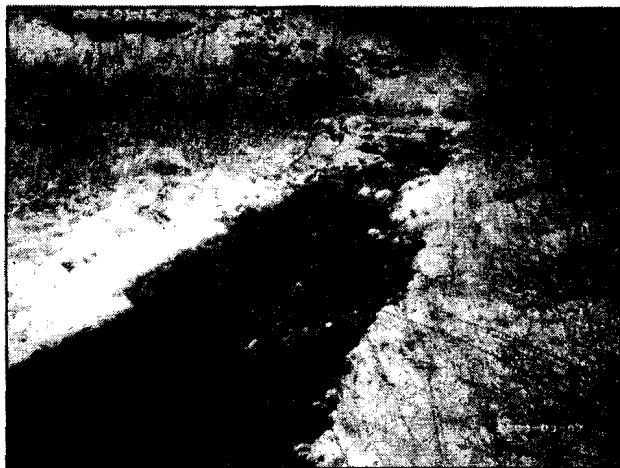
Looking Downstream

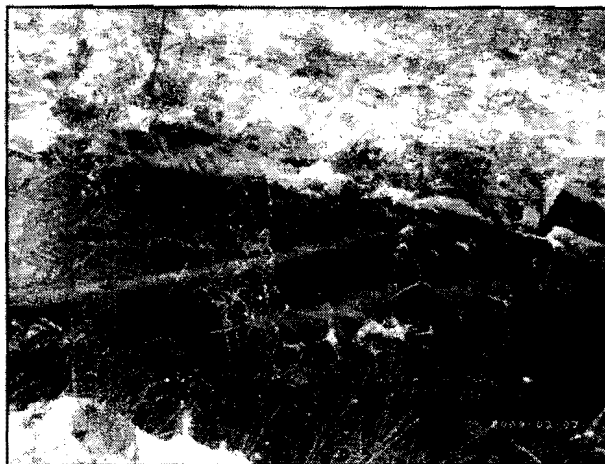
Photo of a Log Vane
