USACE Individual Permit No. 200500359

**Permittee:** Consol of KY, Inc.  
1800 Washington Road  
Pittsburgh, Pennsylvania 15241  
(304) 369-8132

**Consultant:** P & A Engineers and Consultants, Inc.  
P.O. Box 279  
Louisa, KY 41230  
(606) 673-4413

P&A Engineers and Consultants, Inc. (P&A) was retained by Consol of Kentucky, Inc. (Consol) to document and evaluate the off-site mitigation for the MT-500 Surface Mine and prepare the Year 2 Monitoring Report. The stream mitigation specified herein provides compensation for the permanent impacts to jurisdictional waters, as well as offsets temporal loss, as it was constructed prior to or concurrent with the occurrence of stream impacts on MT-500 Surface Mine. Blue Line commenced construction in October 2008 and P&A performed the as-built surveying and Year 1 monitoring assessments in December 2009. P&A Engineers and Consultants, Inc evaluated the project again in December 2011 to satisfy monitoring requirements as part of the Compensatory Mitigation Plan (CMP; REIC 2006; JCS 2006).

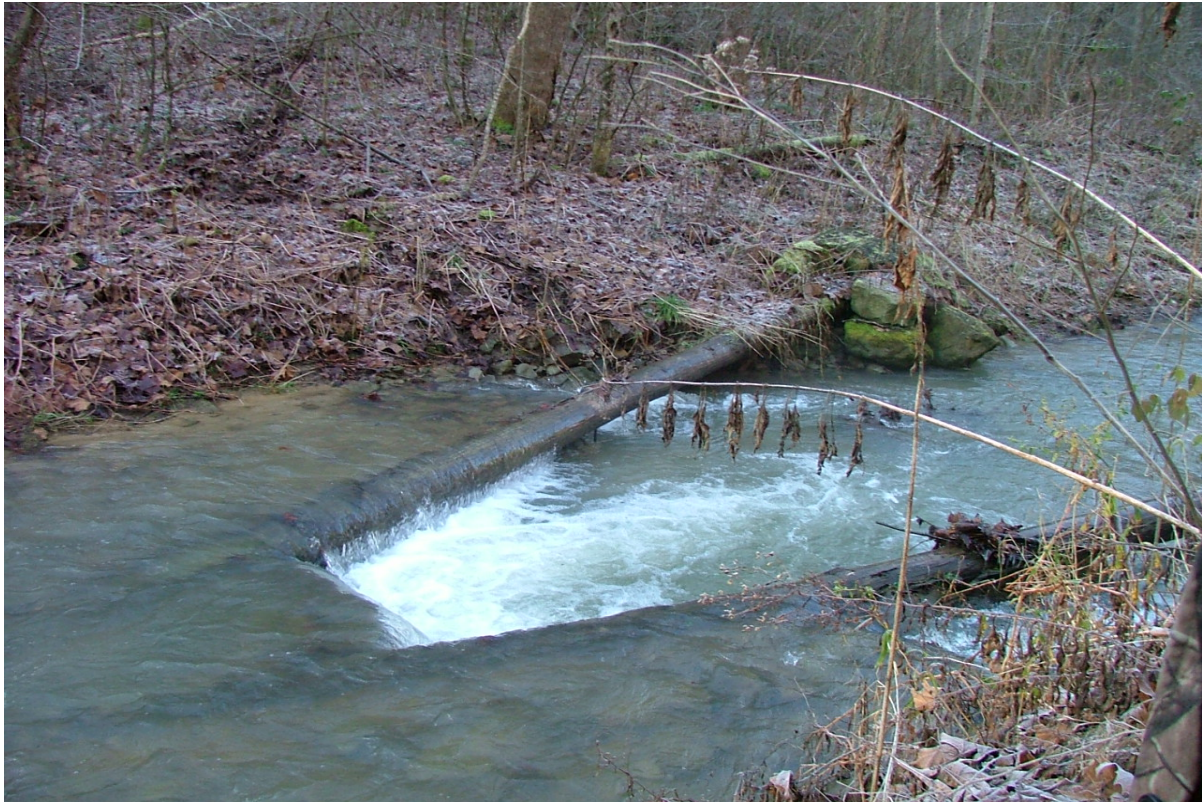
**Photo 1**

During the monitoring, there was some noticeable water piping observed between the header rocks and vane logs and then underneath of the vane logs. (See Photo 1 below) Backer logs/footer logs will, therefore, be installed on every structure, where deemed appropriate, with associated filter fabric. Due to some slight incision noticed on some of the structures, header elevations will also be decreased slightly.

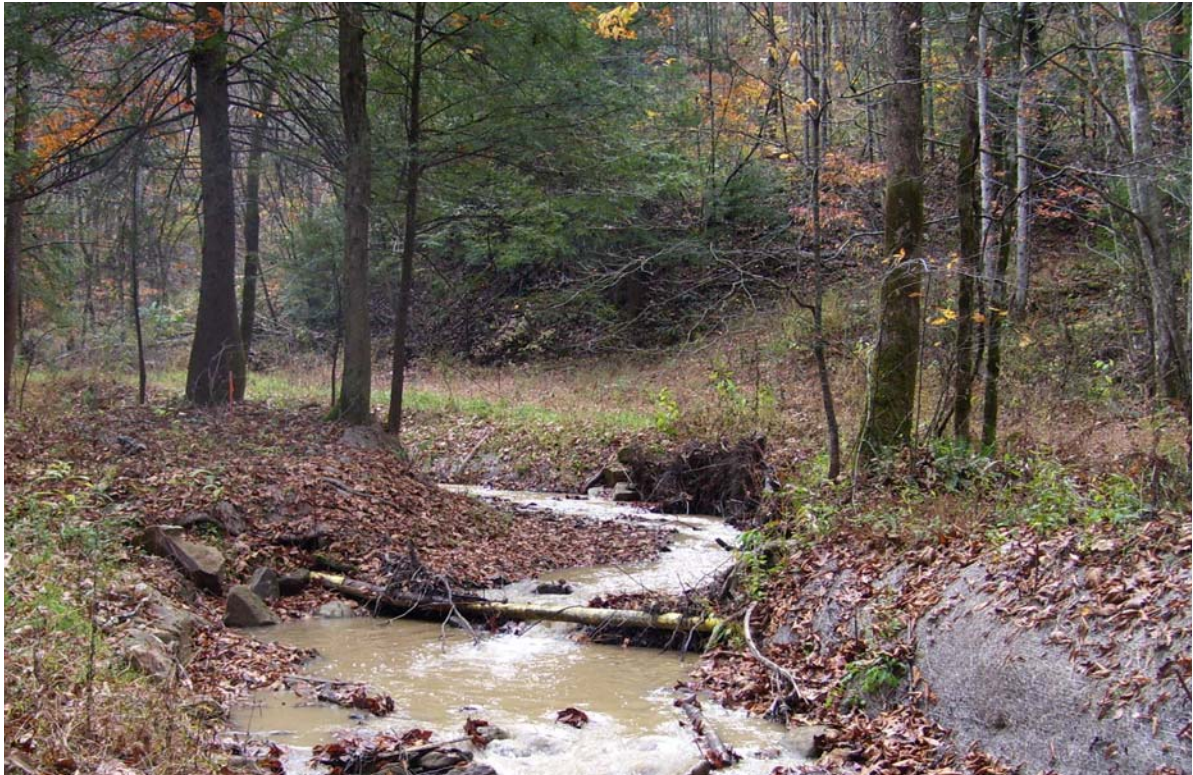
**Photo2**

In Mill Fork, there is some noticeable erosion in two of the small upstream meanders. Those are proposed be corrected by installing bank toe protection. In one section of stream along the road crossing, it is overly wide. Therefore, one to two log cross vanes are proposed to be installed to redirect the thalweg appropriately. The road crossing at the downstream end of the project is proposed also proposed to be stabilized. A footer log will be installed to protect the stream from incision at a gas line (See Photo 2) and to protect a gas line so the combined structure functions more like a step pool. The mouth section is also proposed to be repaired due to issues associated with the road crossing.
