5<sup>th</sup> Year Monitoring of Mitigation Provided  
on the Birch River  
for the O'Brien #2 Surface Mine.

June 20, 2012

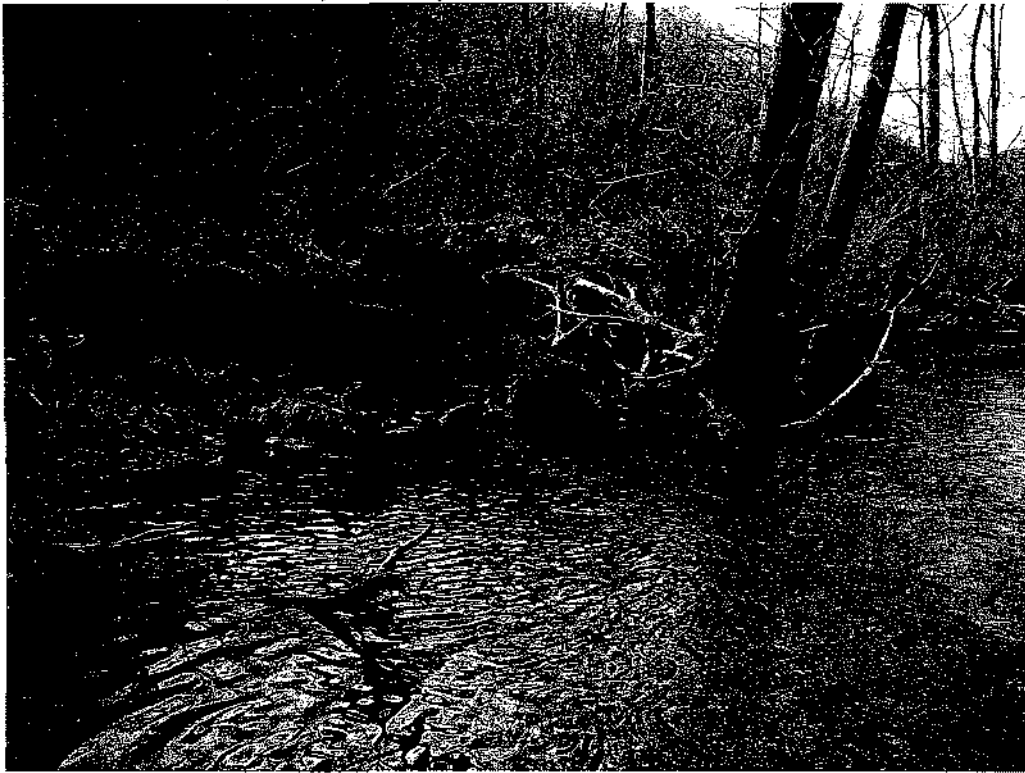
PHOTO 17. IP8: Proposed location to install a J-hook vane to reduce near bank stress on Birch River. ICG Eastern, February 2006.

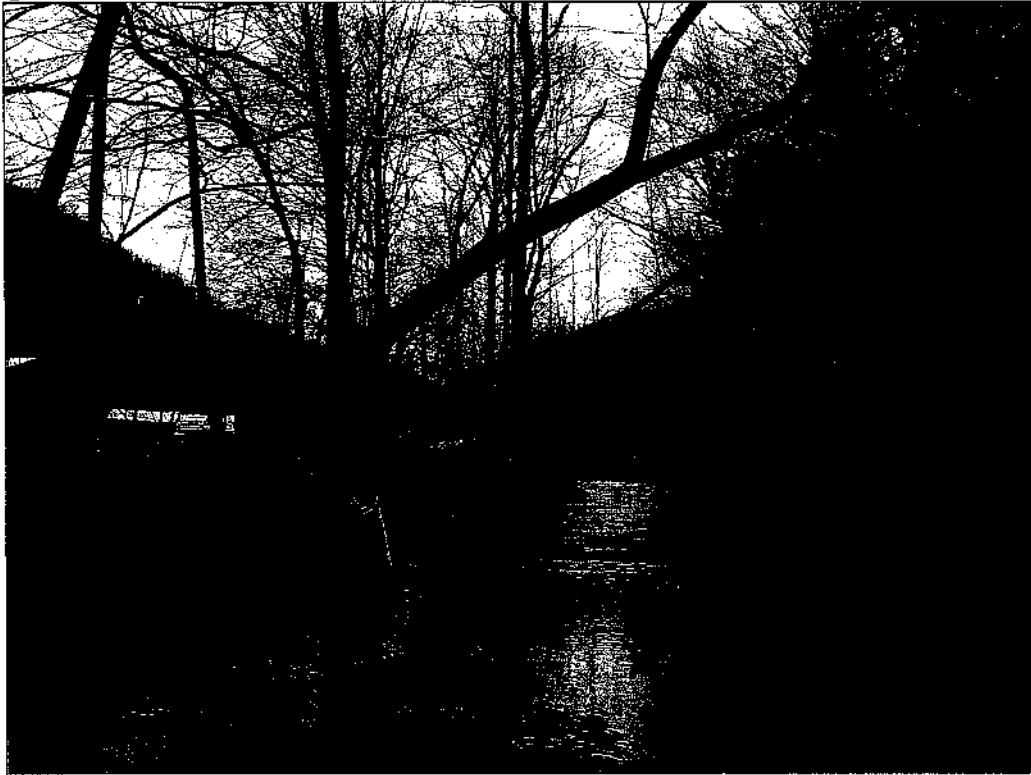
PHOTO 22. IP3: Proposed location to remove falling trees and anchor their rootwads into the right bank of Birch River. ICG Eastern, February 2006.
