**HEN WILDER MITIGATION SITE  
USACE NWP (21) 200601071**

**KDNR # 807-8056  
2011 Annual Report  
December 12, 2011  
(Revised 02-01-12)**

2011 Mitigation Monitoring Report

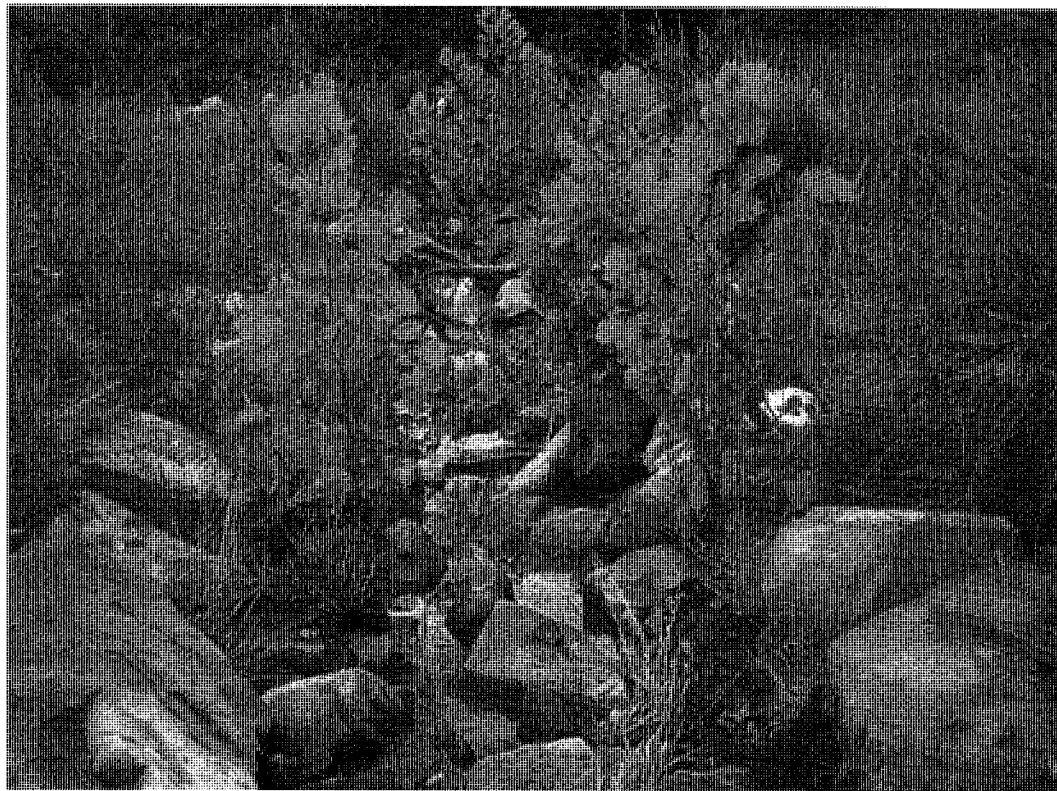
**Photo 1: Volunteer Sycamores In Riparian Zone**

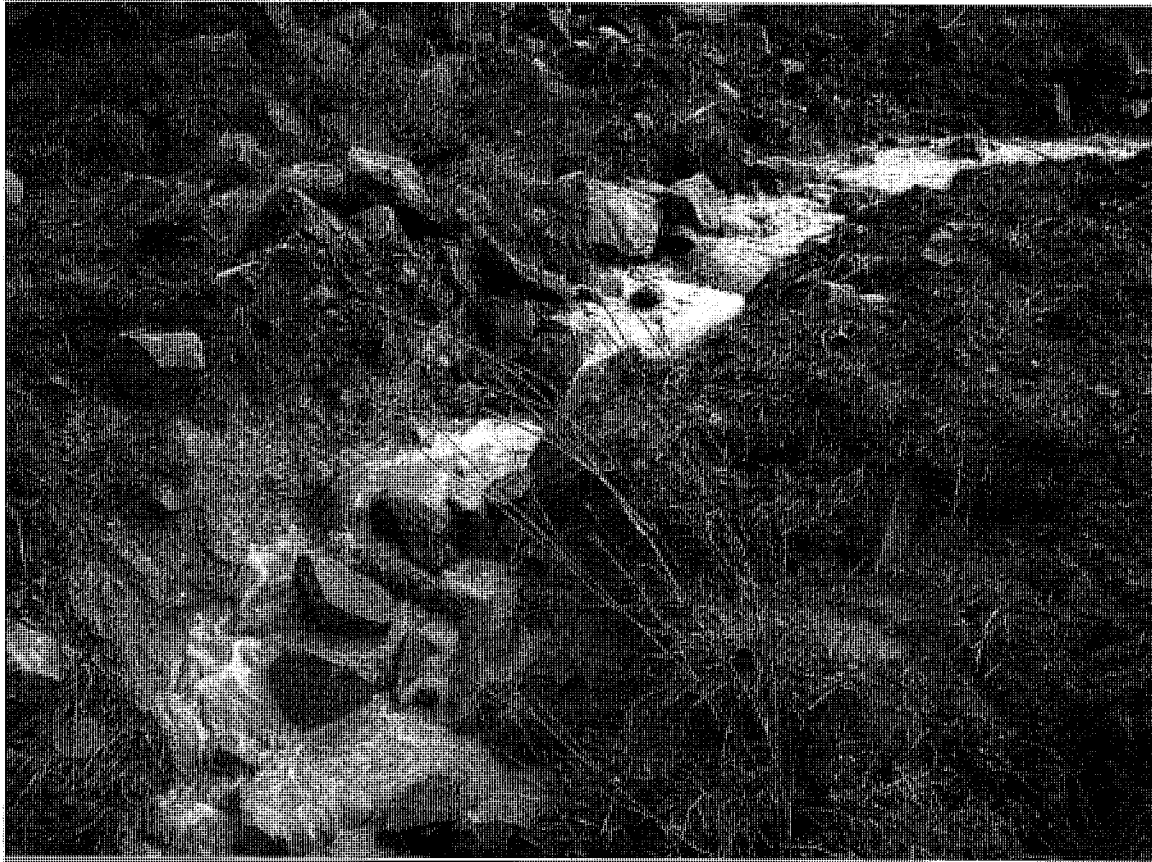
As illustrated the site is developing well. The 60' riparian zone was planted during the fall of 2010 and log structures were added to the channels in 2011. Some bank stability issues are found on the top and side drain of the hollow-fill where recent channel modifications had been made, but the overall channel is considered stable. These unstable sections should be modified to avoid future erosional problems in these areas.

**Photo 5: Unstable Section of Top Drain at Intersection with Side Drain.**

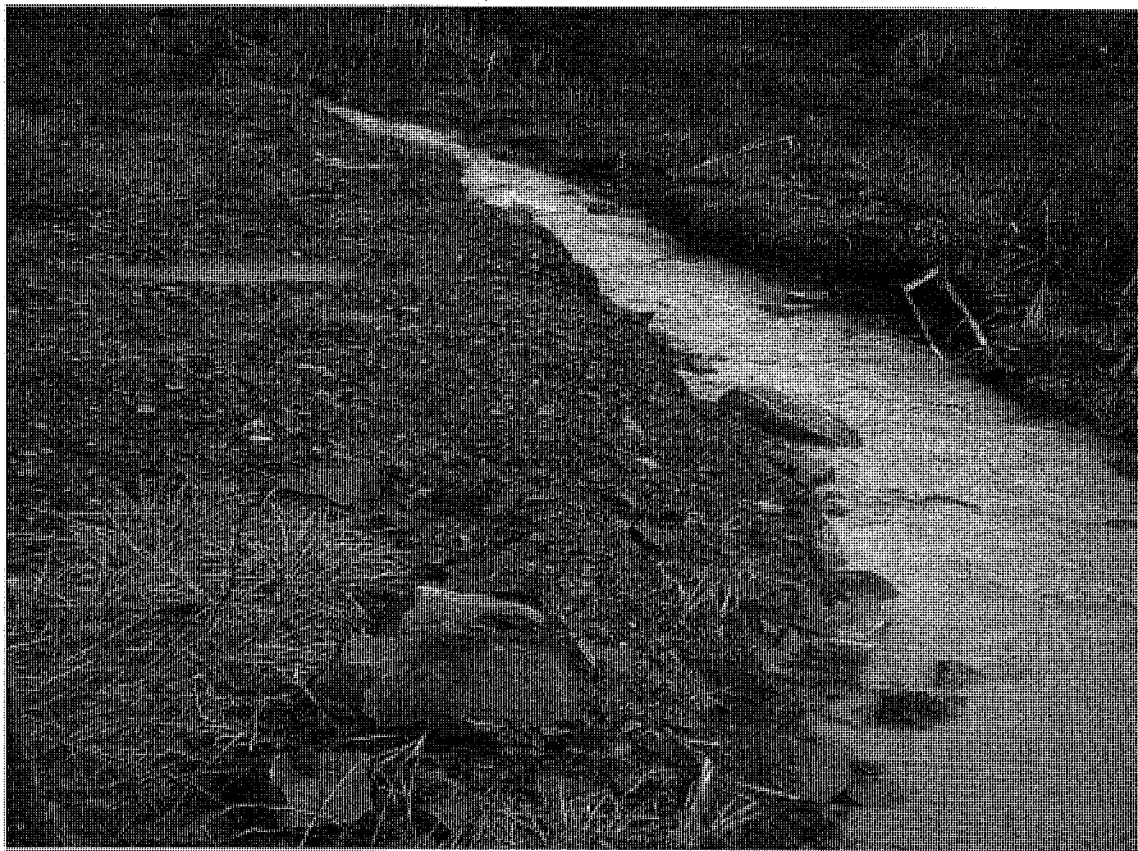
**Photo 6: Top Drain Section (Banks Need Stabilized)**

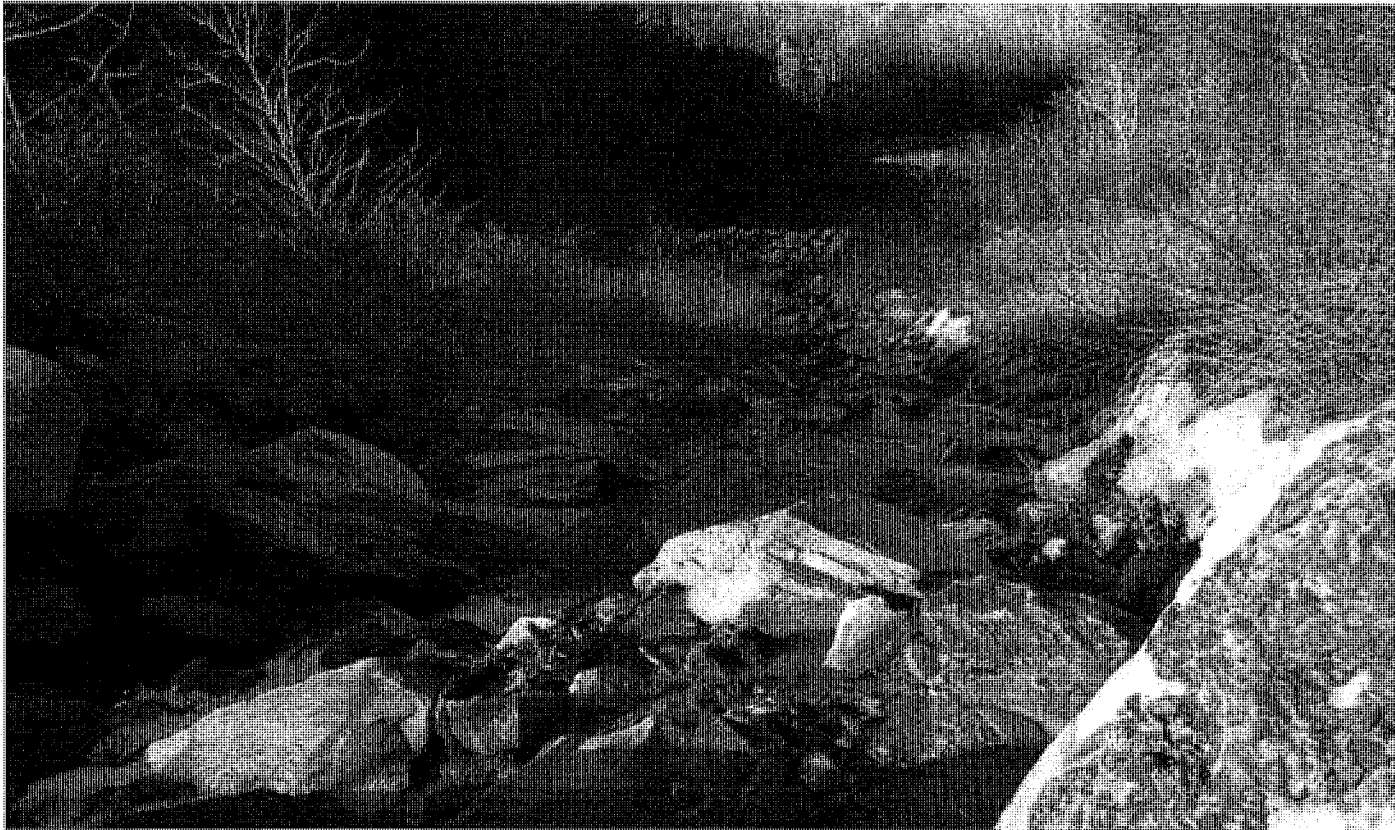
The EII score for the side drain area was 0.30. The habitat score was 115 and the conductivity level was 390. The total length of stream in this section was 549', therefore the EIUs in this reach total 164.7. This is on target to meet the performance measure at year 5.

**Photo 8: Stream Channel at Side Drain**
