Executive Summary

In October 2018, Energisation Ltd. introduced their autonomous battery swapping station that offered Batt-R-E batteries while the swapping system supplied by Lifts and Things Ltd. In April 2020, the photocell was found to be out of service. Tony Best, the operator of the station, was using the emergency override button to initiate the battery swapping process. After 2 years of service, Batt-R-E put a new variant of batteries in circulation. Unfortunately, after a few days, an explosion occurred while a customer, John Taylor, was having his car's battery swapped.

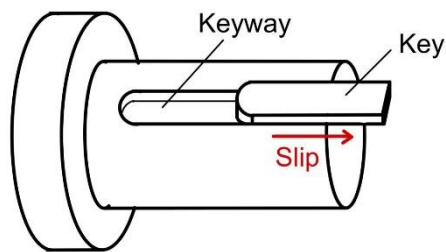
FIGURE 3

The marks on the surface of the key and drive shaft indicate that the grub screws were used as set screws to restrict the movement of the components using friction. Because of overloading, the grub screws and the sprockets are subjected to higher stress than its intended value. It is believed that the grub screws were loosened over time due to this.

The fainting mark of the grub screw along the key suggests that the friction between the grub screw and surface of the key was insufficient to hold the key in place and resulted in the slip of the key towards the casing (**FIGURE 3**) as mentioned on the 4th service report. This argument is further strengthened by the circular mark on the face of the left casing, which has the same width as the key (**FIGURE 4**). Consequently, it caused a small local movement and resulted in a small wallowing indentation in the middle of the keyway (**FIGURE 5A & 5B**). However, due to the uneven loading, only one side of the keyway was indented.

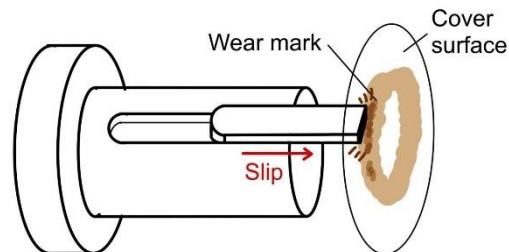
FIGURE 4

View from the top of the keyway

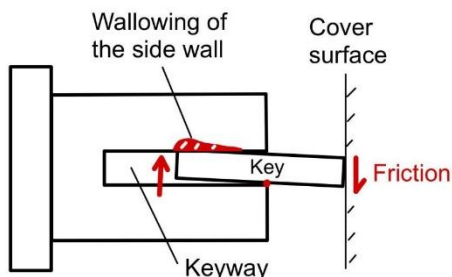
FIGURE 5(A)

Even though this key was replaced in recent service, as mentioned in the maintenance log dated October 2020, the keyway was slightly enlarged due to the vibration effect. This resulted in the new key to slip through easier as the swapping procedure went on. The subsequent slipping of the new key then caused the sprocket of the driveshaft and the sprocket of the lay shaft to misalign (**FIGURE 6**). Consequently, this made the pulling force acting on the chain to be at an angle and

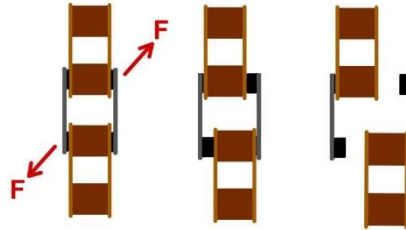
FIGURE 7

opposite to each other (**FIGURE 7**). Hence, it puts greater stress at the weak spot of the chain. Together with the old and rusty chain, the chain components: outer plates and pin, get detached from each other. In turns, the load distribution changed due to one of the chains detach, putting more load through the other 3 chains. Thus, this resulted in a fractured chain on the right-hand side due to overloading (see **Appendix 1**).

Once the two single-roller chains of the same side broke, the platform where the battery is rested tipped over. The battery was then dropped from the platform at height which damaged the battery which led to the explosion.

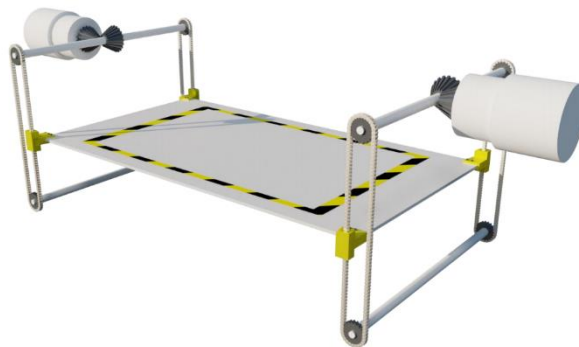
FIGURE 8: SIMPLIFIED SCHEMATIC OF LIFT PLATFORM (HSL - Examination Report, 2020)

The specification for the lift (as shown in **TABLE 3**) in the swapping station was LANDT_XX002A, designed by Lifts and Things Ltd, which can carry a maximum load of 600 kilograms. The platform is made of 12 mm stainless steel plate welded to a square tubular structure. The system uses two three-phase motors rated at 1.1kW and two gearboxes, supplied by Link Controls. A motor and a gearbox are placed at each end of the platform. Also, each motor is connected to two single-roller chains (CA1N04B000), manufactured by Sedis, as shown in the diagram (as shown in **FIGURE 8**).

The drive shafts and layshafts of the lift are directly attached to the wall of the battery swapping bay, this does not provide any structural support to the lifting platform, hence the platform has no solid movement constraints. This causes the platform to move around if the single-roller chains are slacking.
