St-Germain
441
5

The Therac-25 Incident

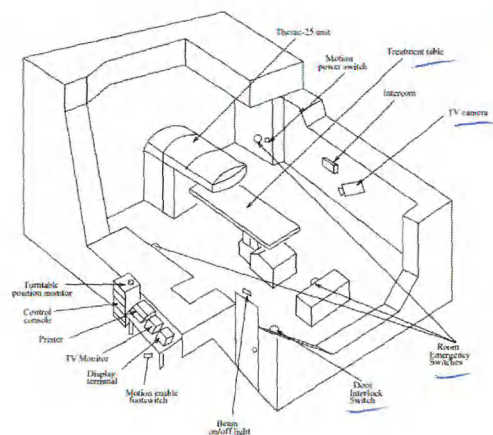
Figure 1. Layout of treatment room and Therac-25 machine [1].

The Therac-25 was a radiation therapy machine, also known as a linear accelerator that was used to treat cancer patients (see Figure 1). The machine was used to eliminate cancerous tissues and remove excess tumours found in cancer patients.

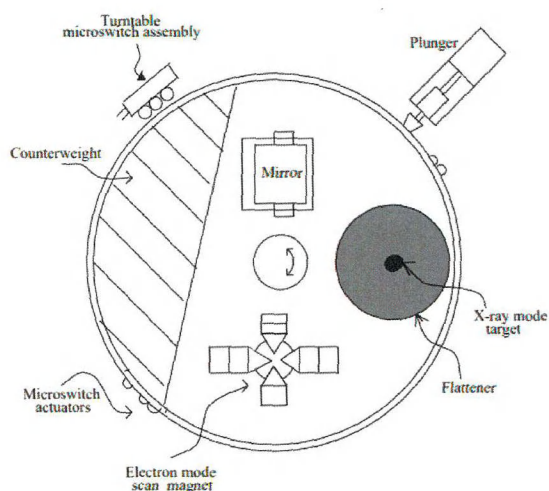
Figure 2. Assembly of upper turntable in Therac-25 [1].

Controlling these two modes of therapy was the turntable (see Figure 2), checked by three microswitches. In the X-ray mode, a beam flattener shaped like an inverted cone ensures that the beam produced are of equal treatment dose. If the turntable is not placed correctly, the beam flattener would also not be in place that results in overdose to the patient [1]. To prevent that from happening, the computer software is used to make sure that the patient, flattener, and photon chamber are in position. A mirror is placed in the machine for the operator to view where the beam will hit before a treatment begins. To start a treatment process, an operator keys in values for treatment manually into the display terminal inside and outside of the treatment room after the patient is in place on the treatment table. The operator also chooses the mode of the beam by keying in 'x' for x-ray beams and 'e' for electron beams. To deliver the beam towards the patient, 'b' is keyed into the terminal. The computer then checks the input variables if they match and rejects treatment if the variables do not match.

Until the second accident happened, AECL did not investigate the machine further. They sent a service technician to the treatment site but as the malfunction could not be reproduced, it was concluded that the microswitches in the turntable had to be fixed and nothing was wrong with the software [1]. Their response later was to ask users check

manually the position of the turntable before use in case the microswitches needed to be fixed [4]. Although an independent consultancy had suggested the use of an independent physical interlock known as a potentiometer, AECL did not adhere to the recommendation and only incorporated tracking of the microswitches movement following the accident [4, 6]. The company even claimed the machine to be 10,000 times safer after the hardware fix [7]. The company did not question the software and only fixed the hardware at this point. Due to AECL's statement, there was no fixes to the software in which errors were later found in it that caused the machine malfunction [1, 4].
