The Therac-25 Incident

ABSTRACT

Safety critical systems, accidents, Therac-25, software safety

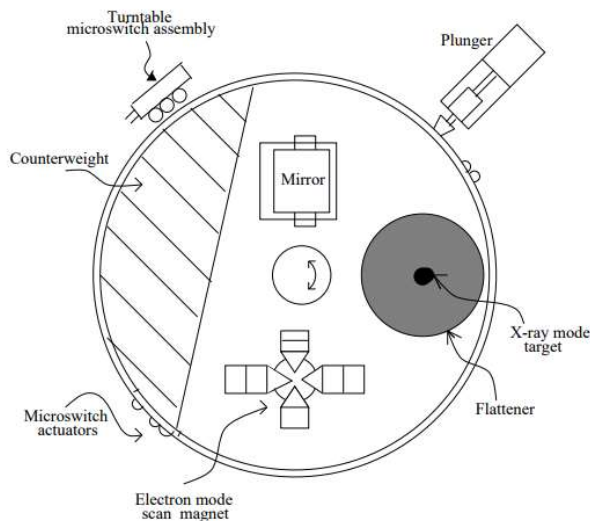
Figure 2. Assembly of upper turntable in Therac-25 [1].

Controlling these two modes of therapy was the turntable (see Figure 2), checked by three microswitches. In the X-ray mode, a beam flattener shaped like an inverted cone ensures that the beam produced are of equal treatment dose. If the turntable is not placed correctly, the beam flattener would also not be in place that results in overdose to the patient [1]. To prevent that from happening, the computer software is used to make sure that the patient, flattener, and photon chamber are in position. A mirror is placed in the machine for the operator to view where the beam will hit before a treatment begins. To start a treatment process, an operator keys in values for treatment manually into the display terminal inside and outside of the treatment room after the patient is in place on the treatment table. The operator also chooses the mode of the beam by keying in 'x' for x-ray beams and 'e' for electron beams. To deliver the beam towards the patient, 'b' is keyed into the terminal. The computer then checks the input variables if they match and rejects treatment if the variables do not match.

Until the second accident happened, AECL did not investigate the machine further. They sent a service technician to the treatment site but as the malfunction could not be reproduced, it was concluded that the microswitches in the turntable had to be fixed and nothing was wrong with

the software [1]. Their response later was to ask users check manually the position of the turntable before use in case the microswitches needed to be fixed [4]. Although an independent consultancy had suggested the use of an independent physical interlock known as a potentiometer, AECL did not adhere to the recommendation and only incorporated tracking of the microswitches movement following the accident [4, 6]. The company even claimed the machine to be 10,000 times safer after the hardware fix [7]. The company did not question the software and only fixed the hardware at this point. Due to AECL's statement, there was no fixes to the software in which errors were later found in it that caused the machine malfunction [1, 4].
