Rim Cracking of the Cross-Linked Longevity Polyethylene Acetabular Liner After Total Hip Arthroplasty

By Stephen S. Tower, MD, John H. Currier, MS, Barbara H. Currier, MChE, Kimberly A. Lyford, AB, Douglas W. Van Citters, PhD, and Michael B. Mayor, MD

Investigation performed at the Thayer School of Engineering, Dartmouth College, Hanover, New Hampshire

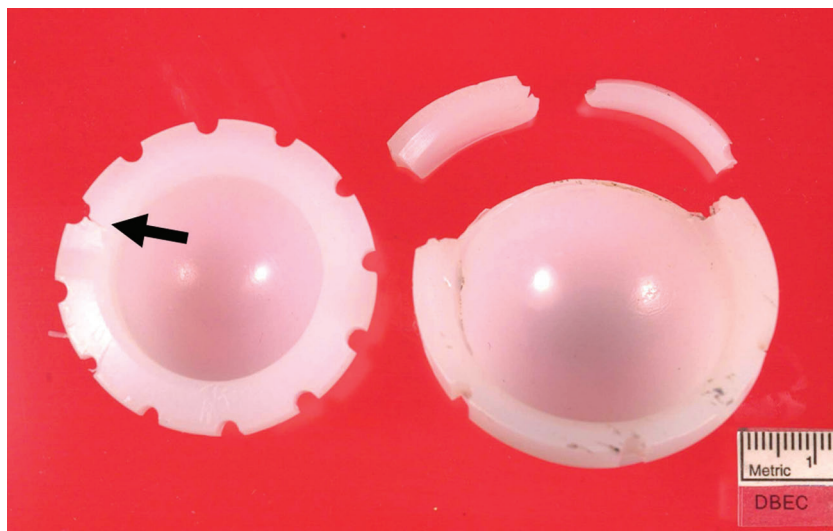
Fig. 1

The retrieved liners demonstrated burnishing, scratching, abrasion, and creep that were in most cases rated as moderate (2 on the scale of 0 to 3)¹¹, implying that there were easily detected levels of change in the material surface. None were rated as severe in these wear modes. There was no instance of pitting or delamination. All of the liners showed severe cracking or failure at the rim with damage evident at the superior aspect at the groove in the polyethylene that engages the locking ring of the Trilogy shell (Zimmer) (Fig. 1).

Components retrieved from the first patient (Case 1). *Left*: The acetabular liner implanted during the primary arthroplasty and retrieved after eleven months in vivo. The arrow indicates the location of a crack in the rim of the liner. *Right*: The revision acetabular liner retrieved after twenty-three months in vivo. Two segments of the rim were found dissociated from the liner at retrieval.

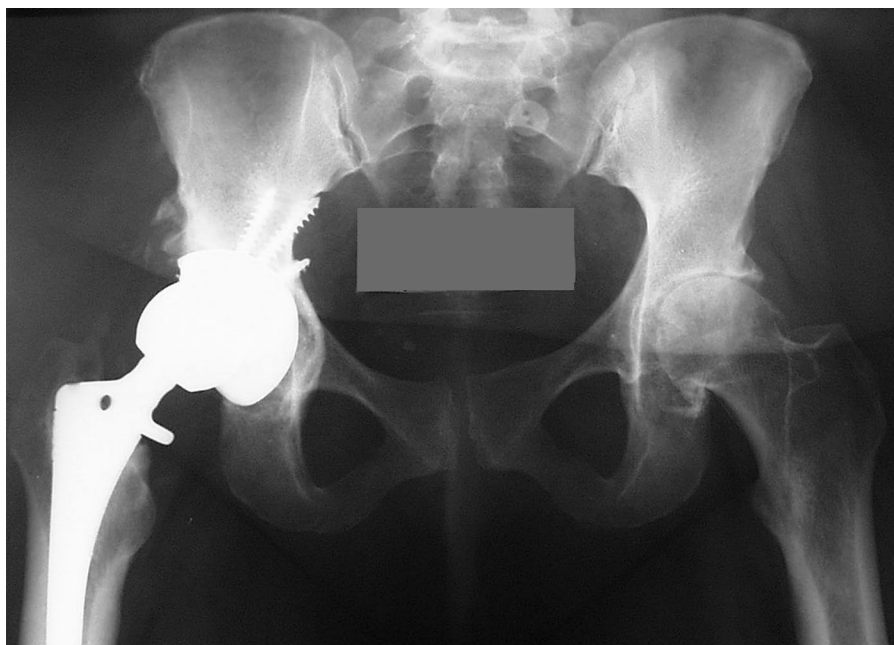
Fig. 2

Anteroposterior radiograph of first patient (Case 1) made fourteen months following revision surgery. The cup abduction angle was 62° at that time.

At fourteen months after the revision, radiographs showed that cup abduction had increased to 62° and a gap estimated at 3 mm in zone 3¹⁵ was noted as the shell had pivoted to a more vertical position (Fig. 2). By eighteen months after the revision, the cup abduction angle had increased to 68°. The patient was again having symptomatic subluxations. A second revision was performed twenty-three months after the first revision. The retrieved Longevity liner was found to be fragmented at the superior quadrant.

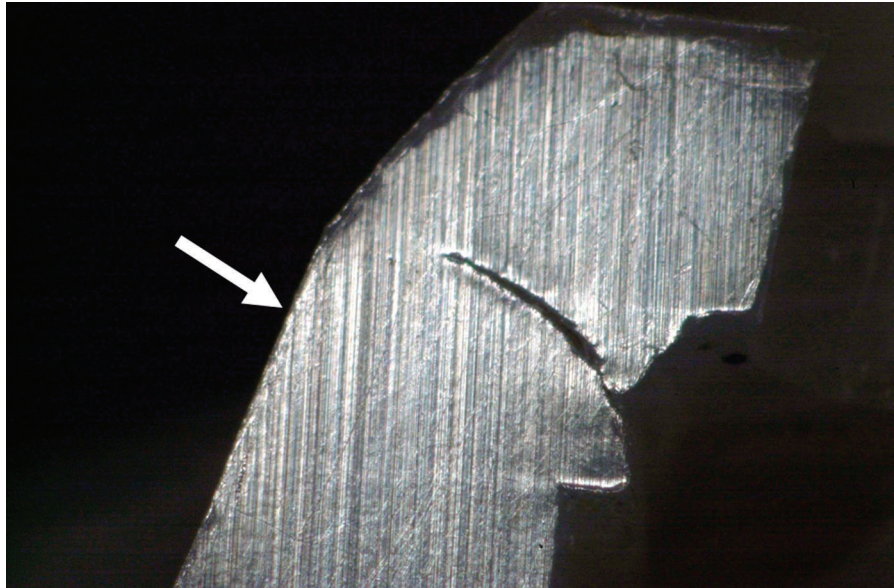
Fig. 3

Cross section of the primary liner from the second patient (Case 2), taken near one end of the fractured segment, confirming that the fracture initiated at the outer edge of the liner and propagated inward toward the articular surface (indicated by arrow).

The character of the fracture surface of the primary liner from the second patient (Case 2) showed evidence of the mode and sequence of these rim failures. The cracking in the liner rims

appeared to have been initiated at the outer edge, near the 90° intersection of the flange and the cylindrical section of the cup. This is consistent with a corner stress concentration and the loading that would result from the rim contact seen in the prerevision radiograph. The crack propagated inward toward the articular surface of the liner and extended laterally around the cup perimeter for the length of one rim segment between the peripheral machined notches. In the instance of the primary liner from this patient, the crack propagated inward only partially through the thickness of the rim, helping to establish the failure sequence (Fig. 3). The fracture surfaces on the primary liner from this patient were the only fracture surfaces among the retrieved devices that had remained undisturbed and were therefore appropriate for fracture surface analysis.
