### STM32F401xD and STM32F401xE device errata

This document applies to the part numbers of STM32F401xD/E devices and the device variants as stated in this page.

It gives a summary and a description of the device errata, with respect to the device datasheet and reference manual RM0368.

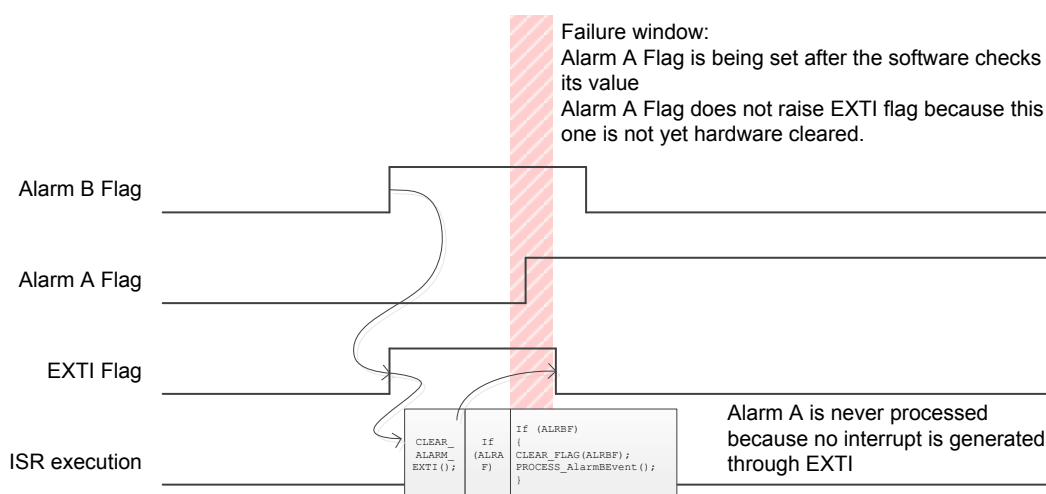
Figure 1. Masked RTC interrupt

The following code example and figure illustrate the failure mechanism: The Alarm A event is lost (fails to generate interrupt) as it occurs in the failure window, that is, after checking the Alarm A event flag but before the effective clear of the EXTI interrupt flag by hardware. The effective clear of the EXTI interrupt flag is delayed with respect to the software instruction to clear it.
