BMW Airhead Oil Filter Canister Displacement: Service Practice, Load Paths, and the \$2,000 O-Ring Myth

Custom Konrad

January 11, 2026

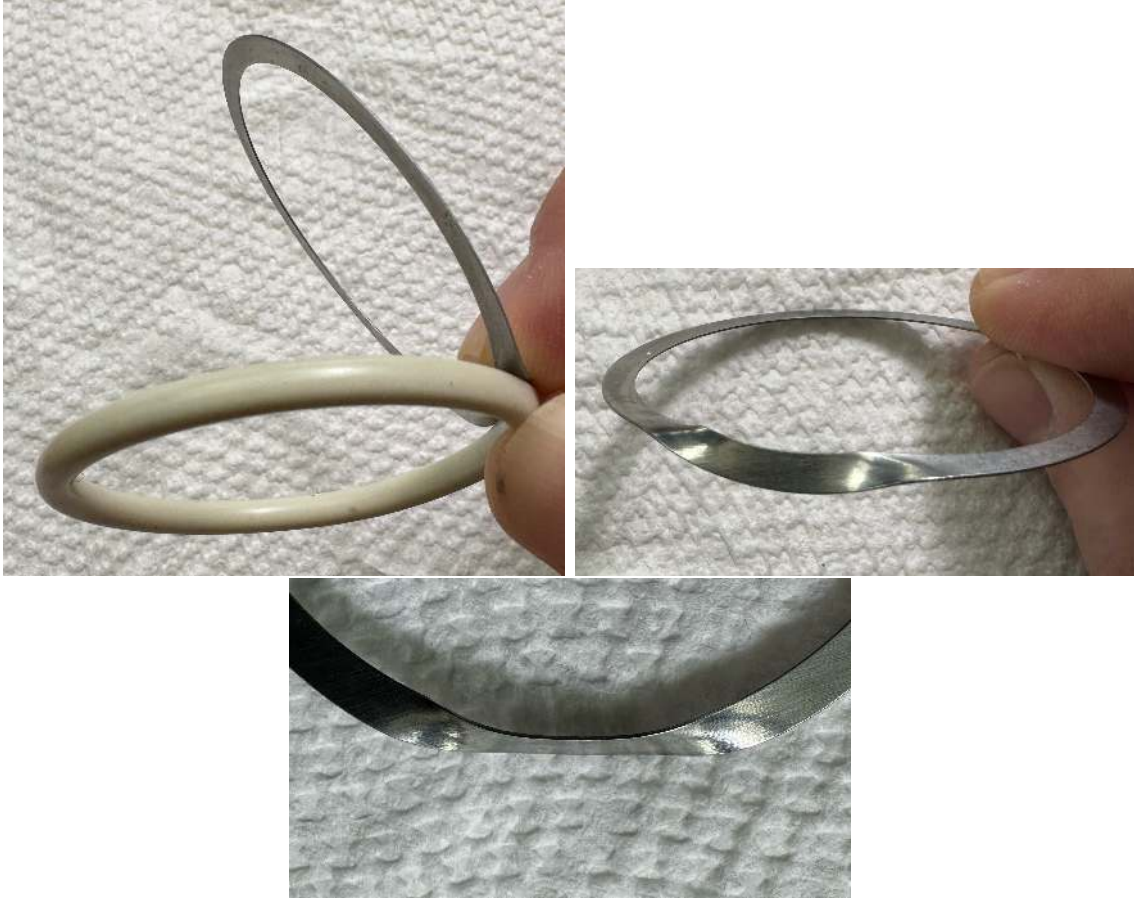
Figure 1: *O-ring and shim condition as found. The shim shows smooth, continuous plastic curvature in the region rendered unsupported by radial displacement of the canister mouth. The O-ring appears nominal in the images and is included for reference; its contribution to the observed deformation arises from load redistribution under geometric constraint rather than from visible material distortion.*

Further inspection identified radial interference between the oil filter canister and an overlong oil pan fastener located beneath the canister mouth. During installation, slight resistance was felt while tightening this fastener. This resistance was initially interpreted as normal thread engagement but is more consistently explained as the onset of lateral contact between the fastener tip and the thin-wall steel canister, introducing an unintended radial jacking load.

Under these altered support conditions, the O-ring continues to transmit its preload into the seal stack, as quantified above. Because the shim is no longer uniformly supported, this force is applied over a reduced and asymmetric area, causing the unsupported portion of the shim to plastically deform and translate axially. The resulting axial motion drives the elastomer laterally into the annular gap between the canister and the crankcase face, producing the observed external oil leak.

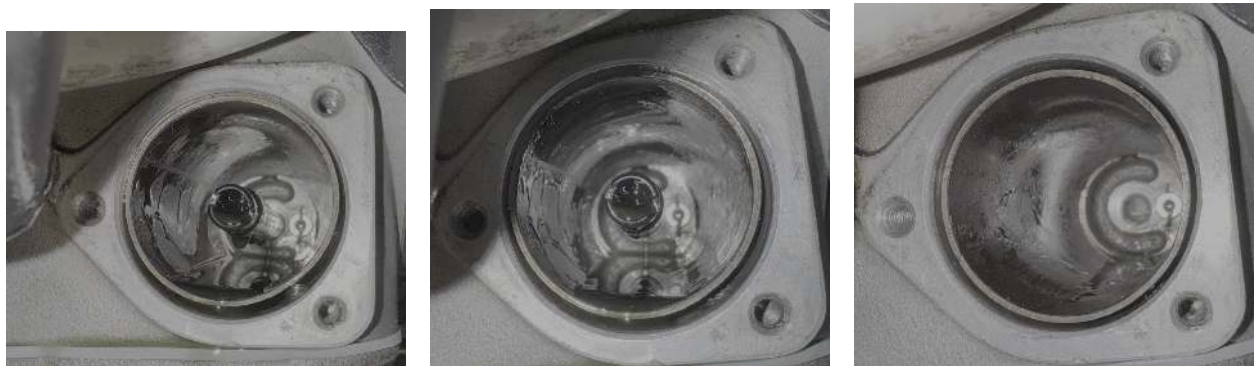
The mechanical response of the canister to this interference is documented in Fig. 2(a–c). After removal of the fastener, partial elastic spring-back was observed, but the canister did

(a) Localized deformation identified (b) Fastener removed as first corrective action (c) Canister mechanically re-centered by controlled levering

Figure 2: Canister displacement and recovery sequence, demonstrating dominant rigid-body motion about the distal press-fit region. (a) Localized deformation at the canister mouth caused by unintended radial jacking. Note the bolt protrusion visible in the lower-right quadrant (near the 5 o'clock position). (b) After fastener removal, partial elastic spring-back occurs, but full self-centering does not occur without an applied corrective moment. (c) Deliberate mechanical re-centering at the mouth restores nominal alignment of the canister relative to the crankcase bore. The central PIPE was removed at this stage to provide clearance for controlled levering without interference.

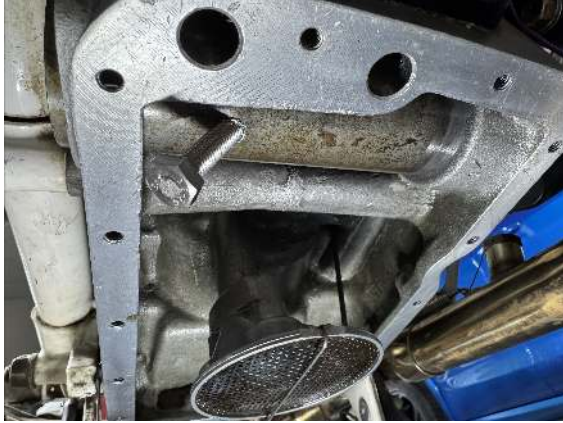
(a) Localized wall deformation during drive-out tapping. The bolt contact reaction at the canister wall was effectively radial prior to tapping. Plastic deformation and bolt rotation within the thin sheet are unavoidable.

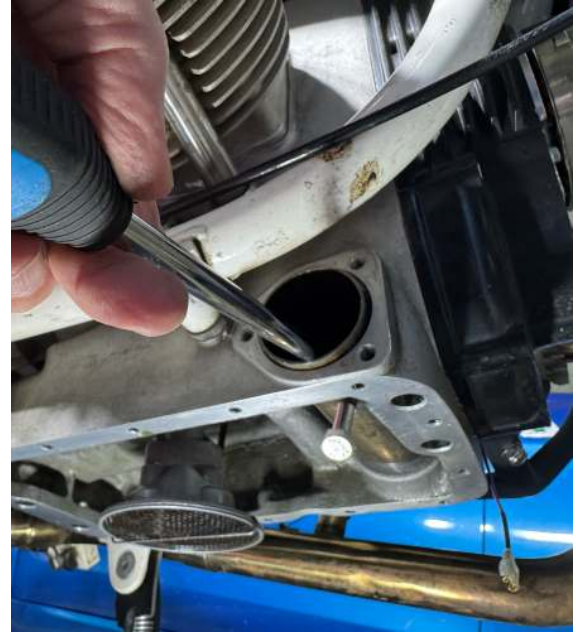
(b) Counter-torque applied to maintain axial alignment and prevent bore damage.

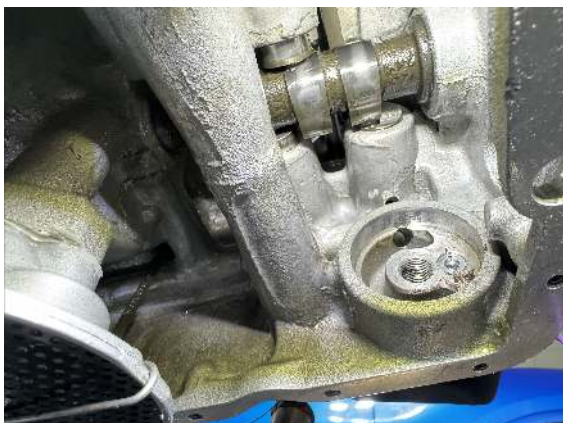
(c) Canister removed after controlled tapping se-

5. **Completion and inspection.** Once released, remove the canister by hand. Carefully remove all chip containment measures and clean the cavity thoroughly. Inspect the bore for scoring, raised material, or damage before proceeding with installation.

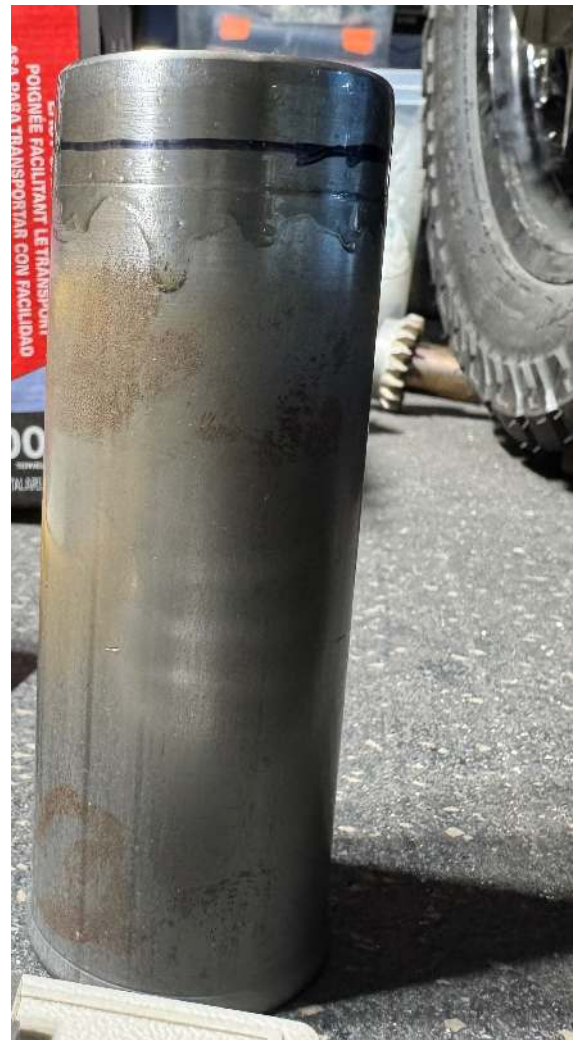
(d) Replacement canister distal end cleaned and

Prior to insertion, the distal end of the replacement canister was cleaned with gray Scotch-Brite to remove light surface oxidation and condition the surface for uniform contact during seating. The contact region was then lightly lubricated with engine oil to reduce insertion friction and mitigate the risk of galling.

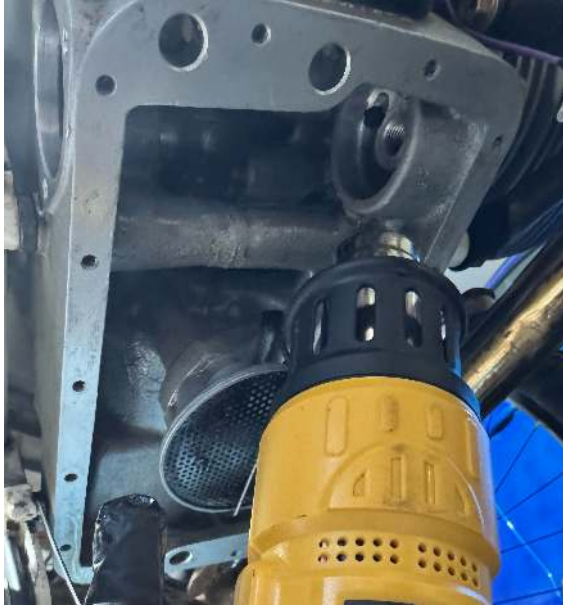
(e) Crankcase warmed with heat gun to reduce insertion force via differential expansion.

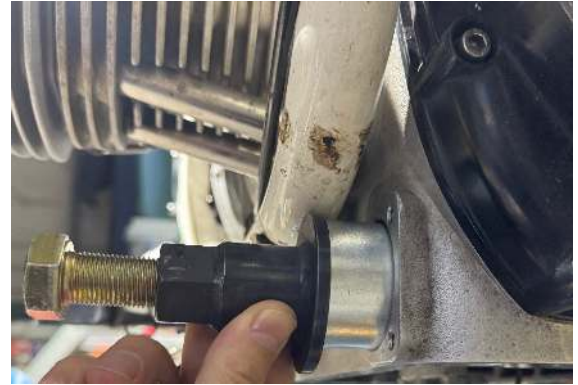
(f) Temporary axial driver assembled from available engine tools.

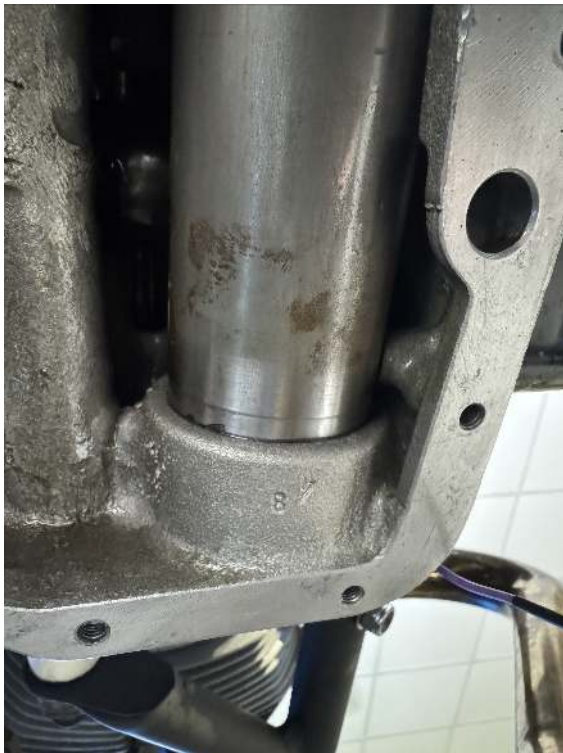
(g) Final installed position relative to the reference depth mark.

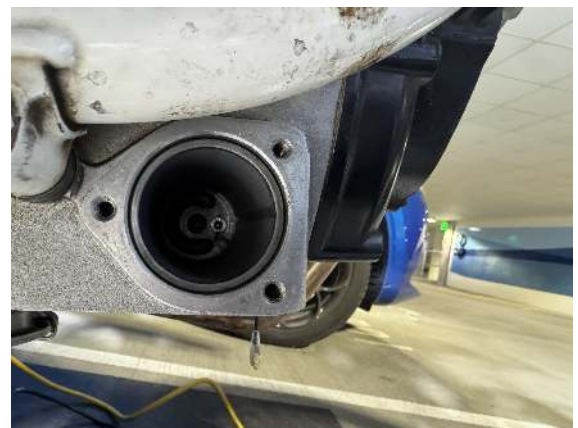
(h) View into installed canister showing improved concentricity and self-centering.

At no point during the installation was corrective re-centering required, and no evidence of asymmetric resistance or elastic spring-back was observed after seating. These observations are consistent with a clean, undistorted bore and with the mechanically more forgiving mouth geometry of the later-style canister.
