# BMW Airhead Oil Filter Canister Displacement: Service Practice, Load Paths, and the \$2,000 O-Ring Myth

Custom Konrad

January 10, 2026

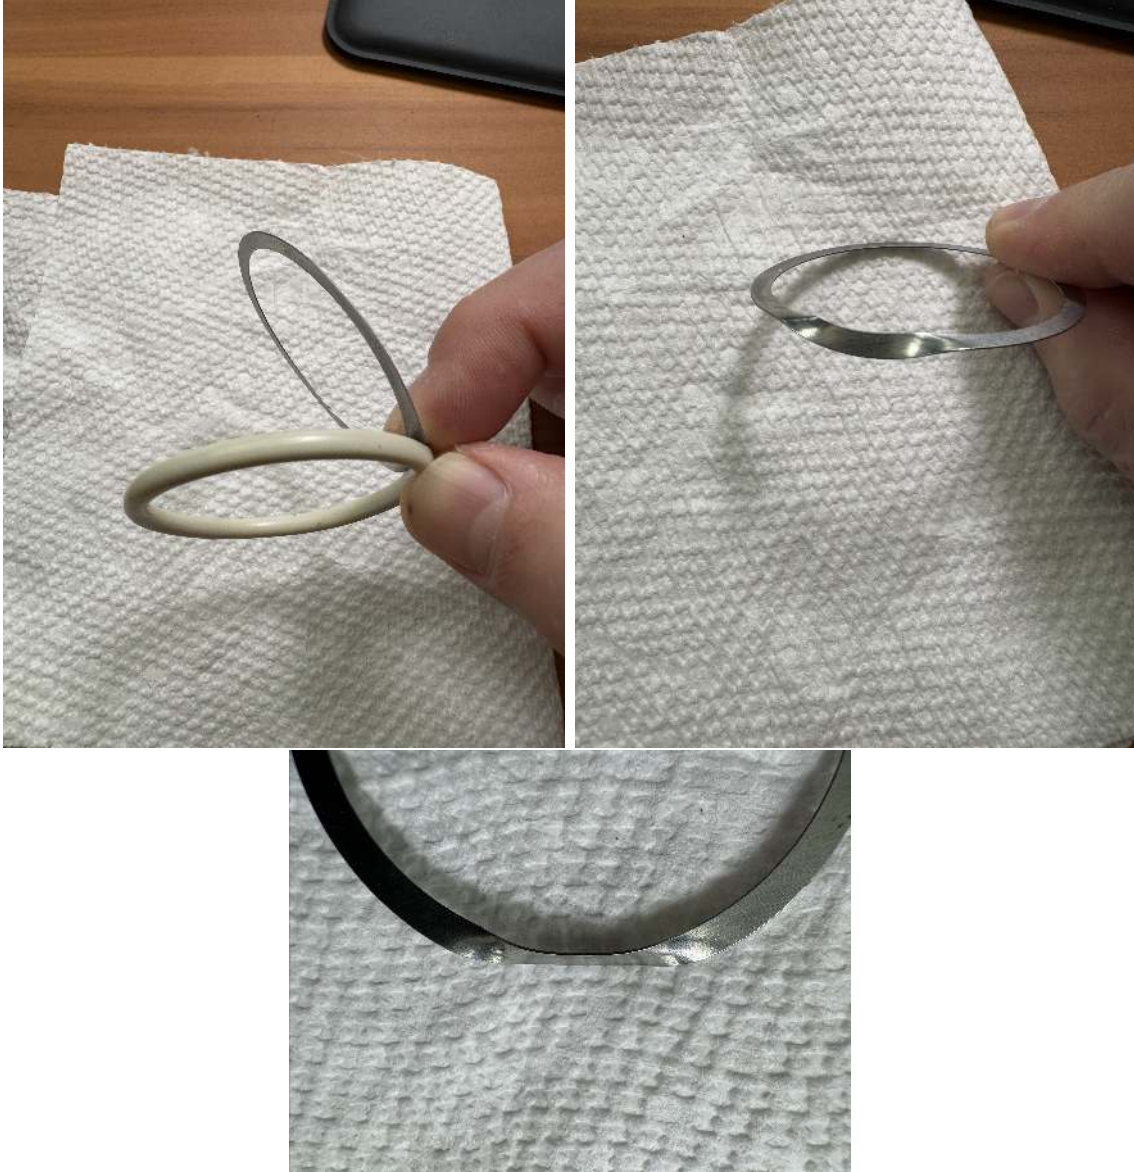
Inspection of the sealing components revealed deformation consistent with a shift in support conditions at the canister mouth rather than gross material failure of the elastomer. In particular, the shim exhibited smooth plastic curvature, consistent with being driven into an unsupported region after a local change in load path. The O-ring appeared nominal visually, but its role in the observed behavior is governed by constraint and load redistribution rather than visible distortion.

**Figure 1:** *O-ring and shim condition as found. The shim shows smooth, continuous plastic curvature in the region rendered unsupported by radial displacement of the canister mouth. The O-ring appears nominal in the images and is included for reference; its contribution to the observed deformation arises from load redistribution under geometric constraint rather than from visible material distortion.*

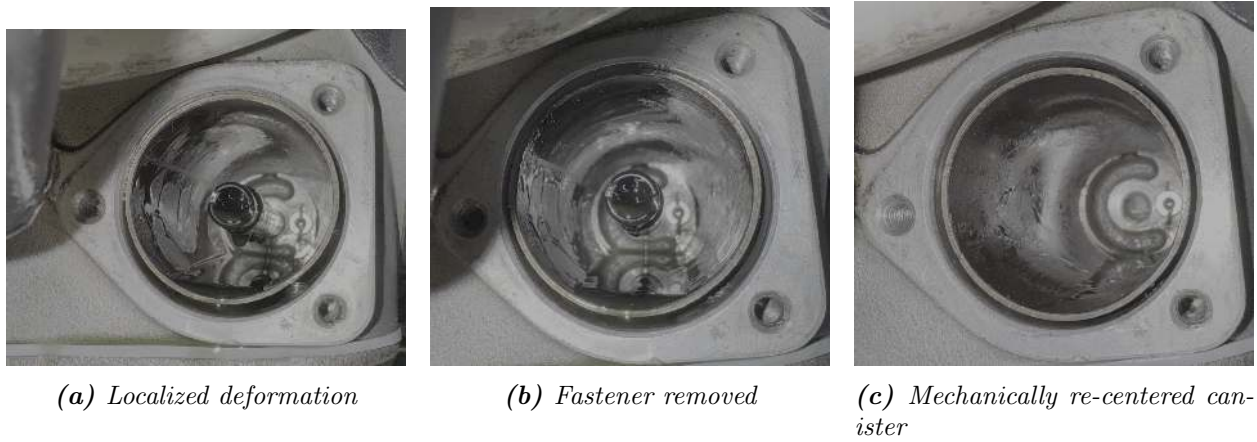
Following fastener removal, partial elastic recovery of the canister mouth was observed, but full self-centering did not occur. Deliberate mechanical re-centering at the mouth restored nominal alignment, consistent with dominant rigid-body motion about a distal press-fit region.

**Figure 2:** Canister displacement and recovery sequence, demonstrating dominant rigid-body motion about the distal press-fit region. (a) Localized deformation at the canister mouth caused by unintentional force in the lower-right quadrant (near the 5 o'clock position). (b) After fastener removal, partial elastic spring-back occurs, but self-centering does not occur without an applied corrective moment. (c) Deliberate mechanical re-centering at the mouth restores nominal geometry and provides clearance for controlled levering without interference.

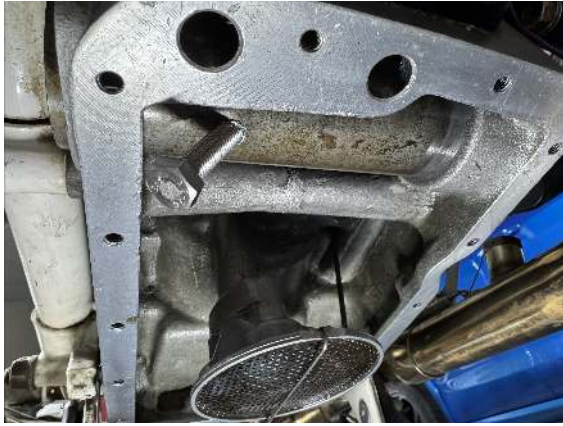
(a) Localized wall deformation during drive-out tapping. The bolt orientation was perpendicular to the canister prior to tapping. Plastic deformation and bolt rotation within the thin sheet are unavoidable.

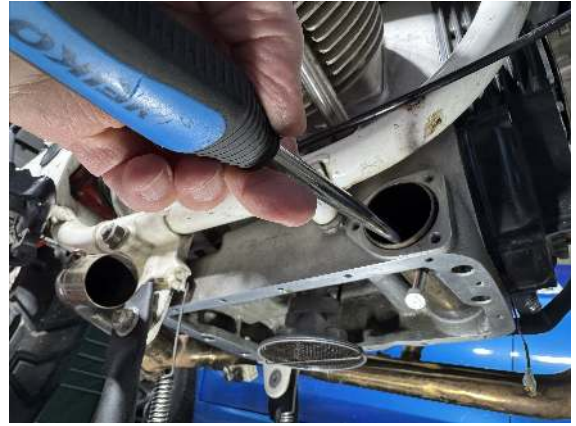
(b) Counter-torque applied to maintain axial alignment and prevent bore damage.

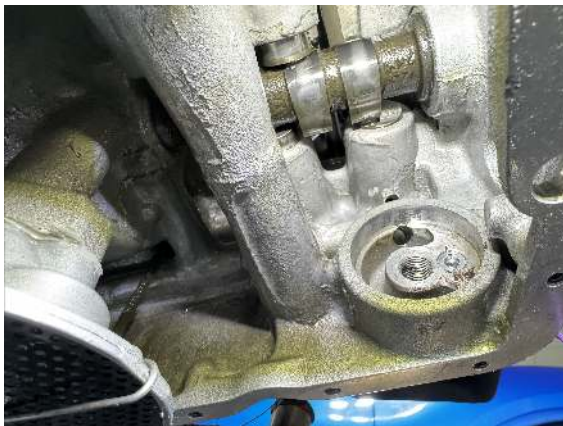
(c) Canister removed after controlled tapping sequence.

5. **Completion and inspection.** Once released, remove the canister by hand. Carefully remove all chip containment measures and clean the cavity thoroughly. Inspect the bore for scoring, raised material, or damage before proceeding with installation.

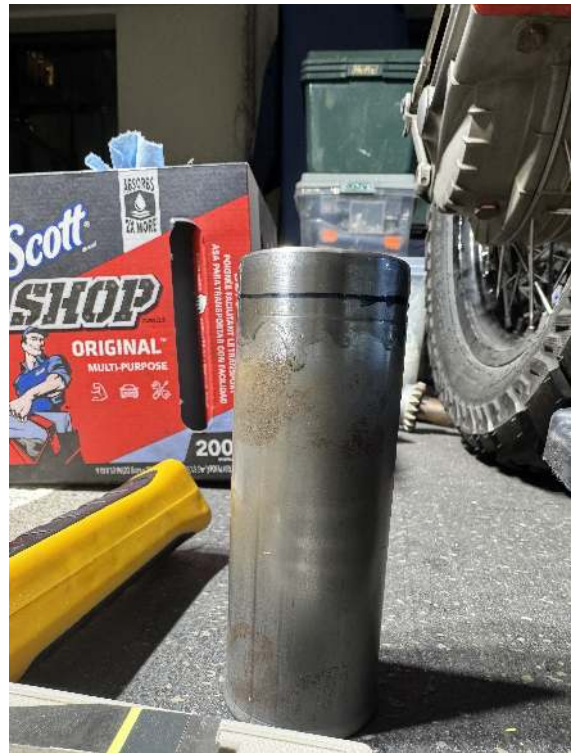
(d) Replacement canister distal end cleaned and lightly oiled prior to insertion. Note the traced insertion depth check line.

Prior to insertion, the distal end of the replacement canister was cleaned with gray Scotch-Brite to remove light surface oxidation and condition the surface for uniform contact during seating. The contact region was then lightly lubricated with engine oil to reduce insertion friction and mitigate the risk of galling.

- Final depth control was achieved through direct measurement by transferring the wear mark from the original canister onto the replacement canister (Fig. 3d), and tapping the replacement canister into the bore until this reference mark was reached (Fig. 3g). This approach leverages the confirmed axial equivalence of the original and replacement canisters, with any residual variation accommodated using external shims.

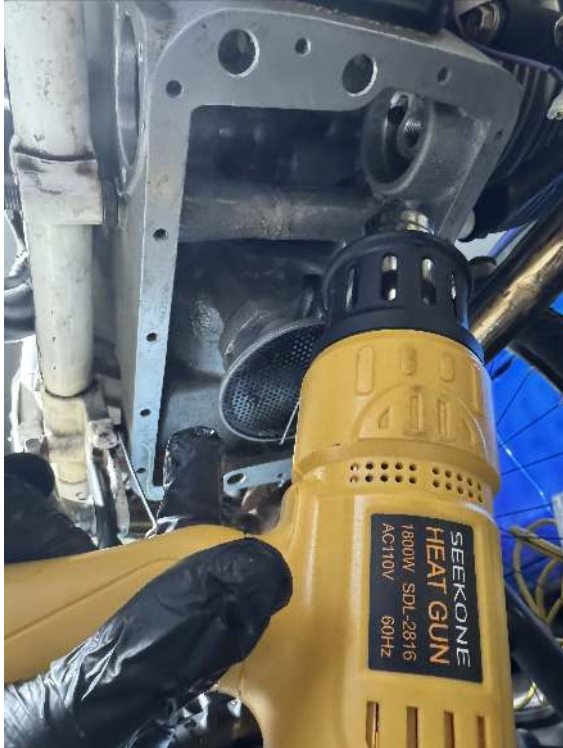
(e) Crankcase warmed with heat gun to reduce insertion force via differential expansion.

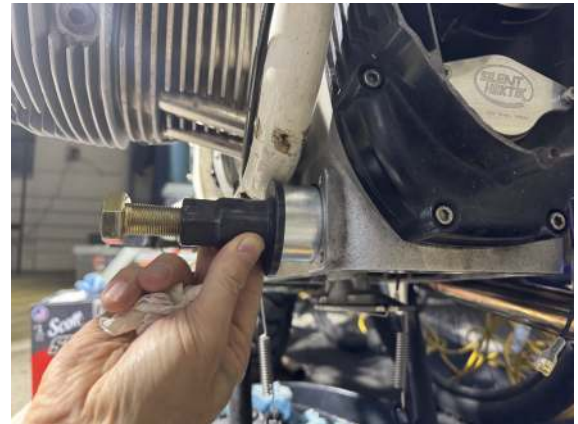
(f) Temporary axial driver assembled from available engine tools.

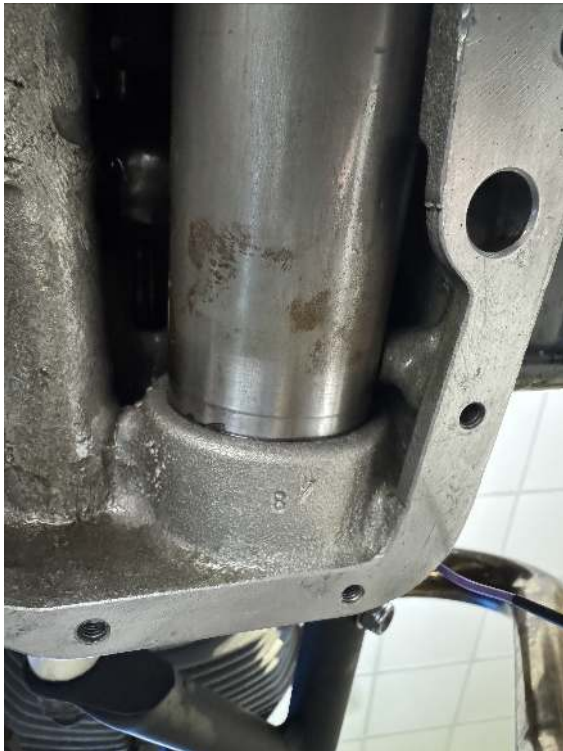
(g) Final installed position relative to the reference depth mark.

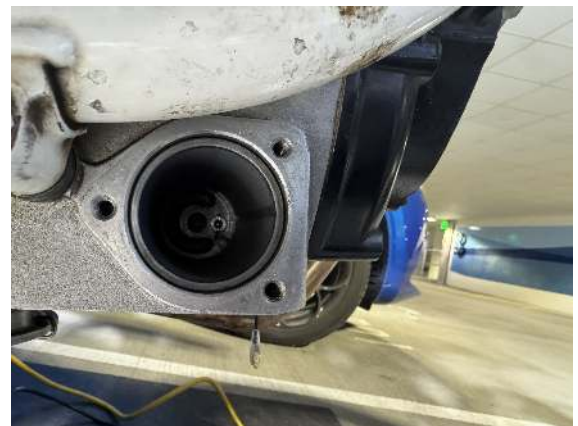
At no point during the installation was corrective re-centering required, and no evidence of asymmetric resistance or elastic spring-back was observed after seating. These observations are consistent with a clean, undistorted bore and with the mechanically more forgiving mouth geometry of the later-style canister.

(h) View into installed canister showing improved concentricity and self-centering.
