BMW Airhead Oil Filter Canister Displacement: Service Practice, Load Paths, and the \$2,000 O-Ring Myth

Custom Konrad

January 10, 2026

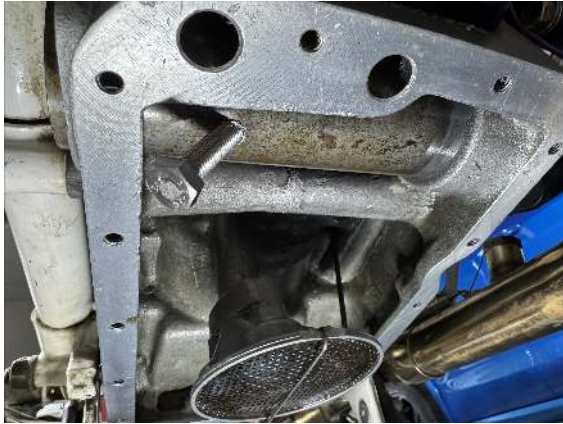
(a) Localized wall deformation during drive-out tapping. The bolt orientation was perpendicular to the canister prior to tapping. Plastic deformation and bolt rotation within the thin sheet are unavoidable.

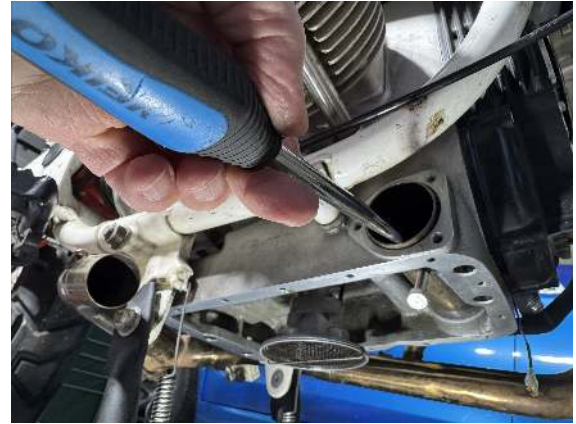
(b) Counter-torque applied to maintain axial alignment and prevent bore damage.

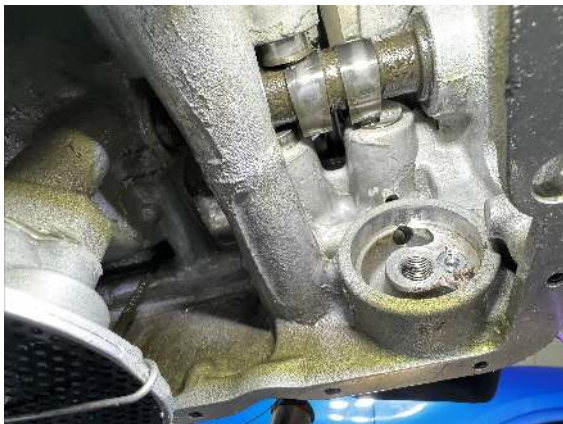
(c) Canister removed after controlled tapping sequence.

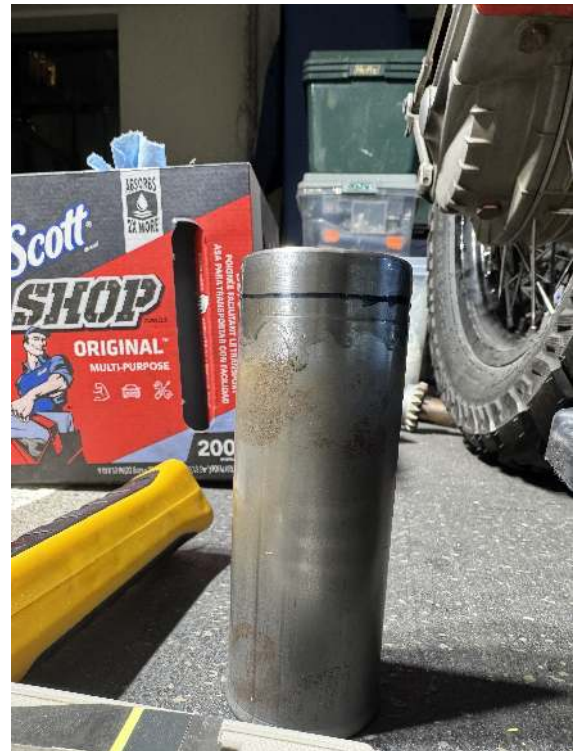
(d) Replacement canister distal end cleaned and lightly oiled prior to insertion. Note the traced insertion depth check line.

- Final depth control was achieved through direct measurement by transferring the wear mark from the original canister onto the replacement canister (Fig. 1d), and tapping the replacement canister into the bore until this reference mark was reached (Fig. 1g). This approach leverages the confirmed axial equivalence of the original and replacement canisters, with any residual variation accommodated using external shims.
