BMW Airhead Oil Filter Canister Displacement: Service Practice, Load Paths, and the \$2,000 O-Ring Myth

Custom Konrad

January 10, 2026

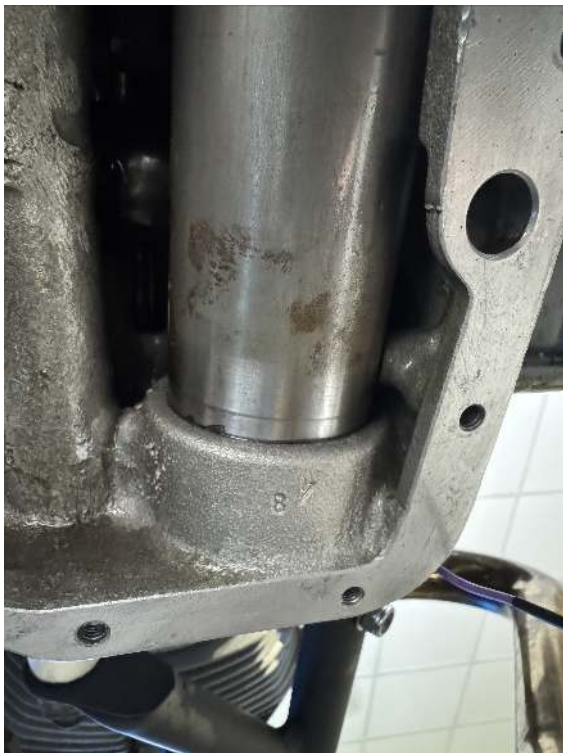
(g) Final installed position relative to the reference depth mark.
