BMW Airhead Oil Filter Canister Displacement: Service Practice, Load Paths, and the \$2,000 O-Ring Myth

Custom Konrad

January 11, 2026

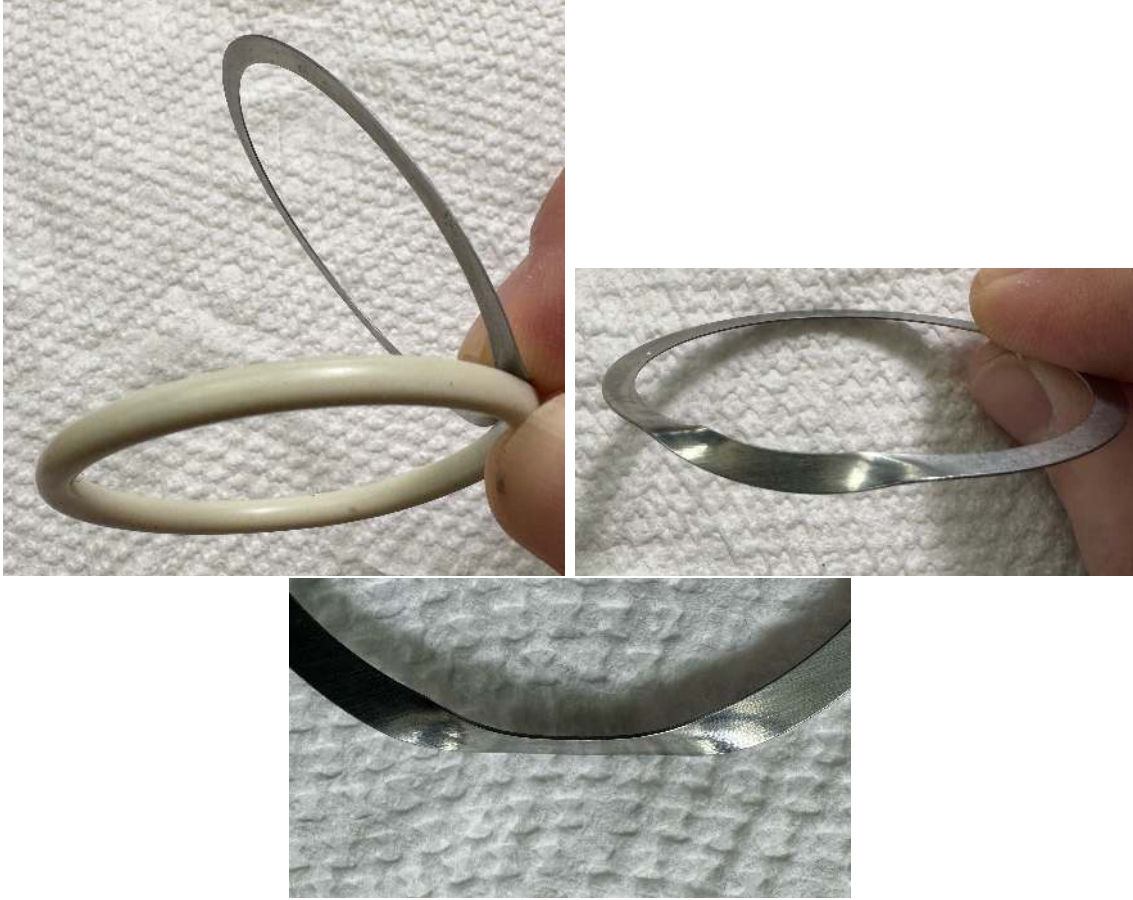
Figure 1: *O-ring and shim condition as found. The shim shows smooth, continuous plastic curvature in the region rendered unsupported by radial displacement of the canister mouth. The O-ring appears nominal in the images and is included for reference; its contribution to the observed deformation arises from load redistribution under geometric constraint rather than from visible material distortion.*

Under these altered support conditions, the O-ring continues to transmit its preload into the seal stack, as quantified above. Because the shim is no longer uniformly supported, this force is applied over a reduced and asymmetric area, causing the unsupported portion of the shim to plastically deform and translate axially. The resulting axial motion drives the elastomer laterally into the annular gap between the canister and the crankcase face, producing the observed external oil leak.
