BMW Airhead Oil Filter Canister Displacement: Service Practice, Load Paths, and the \$2,000 O-Ring Myth

Custom Konrad

January 10, 2026

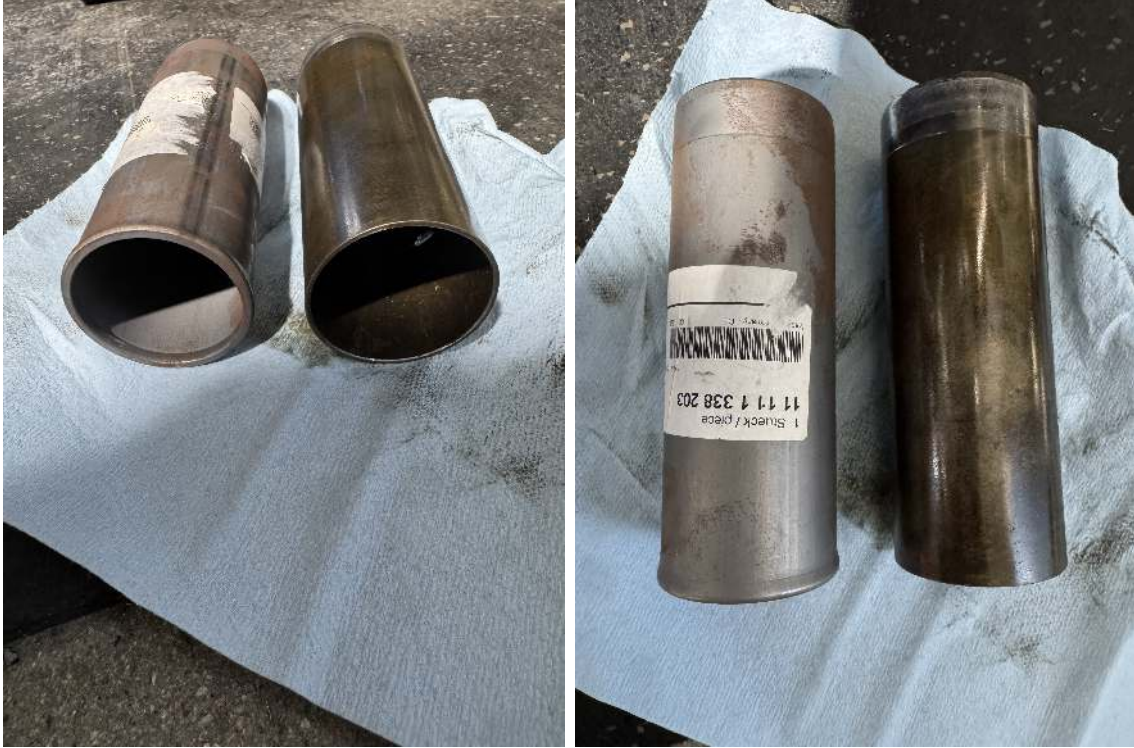
Figure 1: Replacement canister mouth geometry and comparison. The later-style mouth is formed by outward flare, inward roll, and final axial flattening, producing a broad, stiff sealing land. A side-by-side view shows the mouth profile and the BMW part number presentation on the replacement canister.

Mechanically, the formed mouth behaves like a locally thickened ring, improving O-ring support and load distribution and raising resistance to local deformation under axial preload. A practical consequence is earlier feedback under abnormal contact: the enlarged mouth reduces available radial clearance, so an intrusion (e.g., an overlong fastener) arrests motion sooner and converts added fastener rotation more directly into reaction force, causing installation torque to rise more steeply and be felt earlier. This does not imply interference is ever “silent”—in the present case resistance was distinctly abnormal and should have been treated as a stop condition—but it does indicate a higher force scale is required to drive meaningful mouth displacement in the later design.
