Embankment breaching and its management in Gosaba and Basanti blocks of Sundarbans, West Bengal

Kanail Das¹

Karabi Das²

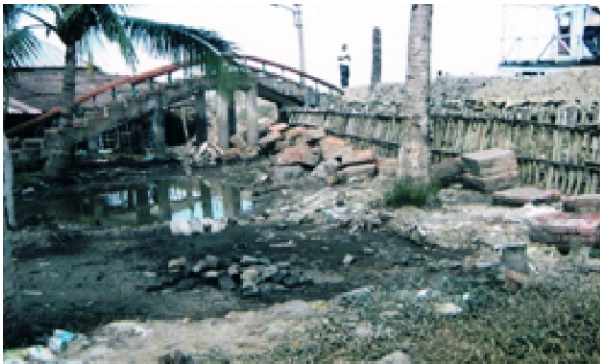
dilapidated condition of the earthen embankment has led to the inundation at Bidhan colony near Kakmari Bazar. The temple at Kakmari bazaar had got submerged during Aila with no recovery further. The new embankment at the left has been constructed after Aila as the previous embankment had been damaged during Aila. Moreover the settlement to the south of Kakmari Bazar has been included in the river Garal. Birajnagar, at the confluence of Bidya and Durgaduani was considered for this study. A tubewell there is the only source of drinking water for 1800 people. The field photograph shows the temporary tents the only shelter of the people on the embankment of Bali II. The condition of the houses there is dilapidated mostly earthen huts on the embankment. Rice cultivation has been affected by saline water condition of November 2010.

Fig. 1: Temple near Kakmari Bazaar.

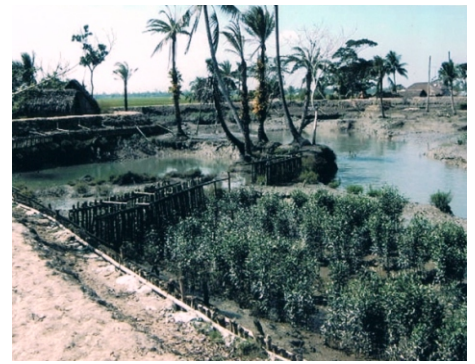
Fig. 2: Bidhan colony near Kakmari Bazaar

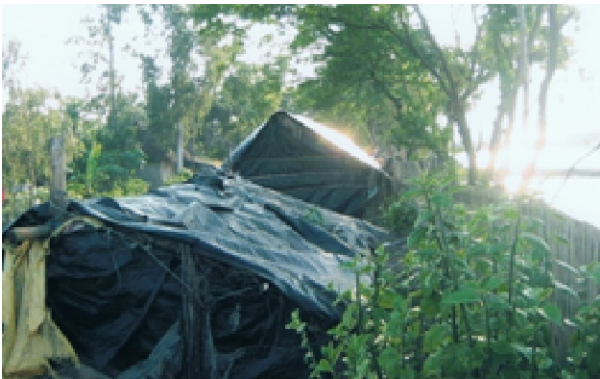
Fig. 3: Tents on the Embankment - Bali 2

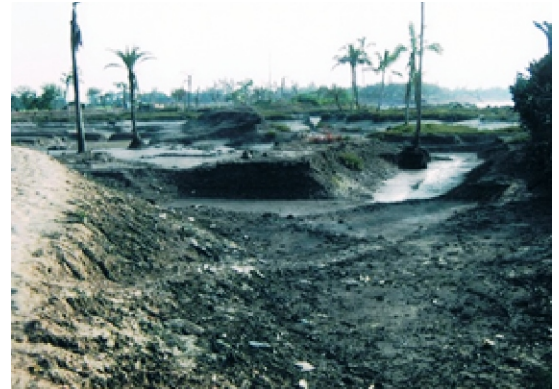
The field photographs show that the settlement has been abandoned due to inundation of water during Aila. The agricultural plots have been totally submerged and the trees are seen to be left in worst condition.

Fig. 4: Ramnagar Abad after Aila

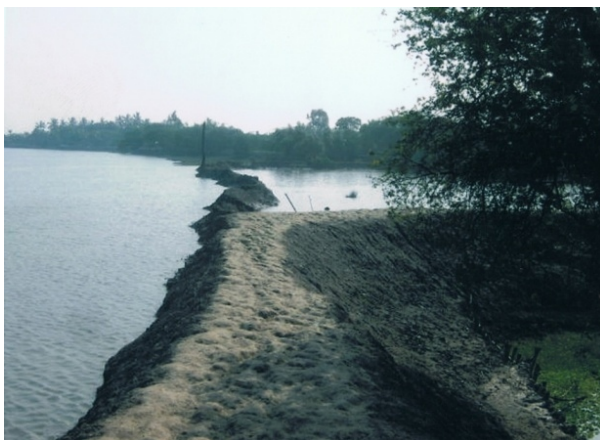
During Aila, the river Suryaberia of Sambhunagar had joined the Hatakhali river on its opposite side through a small creek inland. This situation had left about 5.56 sq km area totally inundated. Photo 5 Suryaberia river had joined the Hatakhali during Aila. This embankment was photographed in 2010. In the subsequent years, this embankment had got submerged and now the local people stand and walk on the submerged part to indicate its trace. New embankments have been built in subsequent years.

Fig. 5: Suryaberia river had joined the Hatakhali during Aila.

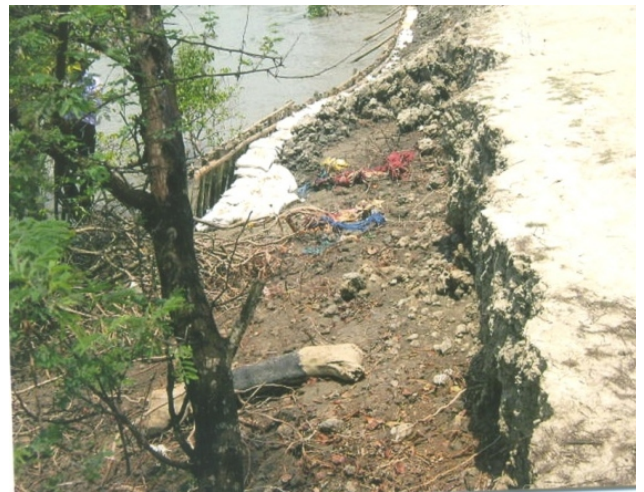
In Jharkhali no 1, 250 m of embankment along the Matla river near Jharkhali market has been maintained using bamboo piling. At Laskarpur, there is 500 m embankment with block pitching along Matla river. This embankment is meant for protecting Laskarpur, Mondalgheri and Parbatipur from Matla. There is a stretch of earthen embankment in between two stretches of concrete embankments. The earthen portion is highly damaged by the wave thrust of Matla during high tides. At Jharkhali 4, 1 km long embankment was totally washed out. Before Aila 2009, two parallel embankments were destroyed by the Herobhanga river in different storms. After Aila concrete embankments have been constructed.

Fig. 6: Damaged embankment at Mondalgheri, Laskarpur (14th June, 2011)

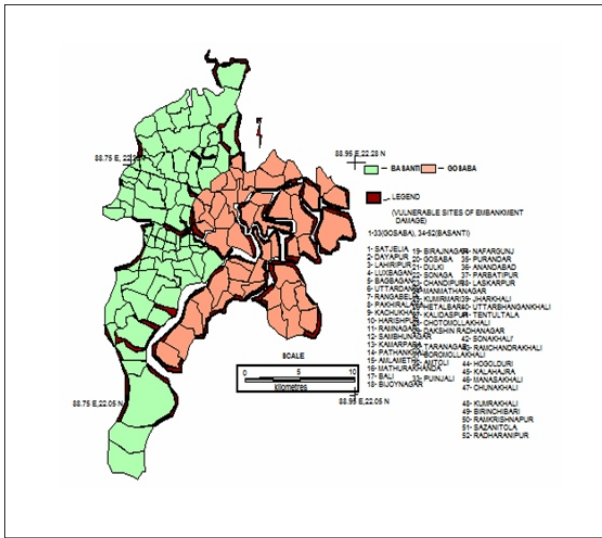
due to breaching of embankments. For this lengths of damage more than 600m have been taken into account. Gosaba testifies 18 sites of damage while Basanti has 6 sites of damage with damaged length of more than 600 m. The rivers and the banks damaged have also been tabulated. Subsequently a map has also been prepared according to this data. In the map all the sites have been shown with lengths of damages ranging from 200 m to 7000 m.

Fig. 11: Vulnerable Sites of Gosaba, and Basanti due to Embankment Breaching
