Analysis of Failed and Working Power Transformer and Their Diagnostics

In this paper various condition monitoring methodologies and its results analysis are explained by discussing the different case studies of failed and saved transformers.

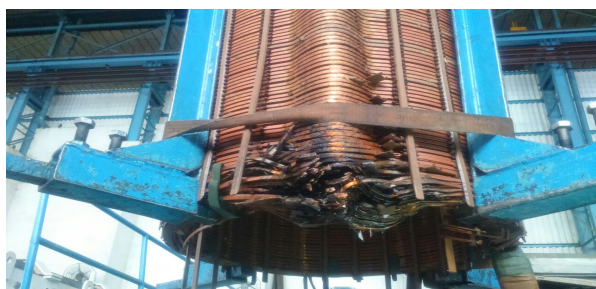
1. From the above graph it may be conclude that there may be chances of axial displacement of HV / LV winding, there is major damage of LV winding which can be short circuited.

- Due to short circuit of LV to earth heavy mechanical forces acting on LV winding resulted into damaging HV winding also which reflected into winding resistance & SFRA.

L.V Winding Found Damaged

1. The frequency of DGA testing of TF needs to be modified as TF DGA should be carried out within one month after taking load on TF & needs to be repeated after 03 months.
2. The SFRA of TF needs to be repeated after 06 months for new TF along with Tan delta of winding & excitation currents for ease of monitoring & further action.
3. If the key gases like C₂H₂, CH₄, C₂H₄, C₂H₆, CO₂, CO, H₂ are in rising trend then take immediate action consulting with manufacturer.
4. Probably used calibrated DGA kits on site for quick decision making.
5. Tan delta test, SFRA, PI & excitation test gives idea of fault inside TF with help of DGA ration analysis tool.
6. TF having commissioning year less than 02 years needs to be tested half yearly & closely monitored.

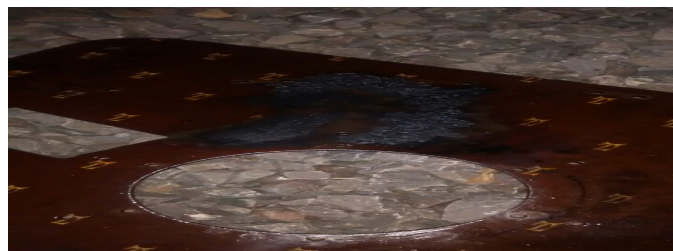
The TF kept out of service from previous case studies, It is recommended for internal inspection of OLTC. During inspection it was found that the Bakelite barrier plate in OLTC found to be burnt.

The overhauling of OLTC after replacement of Bakelite plate was carried out and Transformer low voltage test as follow.

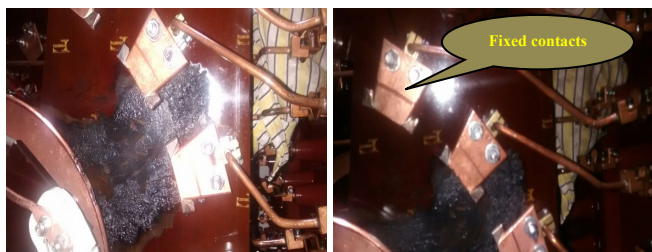
1. From test results it was found that the results are normal from Tap no. 1 to 9. From tap no. 10 to 17 No load magnetizing current goes on increasing.
2. The increasing trend shows carbonization in OLTC contact, considerable open circuit from tap no.10 to 17.

- 1.From above observation it was insisted to open OLTC chamber till that not to charge transformer.
- 2.The OLTC chamber was opened and checked for any abnormality .
- 3.The spring tension for fixed contact and moving contact from tap no. 9 to 17 found to be loose for B ph.
- 4.The spring tension was properly adjusted and fixed contacts were replaced where required.
- 5.Transformer charged after satisfactory test results.

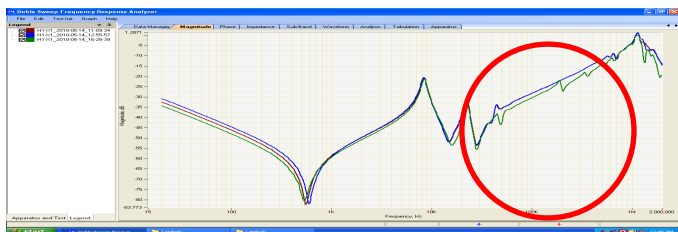
HV to LV R Ph , Y Ph , B Ph (Open Circuit Test)

From the SFRA test results loss of clamping pressure was observed for the B ph unit. As well there might be problem involving core portion & joints etc.

- 1.Tightness of core bolt, winding insulation and lead tightening was confirmed.
- 2.finally it was coordinately decided to lift transformer winding for checking any damages to the core behind winding.
- 3.There was failure of interlamination insulation of core below transformer winding. Due to failure of interlamination insulation the eddy current produces in the affected core area.
- 4.Due to flow of eddy current the area of core get heated which also affect the insulation of winding near neutral as ' Paramalli ring between winding and core get displaced .
- 5.Which causes production of Acetylene gas in the ICT.

- 1.As per guideline the frequency of tests are closely followed including DGA results.
- 2.The test results except DGA found normal.

- 3.In DGA the presence of acetylene was detected hence the frequency of DGA is increased i.e fortnightly DGA results are monitored which shows increasing trend of Acetylene.
- 4.The matter was refer to manufacturer and strongly insist for internal inspection.
- 5.The ICT was opened for internal inspection.
