24H3-211C

Single Curb

Structure Summary

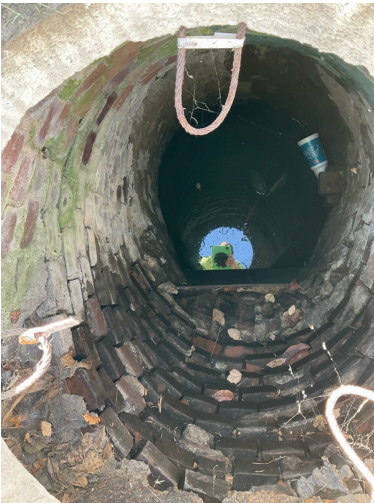
Topside Photo

Wall Material	Brick
----------------------	-------

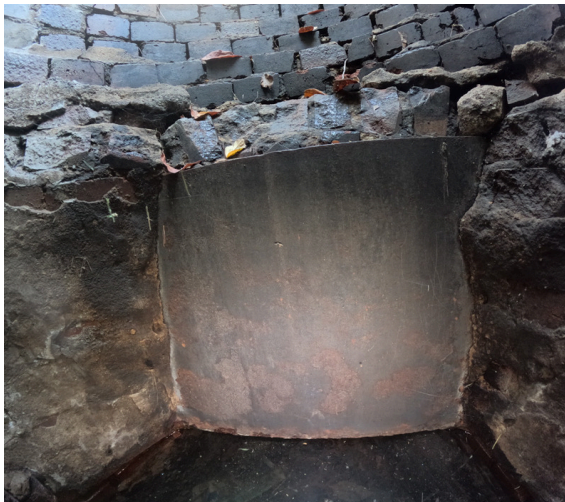
Pipe Photo - Report

MSD pipe facility ID	24H3-211C:24H3-205C
Pipe System	C
Pipe Number	1
Can you verify pipe characteristics?	No
Reason Cannot Verify	BULKHEAD PRESENT
Trench Grate Y/N	No
Pipe Status	Active
Clock Position	6
Pipe Direction	Out
Pipe Type	(GR) Gravity Connection
Pipe Material	(XXX) Not Known
Rehab Type	NONE
Connecting Structure ID	24H3-205C
