# Comprehensive survey on radon mitigation and indoor air quality in energy efficient buildings from Romania

B.D. Burghiele<sup>a</sup>, M. Botoș<sup>a,b</sup>, S. Beldean-Galea<sup>a</sup>, A. Cucuș<sup>a,\*</sup>, T. Catalina<sup>a,c</sup>, T. Dicu<sup>a</sup>, G. Dobrei<sup>a</sup>, Ș. Florică<sup>a,d</sup>, A. Istrate<sup>a,g</sup>, A. Lupulescu<sup>a</sup>, M. Moldovan<sup>a</sup>, D. Niță<sup>a</sup>, B. Papp<sup>a</sup>, I. Pap<sup>a</sup>, K. Szacsvai<sup>a</sup>, C. Sainz<sup>a,e</sup>, A. Tunyagi<sup>a,f</sup>, A. Tenter<sup>a</sup>

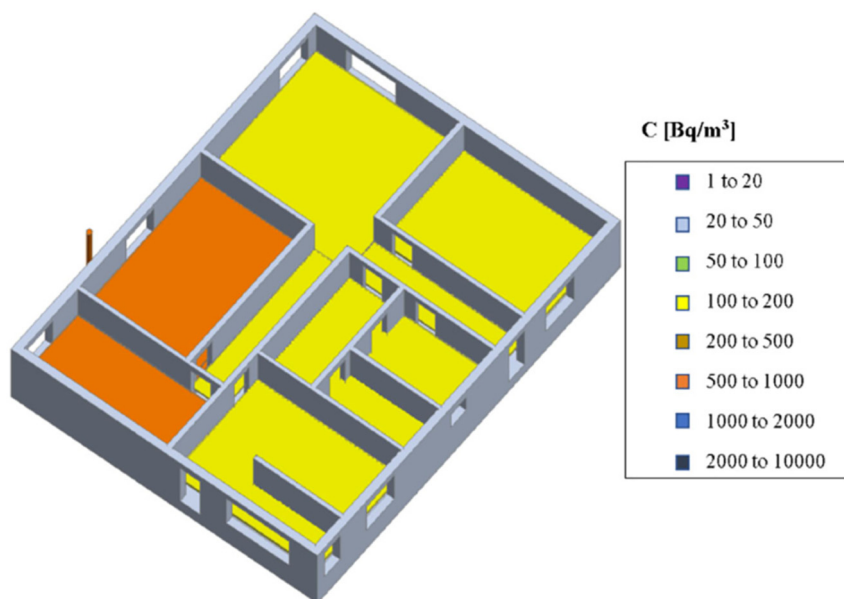
the presence of opened staircases to upper floors and/or a chimney stack. All these construction features, often combined with a non-thermally insulated wooden ceiling, guaranteed the stack effect which lead to the accumulation of indoor radon above the levels expected based solely on the concentration of radon in soil. Building radon mapping revealed horizontal and vertical variability of indoor radon, one example of such behavior being represented in Fig. 1.

**Fig. 1.** Horizontal distribution of indoor radon in a detached house (B9).

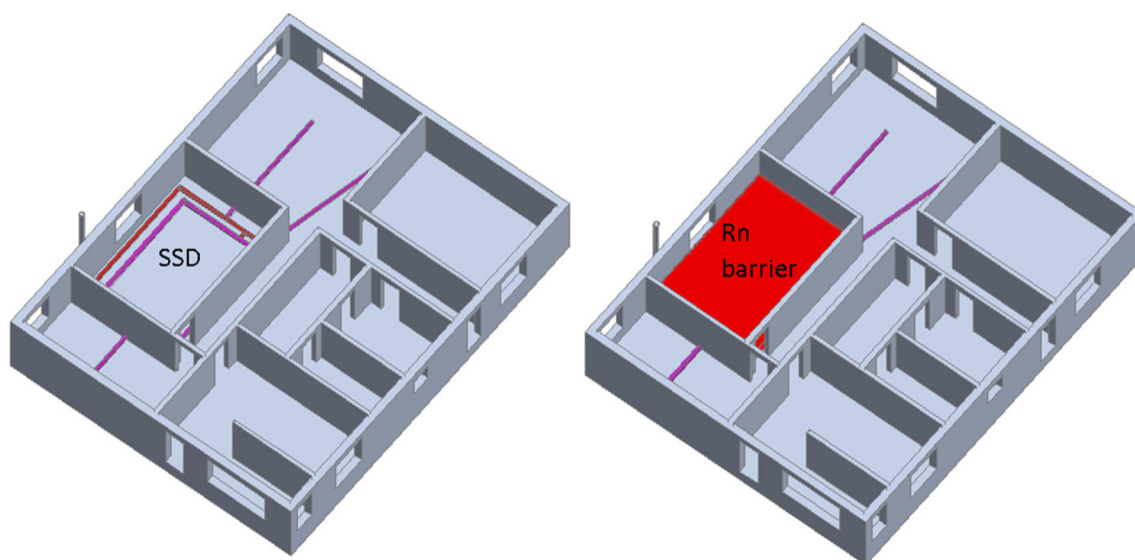
only up to 92% when the radon membrane was absent. Sub-slab depressurization systems were designed to serve between one and three rooms, as needed, yet considering the least disturbance of the living spaces. This task was achieved by drilling – and inserting perforated pipes under the target slabs – from outside the building or from only one room located inside the house. Fig. 2 presents a graphical representation of a sub-slab depressurization system implemented in one of the studied buildings.

Fig. 2. Post-construction implementation of a sub-slab depressurization system combined with radon barrier (B9).

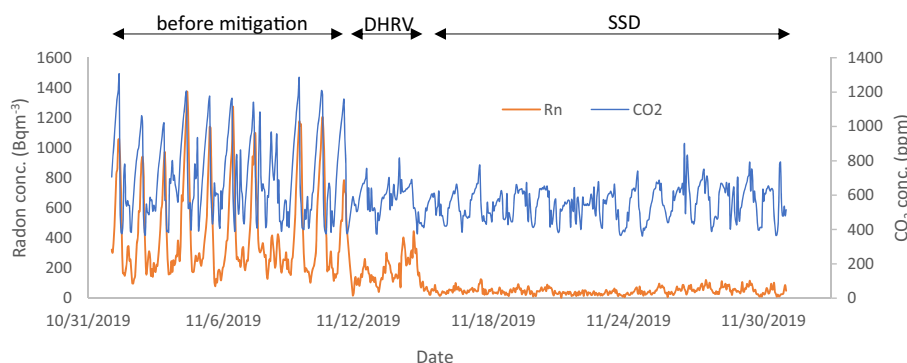
Fig. 4. Impact of different mitigation measures on indoor air quality in house B7.

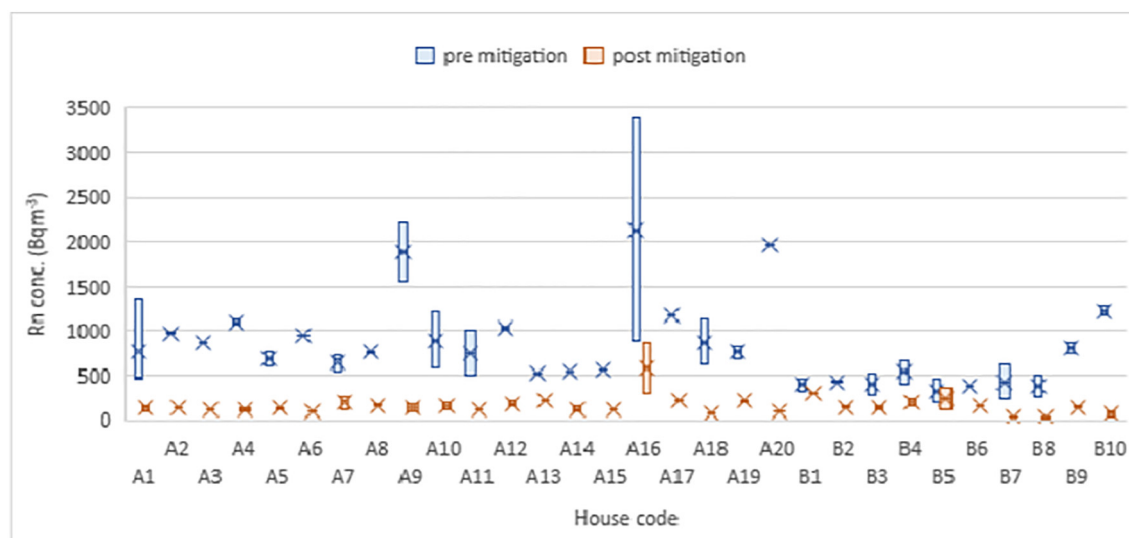
Although the national criteria were met in all but one house, according to cost-effectiveness studies (Haucke, 2010; Gaskin et al., 2019), these mitigation systems should be tuned in such a way that the radon concentrations decrease to levels below  $100 \text{ Bqm}^{-3}$ , or according to the ALARA principle (as low as reasonably achievable). It must be emphasized that the only threshold taken into consideration for experimental radon mitigations in Romania was the national recommendation of  $300 \text{ Bqm}^{-3}$ . On the other hand, the ICA systems linked to the ventilator provides the possibility to adjust the exhaust airflow, thus creating the prospect of decreasing the indoor levels in accordance with the ALARA principle. Long-term monitoring of these houses will be able to show if these mitigation systems alone will suffice in reducing indoor radon below  $100 \text{ Bqm}^{-3}$ . The distribution of individual annual indoor radon concentration pre/post mitigation obtained based on passive monitoring has been represented in Fig. 5.

**Fig. 5.** Distribution of annual indoor radon concentration based on passive monitoring.

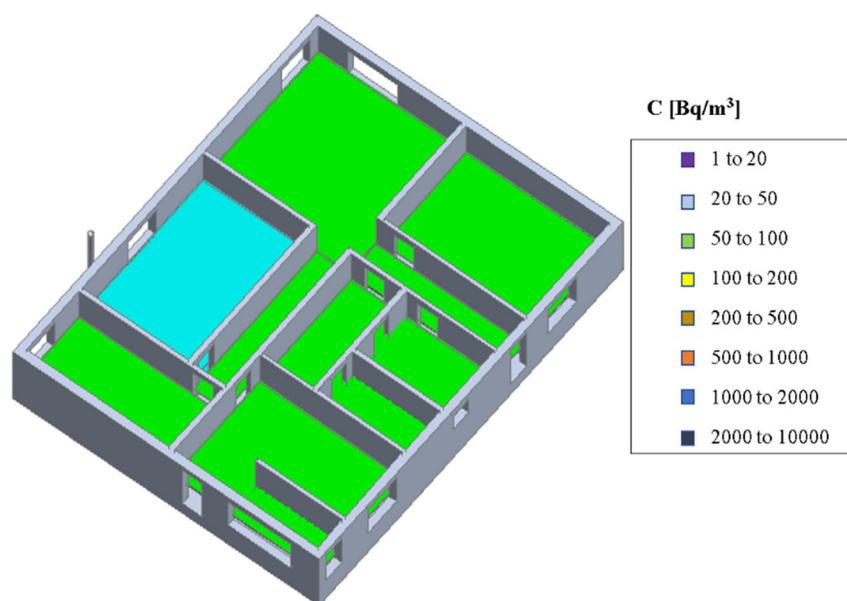
Additional active monitoring has been used post-mitigation to map the indoor radon levels in each house. Figs. 1 and 6 presents one example of indoor radon distribution before and after the installation of sub-slab depressurization. It can be observed that the radon levels dropped below  $100 \text{ Bq m}^{-3}$  throughout the house even if the mitigations system serves physically only 3 of the investigated rooms, as it can be seen in Fig. 2.

Fig. 6. Indoor radon mapping post mitigation (B9).
