MIN-D

NASA's Space Grant Midwest High-Power Rocket Competition

University of Illinois at Urbana-Champaign

September 6th, 2019

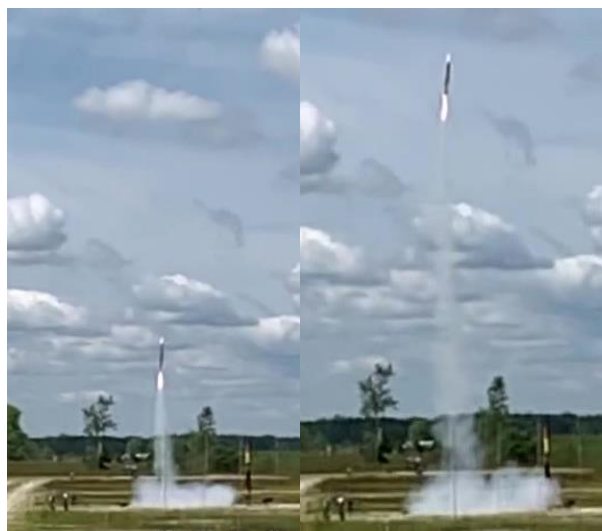
The rocket was initially guided by the rail. Then it started banking clockwise by about 10 degrees, as shown in Figure 2, as soon as it left the rail at 84.4 ft/sec. There are many possible reasons that the rocket started banking. One of them could be that there was a large amount of friction between the rail and rail guides, causing the rocket to tilt. Since the rocket did not bank at the start of every launch, another possible reason for the banking could be that a strong gust of wind caused the rocket to tilt during the first flight. Soon after, the rocket corrected its path from an increase in stability as the motor propellant burned. For the remainder of the flight, the rocket flew straight until it started coning. Coning can occur when the center of gravity is too far forward, or the fins are too small to counteract rotation. Overall, the first flight was successful, but it would have been better without banking and coning. The banking and coning likely decreased the maximum velocity and altitude of the rocket, since the thrust vector of the rocket does not point completely

perpendicular to the ground. As a result, propellant and energy is wasted in forcing the rocket to correct its path. The effects of coning and banking on the rocket's actual velocity and altitude compared to its predicted is shown in Section 3.

Figure 2: Smoke trail from beginning of first flight (left); smoke trail when rocket starts banking during first flight (right)

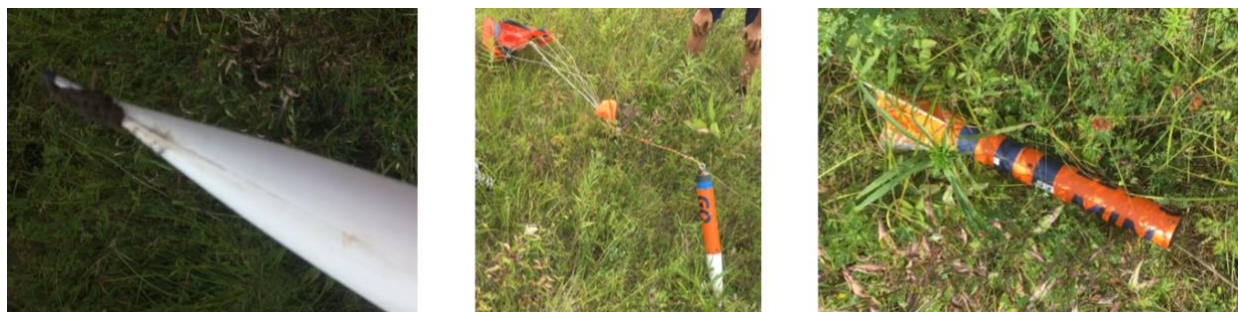
transition into the next flight. The backup nosecone was used for the second flight due to the original pitot tube damage.

Figure 3: Nosecone and pitot tube after recovery (left), upper body tube and parachute (middle) and lower body tube (right)

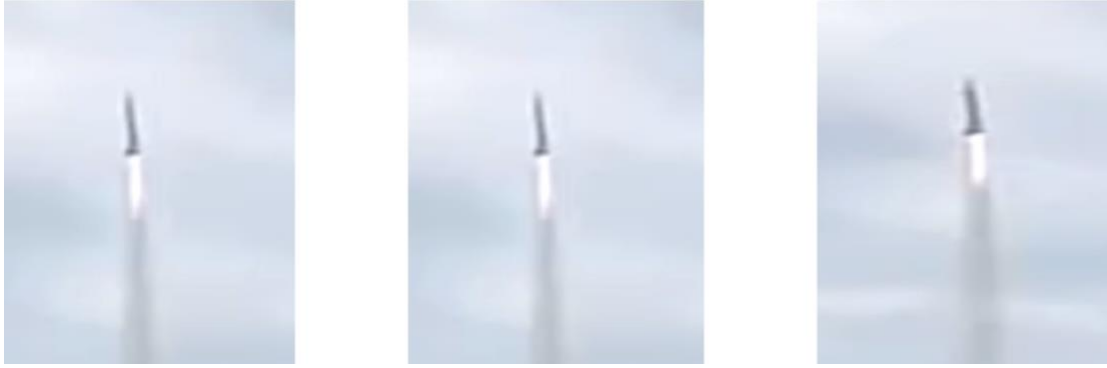
This flight with the J-430 motor flew straighter than the previous flight and did not bank. Instead, its trajectory began straight off the rail at a speed of 112.0 ft/sec but started spinning soon after. Examining the video time stamps revealed a spiral smoke trail, which implied the rocket started coning about 0.5 seconds into the flight as shown in Figure 5. Coning is visible when the rocket spins as it ascends and when the nose of the rocket changes directions. Once again, without coning, the rocket would have likely flown higher and faster and would have come closer to the estimates shown in the OpenRocket simulations in Section 3.

Figure 5: Rocket coning and changing its axis of rotation during flight

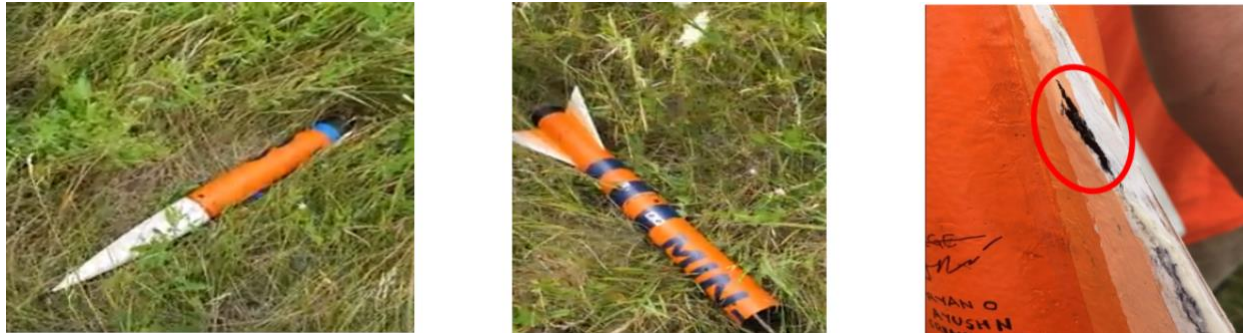
Figure 7: Ground recovery after the second flight: upper body tube (left), lower body tube (middle), and torn tip-to-tip (right)

One of the rocket's fins experienced a greater amount of delamination of the "tip-to-tip" layering during the 2nd flight in July. The team thinks it originally occurred due to an insufficient amount of epoxy used in the carbon fiber layering. The fin was repaired for the August launch with RocketPoxy. The same tearing occurred again but this time on the upper part of the same fin due to lack of repair epoxy on the upper part of the fin. The team suspects the damage itself happened during flight due to dynamic instability or fin flutter which can occur near Mach speeds. See the right-most image of Figure 7 for the tip-to-tip tear.

Between flights, the team researched and executed the best way to fix the fin. RocketPox was used to glue the torn "tip-to-tip" part onto the fin. The team also constructed two new nosecones with pitot tubes, found a solution to ensure Raspberry Pi data collection, and had backups for different failure modes that could potentially come up to prevent Raspberry Pi failure.

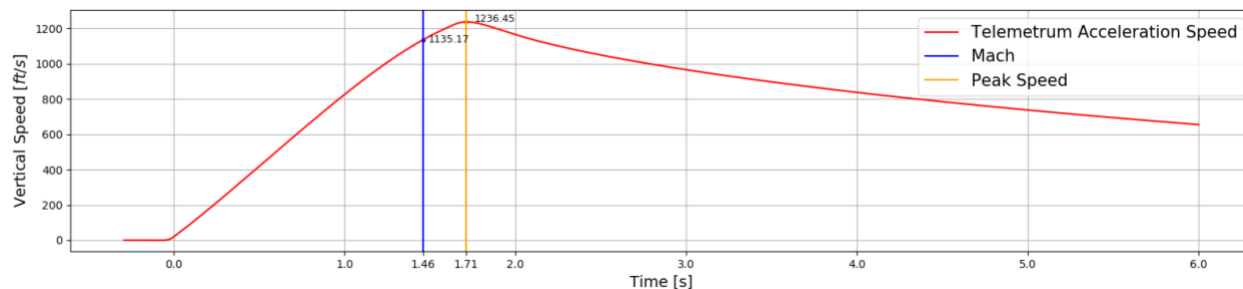
During the second (supersonic) flight, the TeleMetrum recorded a peak velocity of **1236.35 ft/s**, which occurred 1.71 seconds after launch was detected. Considering local air temperature and altitude, the rocket achieved a peak Mach number of **1.0754**. The rocket achieved supersonic flight 1.46 seconds after launch. Figure 12 details the vertical speed of the rocket during the first six seconds of the supersonic flight.

Figure 12: Vertical Speed vs Time data recorded by the Telemetrum
