Service Bulletin

Ref. No. **2XN-0043(P110)**

<Date> May 15, 2025

Subject:	Firmware upgrade (Upgrade Pack 2XN/2XV/2XT_V3.00) (Except Russia and Belarus)		
Model:	TASKalfa 8353ci, TASKalfa 7353ci, TASKalfa 9003i, TASKalfa 8003i, TASKalfa 7003i, PF-7120		
Classification:	Field measures timing:	<input type="checkbox"/> At Set Up <input checked="" type="checkbox"/> Next Visit/Service Call	<input type="checkbox"/> Next Periodic Maintenance <input type="checkbox"/> Information only
	Phenomenon:	<input checked="" type="checkbox"/> SC/Error <input type="checkbox"/> Image	<input type="checkbox"/> Paper Feeding/Conveying <input checked="" type="checkbox"/> Machine operation <input checked="" type="checkbox"/> Other
	Type of change:	<input type="checkbox"/> Hardware <input checked="" type="checkbox"/> Firmware and Software	<input type="checkbox"/> Information
Remarks	Supplement for KDE	Delivery to Russia and Belarus is prohibited by KDC in consideration of the law.	
	Related SB:	3RL-0003(P046), SWSO-0192(O157)

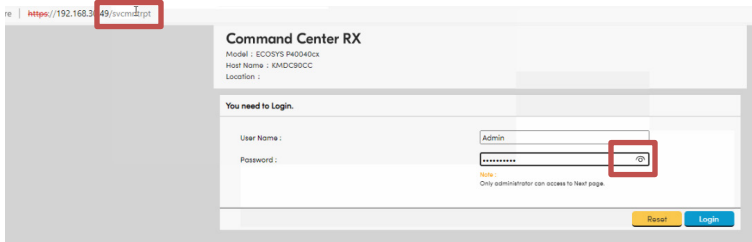
13	Security enhancement	When using a specific API tool, detailed information can be retrieved by tracing with certain specified steps. Therefore, it is corrected.	KDCQA-19720 2V8-13165 2V8-13440 2XN-2599	CONT
14	Corrective measures for incorrect counting in KX Driver [8in1]	The job count for [8in1] settings from KX Driver is incorrect. Therefore, it is corrected.	2XN-2643 2XC-17749 #209 2V9-16138	CONT
15	Corrective measures for password display issues in CCRX	In the following CCRX login screen, pressing the password display button does not reveal the password. Therefore, it is corrected. - AirPrint (https: *IP*/airprint)
