Subject	Corrective measure for the abnormal noise during the secondary paper feed		
Model	TASKalfa 2200		
Classification	Field measure timing:	Next visit/Service call	
	Problem:	Except SC/Error, Paper Feeding/Conveying, Image and Machine operation	
	Type of change:	Hardware

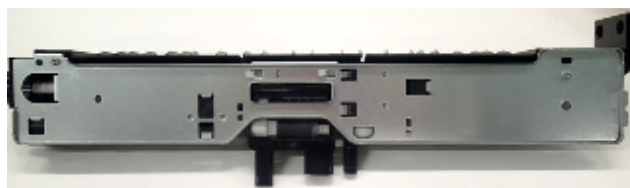
[Primary paper feed unit (No. 1) – Top face] (Old)

If the low grade paper that has a lot of paper dust is used, the surface of the switchback roller may prematurely become worn. Depending on the wear condition, the switchback roller may fail to be driven and stop as the nip pressure between the paper feed roller and the switchback roller in the primary paper feed section is decreased at the secondary paper feed operation. In this case, abnormal noise may be generated due to the friction between the rubber part of the switchback roller and the paper.

Newly added
reinforcing plate

- 1) Add a reinforcing plate on the top face of FRAME FEED UP (No. 2) to increase stiffness preventing the paper feed roller position from moving upward (to the direction the nip pressure becomes weakened).
- 2) Eliminate the CUSHION (No. 3) applied to the bottom of the GUIDE FEED REGIST (upper side of FRAME FEED UP) as it become unnecessary after this change.

Field Measure	If the problem occurs, please replace with new FRAME FEED UP (No. 2). (When doing this, it is not necessary to peel the CUSHION (No. 3).)
----------------------	--

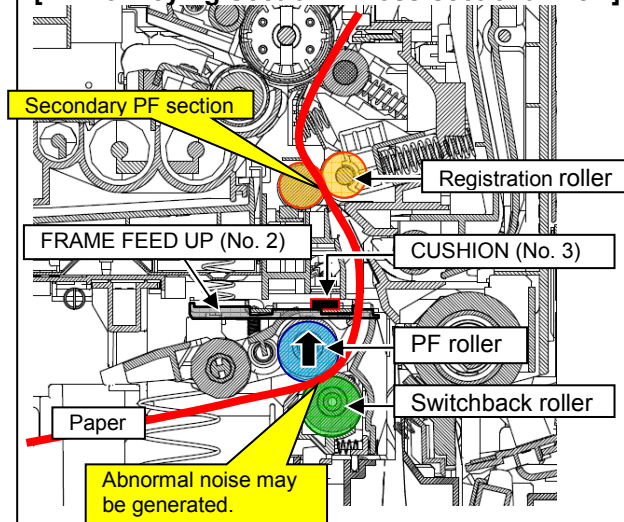
[PF/Conveying Section –Cross-sectional view]

During the secondary paper feed operation, as the registration roller takes up the paper, the paper feed roller in the primary paper feed section is lifted together, causing the weaker nip pressure to occur between the paper feed roller and switchback roller.

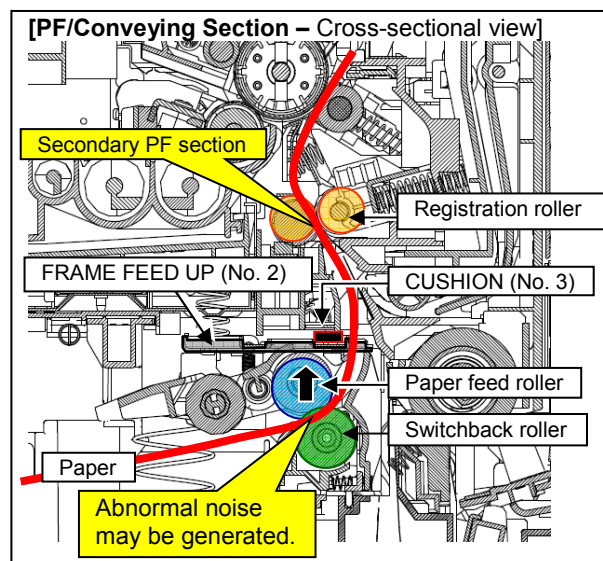
(The above Fig. is same as on Page 1.)

A CUSHION (No. 3) has been applied to the bottom of the GUIDE FEED REGIST over the PF roller from initial mass production so the position of the PF roller does not move upward as much. The FRAME FEED UP (No. 2) is changed this time to secure the proper nip pressure in cases where the surface of switchback roller becomes worn prematurely when the low grade paper is used. This is to further control the PF roller position moving upward.

(According to this change, the conventional part CUSHION (No. 3) becomes no longer necessary.)
