(Revised issue 1)  
**Service Bulletin**

Ref. No. **2NJ-0016 (P022)**

<b>Subject:</b>	<b>Corrective measure for toner dropping (Developer unit 2)</b>		
<b>Model:</b>	<b>TASKalfa 9003i, TASKalfa 8003i, TASKalfa 7003i, TASKalfa 9002i, TASKalfa 8002i, TASKalfa 7002i</b>		
<b>Classification:</b>	<b>Field measures timing:</b>	<input type="checkbox"/> At Set Up <input type="checkbox"/> Next Periodic Maintenance <input checked="" type="checkbox"/> Next Visit/Service Call <input type="checkbox"/> Information only	
	<b>Phenomenon:</b>	<input type="checkbox"/> SC/Error <input type="checkbox"/> Paper Feeding/Conveying <input type="checkbox"/> Other <input checked="" type="checkbox"/> Image <input type="checkbox"/> Machine operation	
	<b>Type of change:</b>	<input checked="" type="checkbox"/> Hardware <input checked="" type="checkbox"/> Firmware and Software <input type="checkbox"/> Information	
<b>Remarks:</b>	<b>Related SB:</b>	2NJ-0015(P008)	
	<b>Revised ver.:</b>	- This time the description with (--->) is revised from the previous information. <Number of changes: 3> - Correction of setting values (P2)

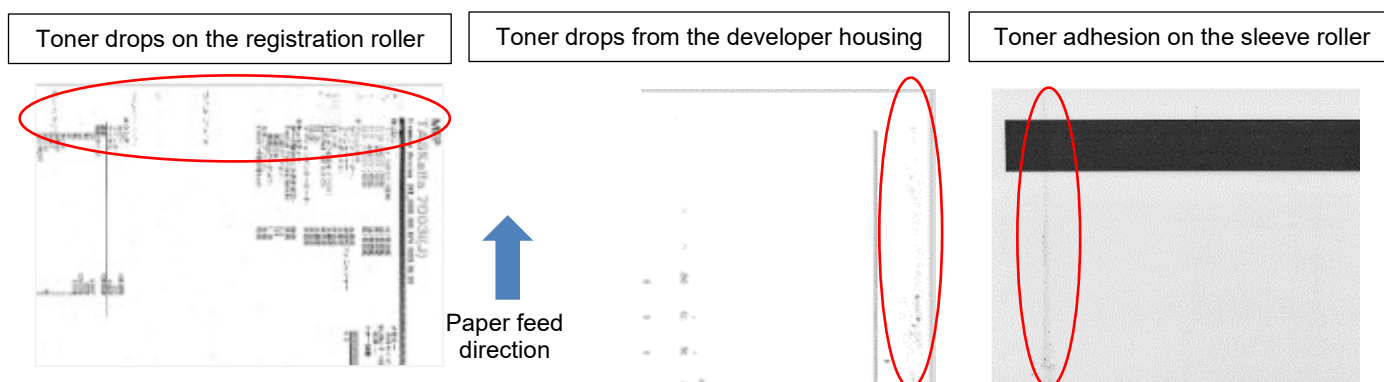
Regarding the toner drop issue communicated in Service bulletin No. 2NJ-0015(P008), the following changes are made as further corrective measures.

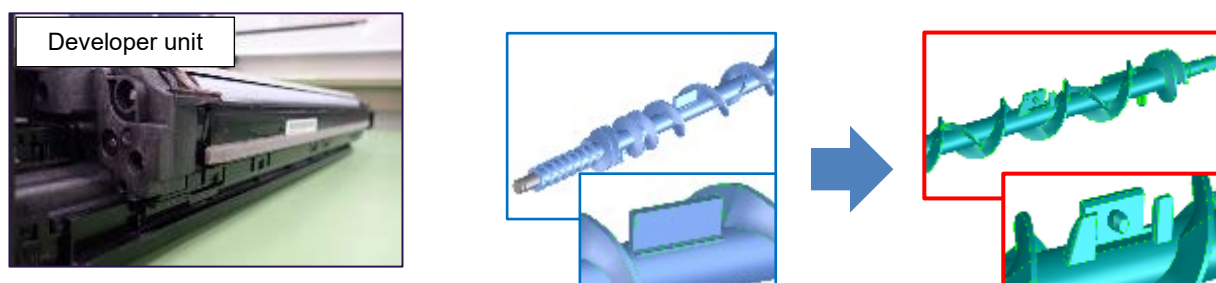
To address the accumulated toner on the developing sleeve roller, the developing rollers are rotated in reverse direction to collect the accumulated toner within the developer unit. With the reverse rotation of the developing rollers, the configuration of the scraper within the developer unit is changed to prevent the scraper from peeling off.
