U.S. CHEMICAL SAFETY AND HAZARD INVESTIGATION BOARD

INVESTIGATION REPORT

SUGAR DUST EXPLOSION AND FIRE

IMPERIAL SUGAR COMPANY

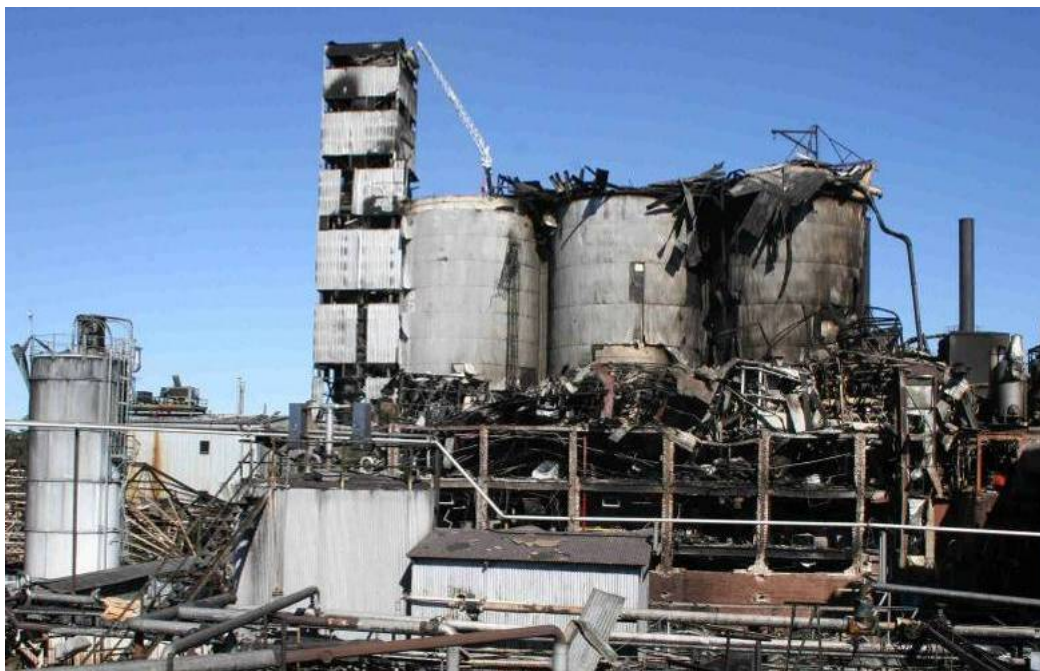
The major fires in the buildings were extinguished the next day, but small fires continued burning for many days. The granulated sugar fires in the 105-foot tall silos continued to smolder for more than 7 days before being extinguished by a commercial industrial firefighting company. The packing buildings, granulated sugar silos, and palletizer room were destroyed. The bulk sugar loading area and parts of the refinery were severely damaged by the explosion and fires (Figure 1).

Figure 1. West bucket elevator tower; silos 3, 2, and 1; and south packing building destroyed by the February 7, 2008, sugar dust explosions and fires

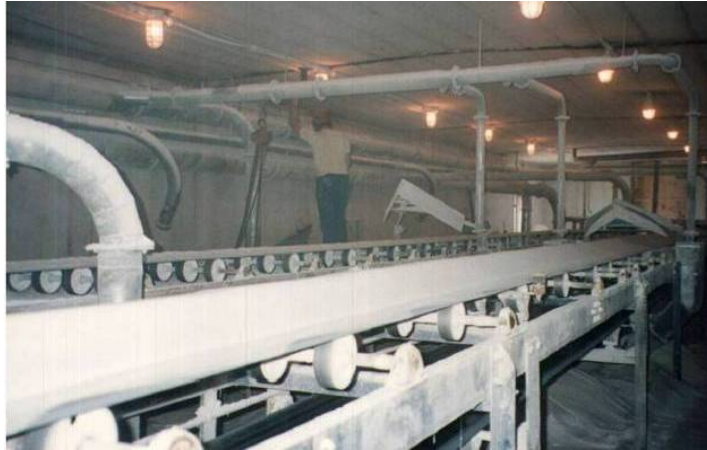
Figure 8. Granulated sugar steel conveyor belts above the silos, circa 1990. Heavy dust accumulation on conduit and spilled sugar on the floor (Imperial Sugar photo)

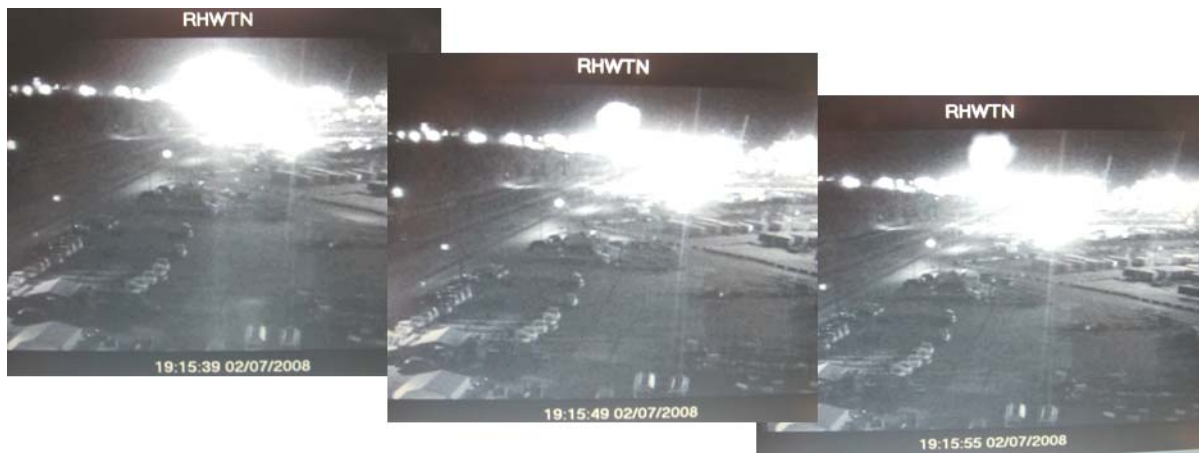
Figure 10. Violent fireball erupting from the facility (elapsed time - 16 seconds)
(Georgia Ports Authority security video).

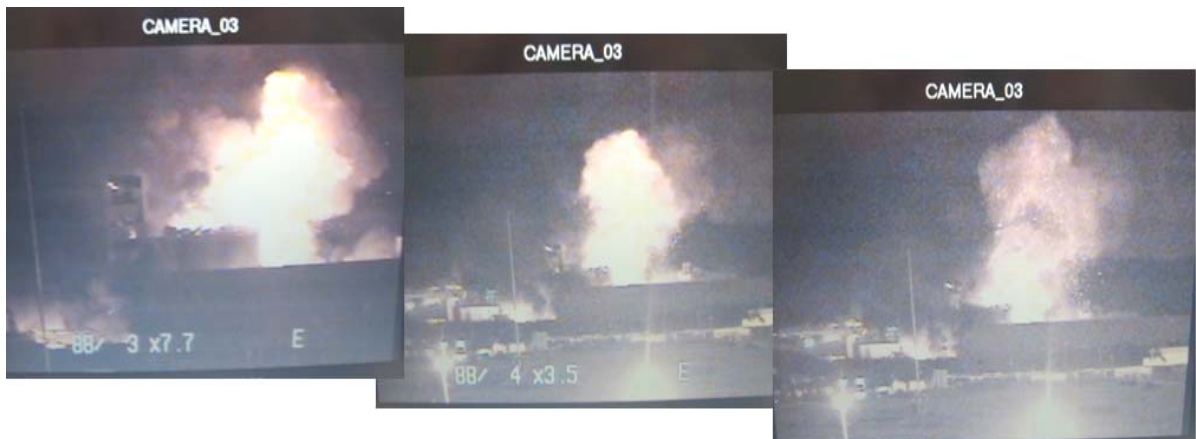
Intense fireballs advanced through the entire north and south packing and palletizer buildings as sugar dust, shaken loose from overhead surfaces, ignited. Heaving and buckling floors opened large crevasses. The piles of granulated and powdered sugar that had accumulated around equipment rained down and intensified the fires burning below. Fireballs advanced through enclosed screw conveyors and ignited fires in the refinery and bulk sugar building hundreds of feet from the packing buildings where the incident had begun. Violent fireballs erupted from the facility for more than 15 minutes as spilled sugar and accumulated sugar dust continued fueling the fires (Figure 11).

Figure 11. Large fireball and burning debris erupt from the packing buildings 15 minutes after first explosion (elapsed time - 10 seconds) (PCS Phosphate security video).

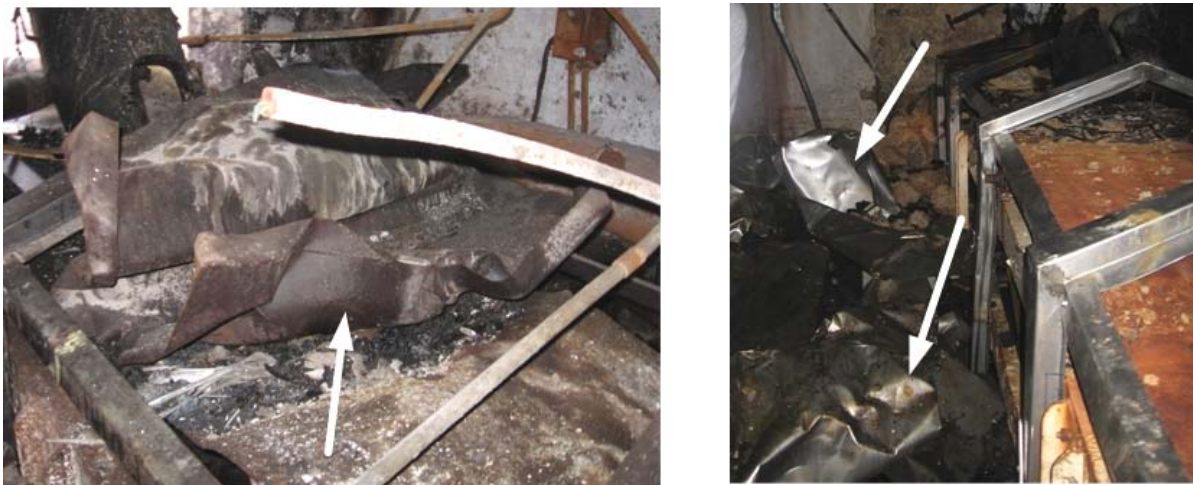
Examination of the equipment in the silo tunnel found that every panel used to enclose the 80-foot long steel belt conveyor had been violently blown off the support frame (Figure 13). Panels east of the approximate midpoint of the conveyor (directly under the silo 1–silo 2 abutment) were deflected eastward, and panels west of the midpoint were deflected westward. Pressure damage inside the pantleg rooms above the tunnel was greatest inside the silo 2 pantleg room and least inside silo 3 pantleg room. Major equipment damage was observed at the east entrance of the silo tunnel with all equipment deflections eastward, away from the tunnel. The equipment under silo 3 and outside the west end of the tunnel had damage patterns clearly indicating that a pressure wave traveled west out of the tunnel.²⁴

Figure 13. Steel belt covers (arrows) crumpled from an initial dust explosion inside the steel belt enclosure (steel frame structure, right photo)

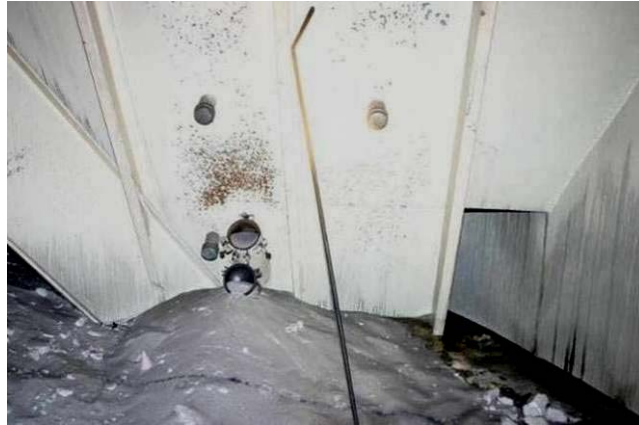
Figure 16. Access port inside the pantleg room and steel rod used to break sugar lumps in the sugar outlet on silo floor

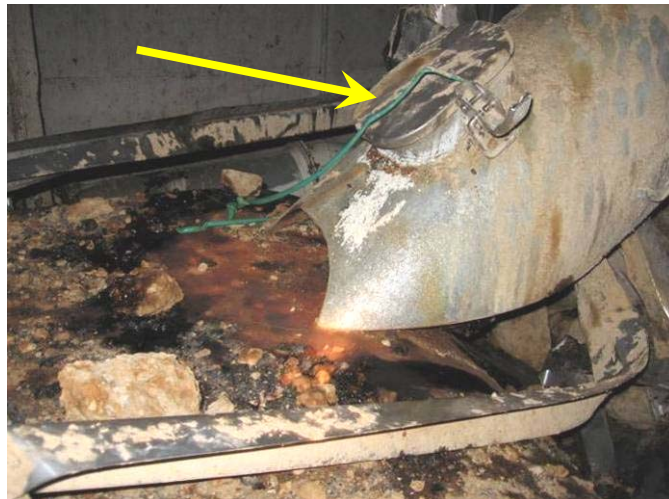
Figure 17. Limited clearance between sugar discharge chute and the steel belt would sometimes be blocked by large sugar lumps; lump-clearing access port (arrow) is on top of the chute

The CSB concluded that as granulated sugar spilled off the moving steel conveyor at the blocked outlet, sugar dust accumulated above the MEC inside the enclosed conveyor, and then ignited. The explosion triggered a series of secondary explosions that rapidly progressed through the packing buildings, palletizer room, and into the bulk sugar station.

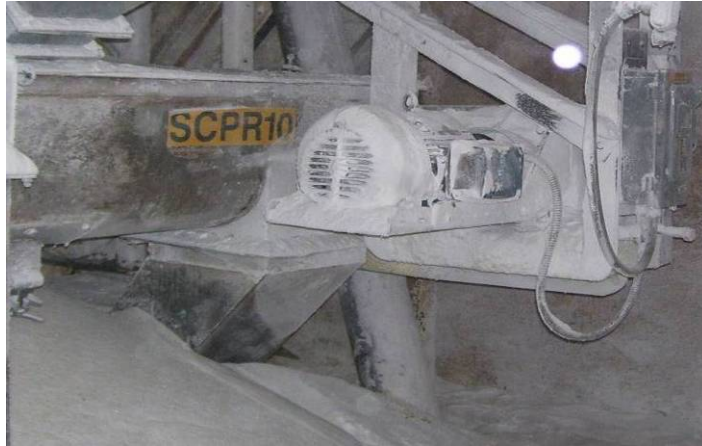
Figure 19. Motor cooling fins and fan guard covered with sugar dust; large piles of sugar cover the floor (Imperial Sugar photo)

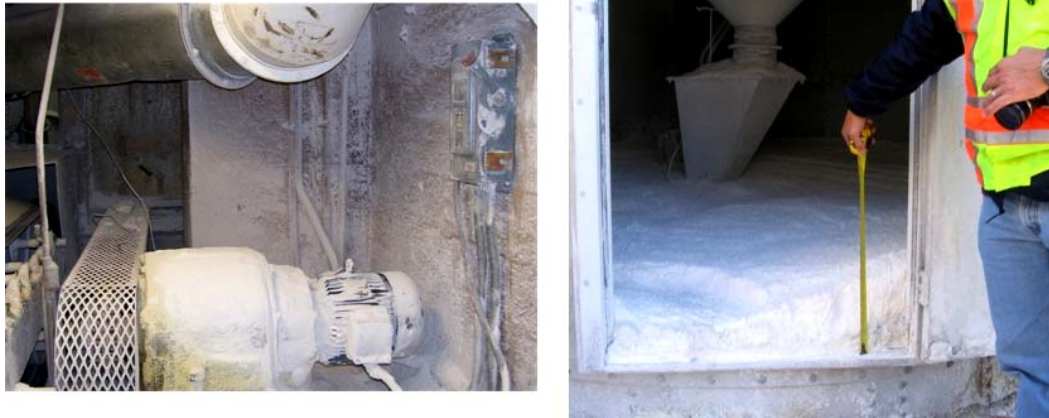
Figure 21. Left: Sugar dust accumulation on steel belt drive motor in silo tunnel (Imperial Sugar Co. photo, Oct. 2006). Right: Cornstarch spilled under cornstarch silo (March 2008).

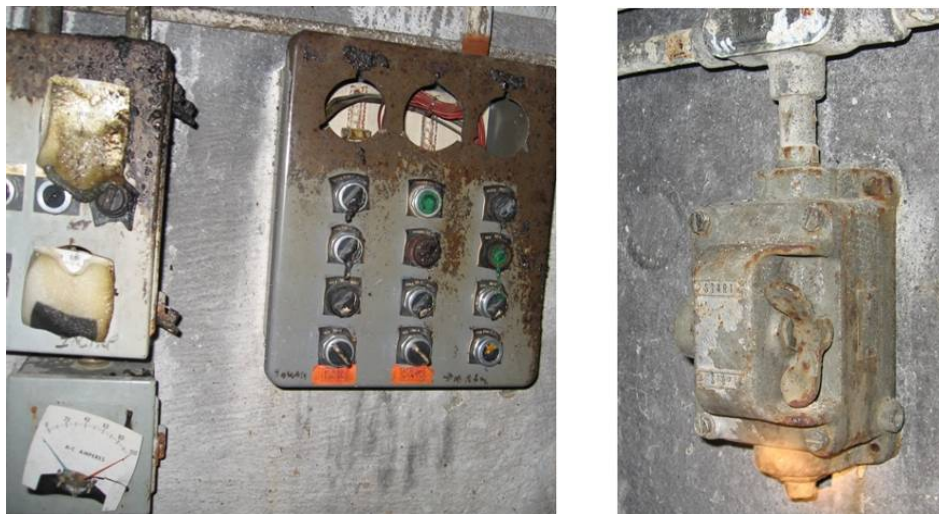
Imperial Sugar had no written policy or procedure to require classifying hazardous areas or require electrical devices rated for such locations at the Port Wentworth facility. Some locations at the facility contained significant accumulations of combustible sugar or cornstarch dust (Figure 21). The CSB investigators noted that some electrical devices were rated for use in hazardous work locations, but non-rated devices were also installed in the same location, frequently near the rated devices (Figure 22). The CSB investigators also observed many non-hazard classified electrical devices installed in dusty work areas and equipment enclosures. Furthermore, some electrical devices in dusty areas were poorly maintained, such as having missing covers or open doors on many breaker panels and other electrical enclosures.

Figure 22. Non-dust rated and rated electrical devices in the silo tunnel

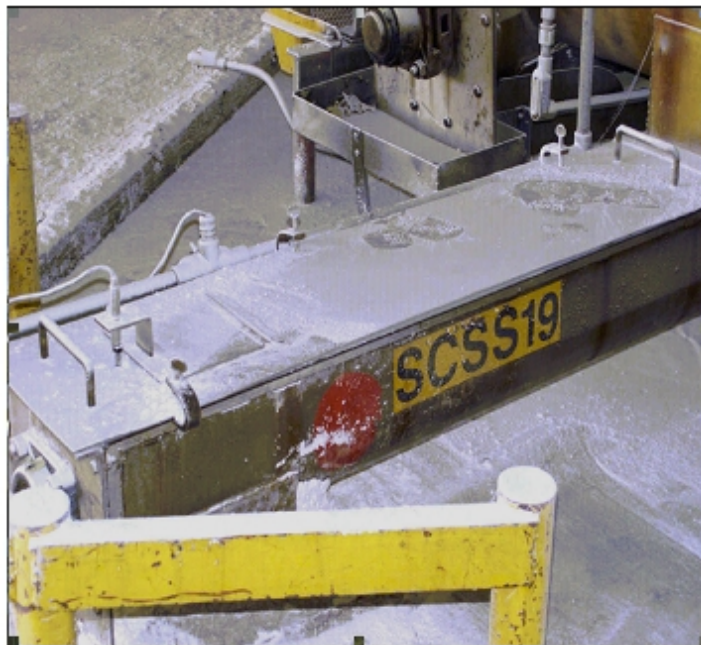
The south packing building sustained extensive blast damage (report cover photo). The ceilings in areas where sugar dust was present were not protected with a suspended ceiling³¹ to minimize dust accumulation on rafters, conduit, conveyors, piping, and other equipment. Elevated areas were infrequently cleaned so sugar dust accumulated to dangerous levels. The secondary explosions were most likely fueled by significant accumulations of sugar dust on elevated surfaces. When the floors heaved from the first series of explosive overpressures, large piles of sugar on the floors (Figure 23) would have been released into the areas below and ignited. Overpressure waves advancing horizontally through the packing buildings would also loft sugar piles into flaming fireballs.

Figure 23. Sugar and dust accumulation on a screw conveyor in the south packing building fourth floor near silo 1 (Imperial Sugar photo)

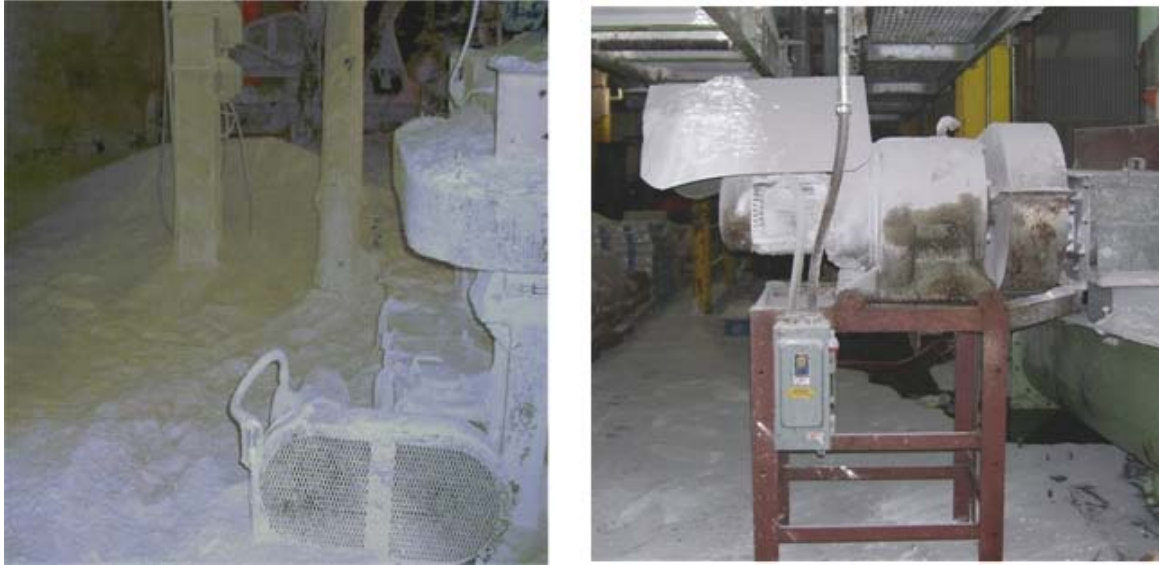
Figure 24. Deep piles of sugar accumulated on floors and equipment. Note shield installed above screw conveyor drive motor to deflect sugar dust (Imperial Sugar photos).
