# **EPA CHEMICAL ACCIDENT INVESTIGATION REPORT**

## **Tosco Avon Refinery Martinez, California**

EPA550-R-98-009  
November 1998

At approximately 7:41 p.m. on January 21, 1997 at the Tosco Avon Refinery in Martinez, CA, a section of effluent piping ruptured on the Hydrocracker Stage 2 Reactor 3. A mixture of light gases starting with methane through butane; light gasoline; heavy gasoline; gas oil and hydrogen was released from the pipe and instantly ignited upon contact with air, causing an explosion and fire. A Tosco Hydrocracker operator checking a field temperature panel at the base of the reactor was killed; 46 Tosco and contractor personnel were injured. Thirteen injured personnel were taken to local hospitals, treated and released. There were no reported injuries to the public.

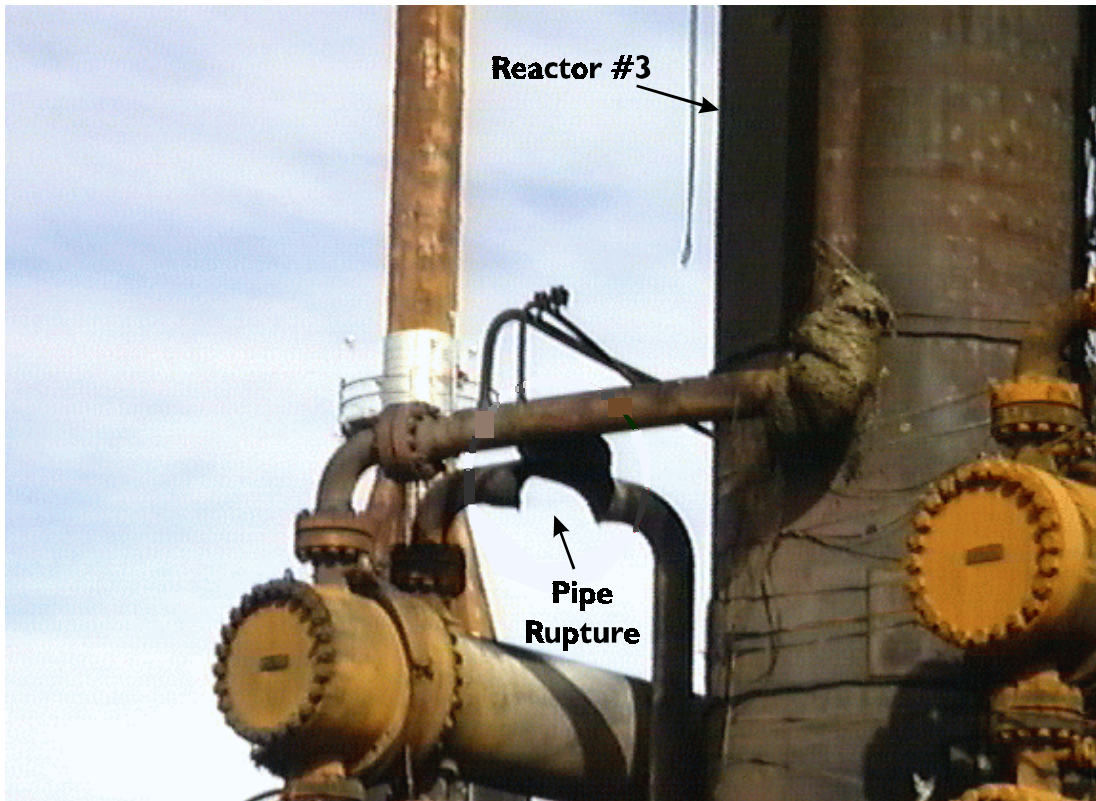
**Figure 10**      **Reactor 3 Effluent Piping Rupture**

The immediate cause of the hydrocarbon and hydrogen release and subsequent fire was a failure and rupture of a Stage 2 Reactor 3 effluent pipe due to excessively high temperature, likely in excess of 1400°F. This high operating temperature was initiated by a reactor temperature excursion that began in Bed 4 of Reactor 3 and spread through the next catalyst bed, Bed 5. The excessive heat generated in Bed 5 raised the temperature in the reactor effluent pipe. The excursion was not brought under control because the Stage 2 reactors were not depressured and shut down as required when the reactor temperatures exceeded the 800°F temperature limit specified in the written operating procedures.

Several Tosco and contractor employees reported hearing a pop or crack sound, followed by two explosions, one small and one bigger. A horizontal straight section of 12" diameter Reactor 3 effluent piping had ruptured just upstream of a 12"x 10" diameter reducer. Beyond the reducer, the 10" diameter pipe entered the top of the 40-foot high feed/effluent exchanger structure for Reactor 3. The hydrocarbon and hydrogen mixture released from the pipe rupture apparently autoignited very shortly after the initial release, causing a fireball over 100 feet high.

The rupture created about an 18 inch long tear in the Reactor 3 effluent piping. The photographs in Figures 9-13 show some of the resulting damage. The fire melted a light pole on the road next to the reactors. The lower part of a metal ladder on Reactor 3 was damaged by the heat. Scaffolding around the Stage 1 and 2 reactors was misshapen from the heat of the fire, but there did not appear to be much blast damage. The fire fighting equipment next to Reactor Road (see Figure 6) was damaged. Wooden platforms near the unit were charred. The six reactors were covered with asbestos insulation overlaid with aluminum, which was blackened by the fire. A large valve on the fire water piping near the road was damaged.
