United States-
Environmental Protection
Agency

Region 7
Emergency Response and Removal Branch
Kansas City, KS

CHEMICAL ACCIDENT INVESTIGATION REPORT

TERRA INDUSTRIES, INC. NITROGEN FERTILIZER FACILITY PORT NEAL, IOWA

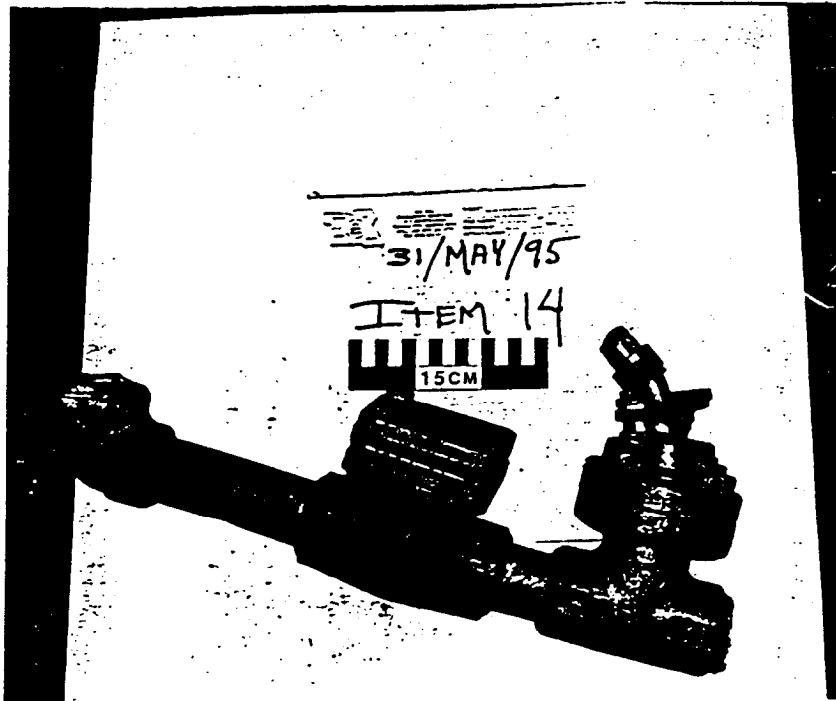
Photo 7 - 1
EPA Item # 14, Unknown Fragment

Based on information available to the investigation team when the report was completed, hydrocarbon contamination could not be eliminated as a factor in the explosion.

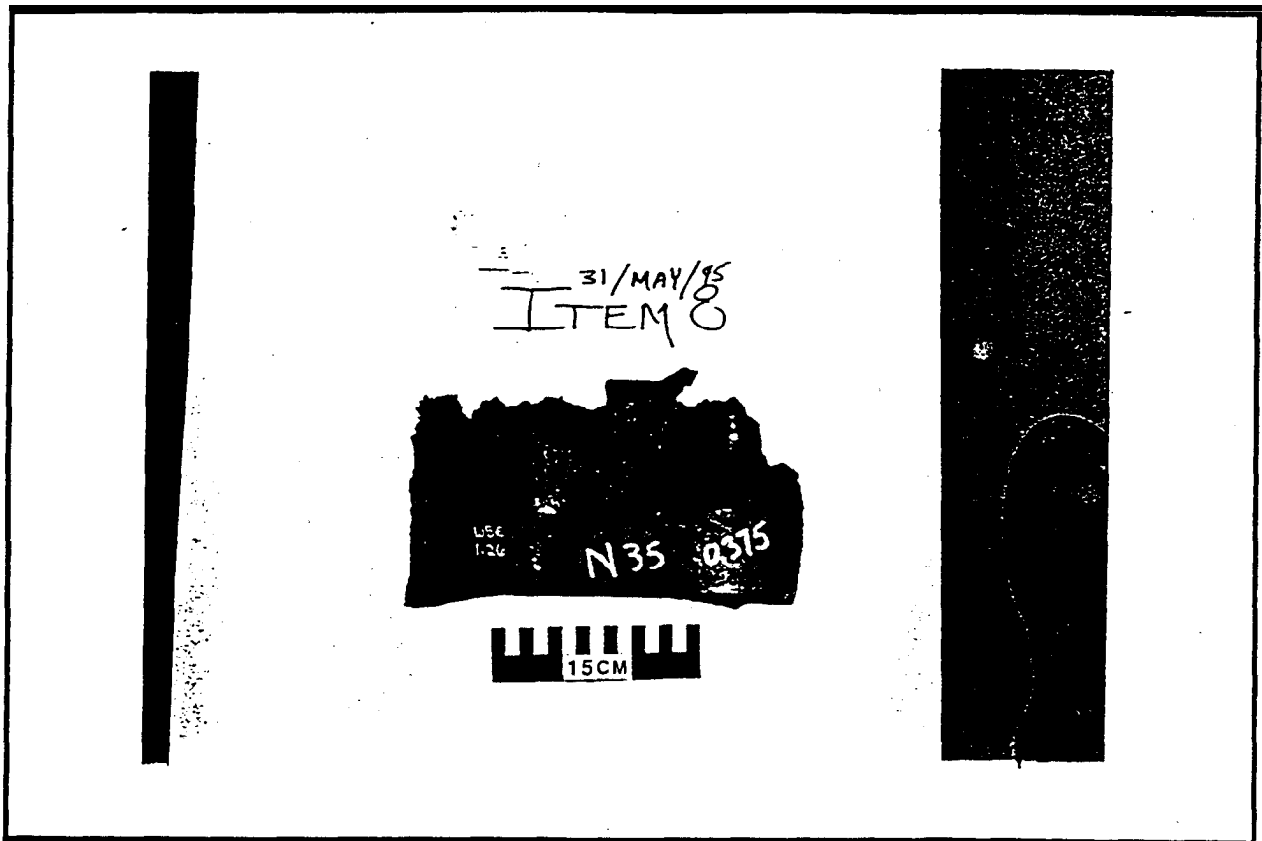
Photo 7 - 2
Neutralizer Fragment

Metallurgical analytical results indicated that the fragment displayed a high-temperature discolored surface and severe erosion in one direction (*Photo 7-2*). The adjacent area showed little discoloration. The opposite surface exhibited severe tearing and fracturing with evidence of high-temperature discoloration (*Photo 7-3*). Unetched cross sections exhibited high-temperature oxidation on the inside diameter with severe surface tearing/seams or laps. The etched cross-sections displayed evidence of severe surface movement and cold working with a one-directional heavy force. Of the fragments analyzed, metalographic analysis suggests that the highest temperature, internal pressure and velocity was located in the area of Item #8. This sample exhibited the most severe surface distortion and high-temperature grain structure change.

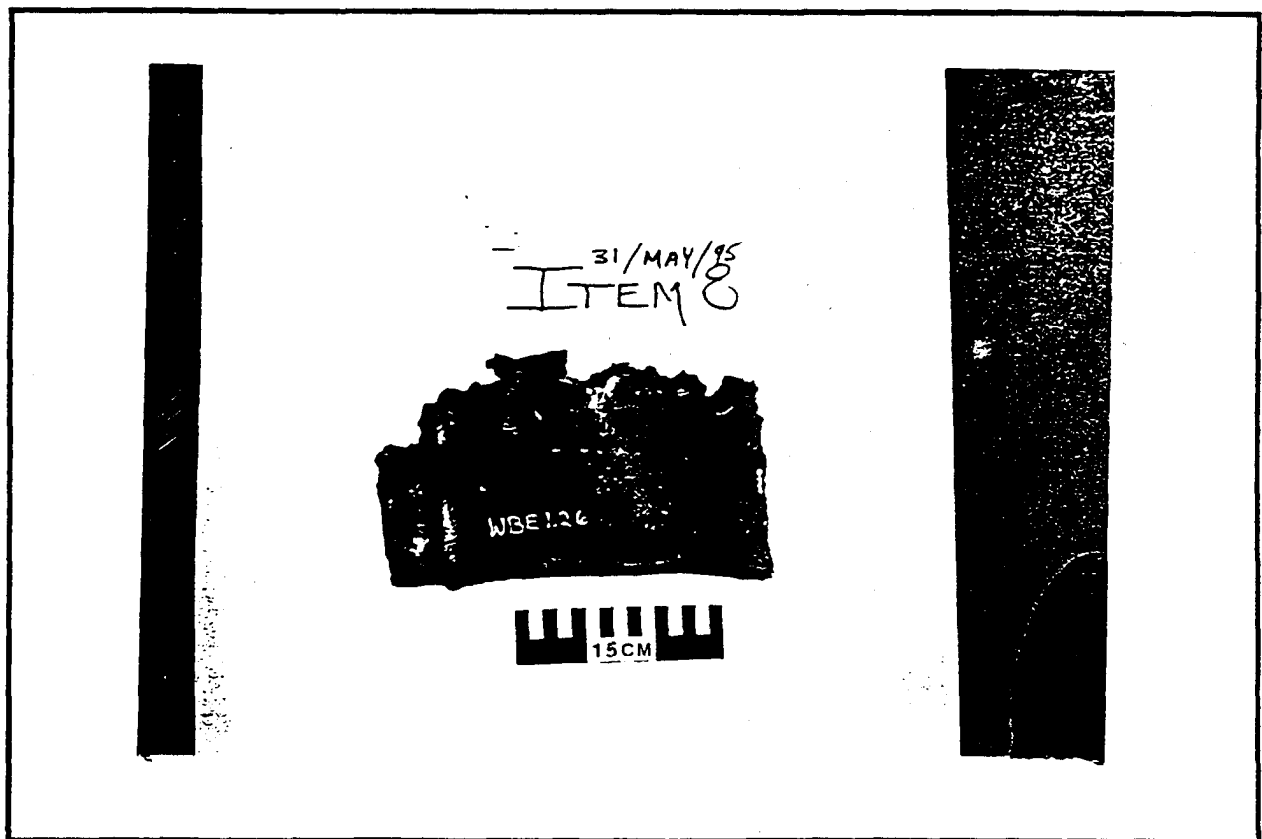
Photo 7 - 3
Neutralizer Fragment

The unetched cross-sections of the outside diameter surface displayed surface indications of heat cracking and deterioration. The etched cross-sections revealed that the parent material had a grain structure typical of titanium which had been heat treated and quenched from 1,300°F. The external surface exhibited a structure similar to one that had been exposed to a 1,700°F temperature and then quenched. The inside surface displayed a slightly lower temperature range with slight surface change.

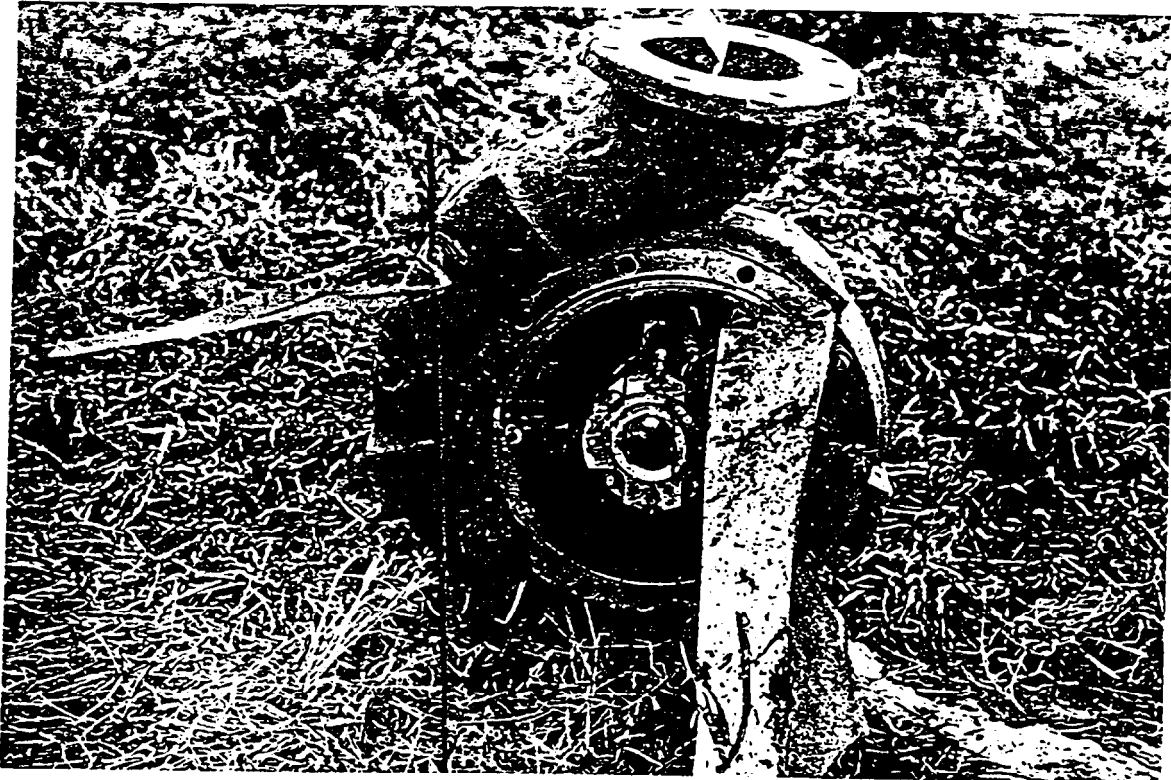
1. The pump casing was intact and located approximately 800 feet northwest of the AN plant as a result of the explosion (*Photos 8-4 A and 8-4B*).

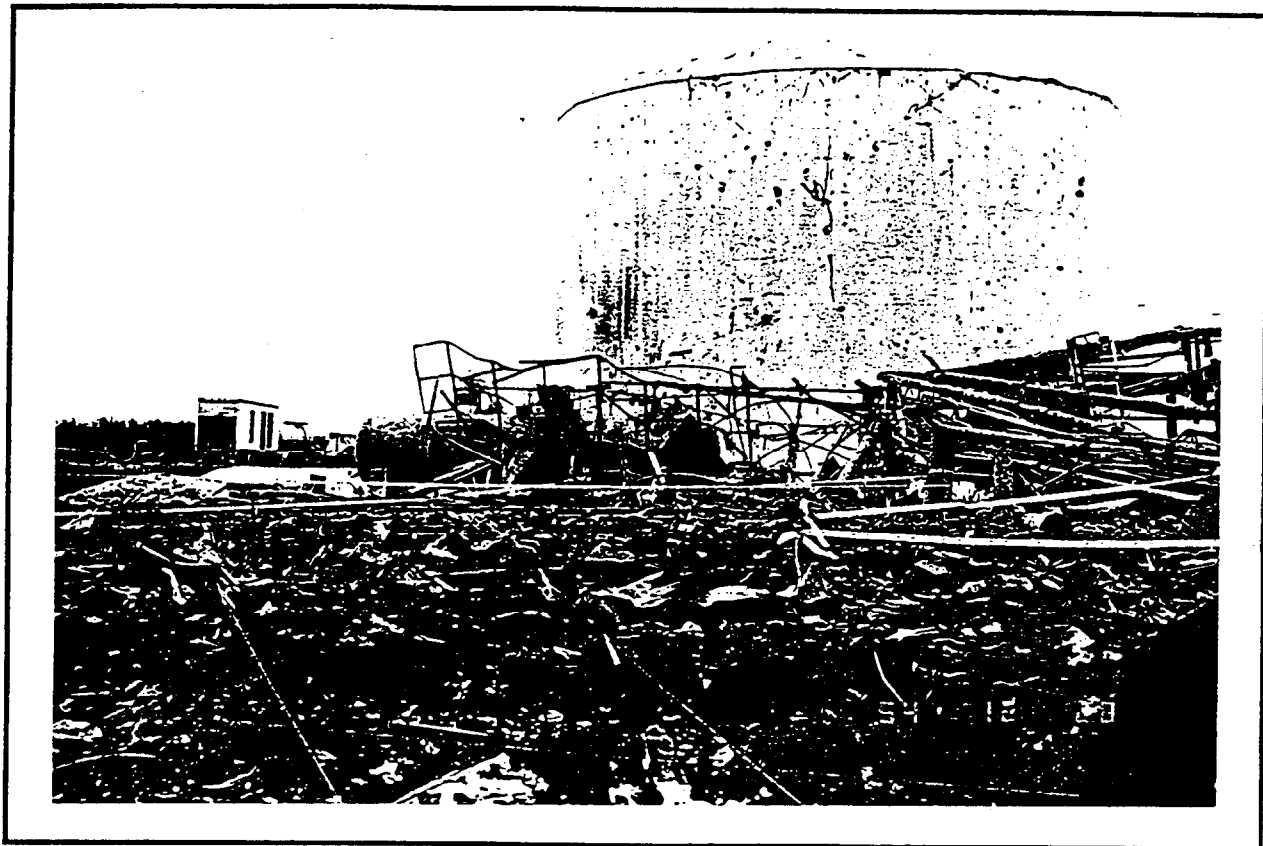
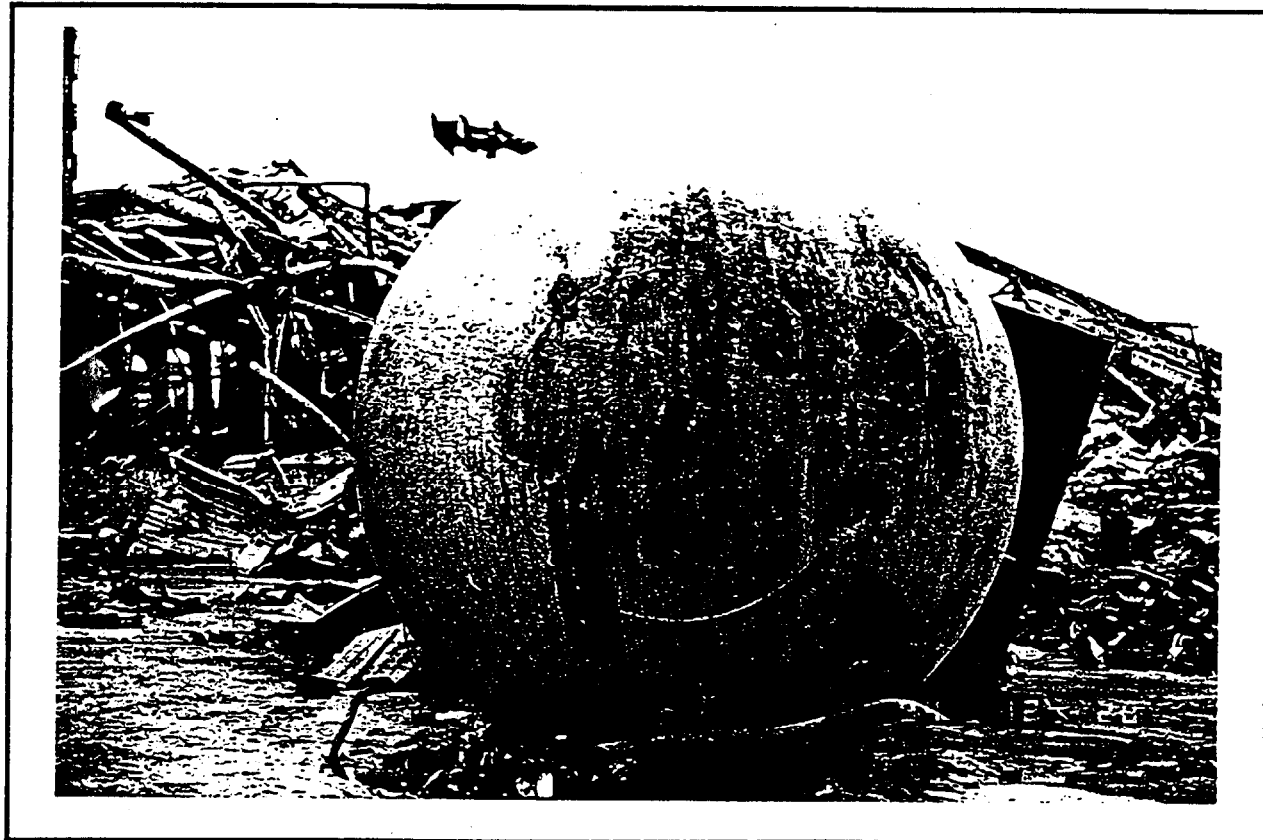
1. Reverse trajectory sighting of damage to a nearby water tank (*Photo 8-12*) and the ends of two pressure ammonia vessels (*Photo 8-13*) indicated that the neutralizer was the source of the penetrating fragments.
2. Reverse trajectory sighting of reinforcing bar angles, anchor bolt directions, and prill tower footing bolts and pads converged on the original neutralizer site.
3. Reverse trajectory sighting of a chemical stripper originally located near the AN plant indicated the explosion origin to be along a line that intersected with the original neutralizer site (*Photo 8-14*).
4. Reverse trajectory sighting of scrubber sections and the ammonia vaporizer indicated the explosion origin to be along a line that intersected the original neutralizer site.
