UNSAFE ACT/ CONDITION and NEAR MISSES REPORT

Dept/MBU: After Paint (APM or Medical Line)

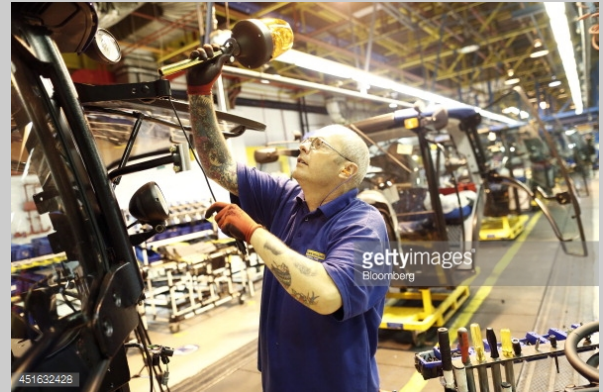
Sketch:

The worker lay down on a duckboard in order to move under a tractor to check for possible oil leaks, but the duckboard shifted as the worker sat down and the worker fell and received a superficial cut to the head

provide a shell or cover for the issue like cover for the employee working under the tractor; quality department checked parts to spec and found that floor ducting measurements were out of spec. the company are dealing with this and we are waiting for good parts. That will prevent any force having to be used to fit lower hood.; use liquid or air with the hit - hot liquid investigated; even out the environmental forces that affect the point;

use liquid or air with the hit - hot liquid investigated; even out the environmental forces that affect the point
