Project Quality Observation Summary

Project Name: GM - Project A

DATE: 3 days - September 24th to September 26th 2024

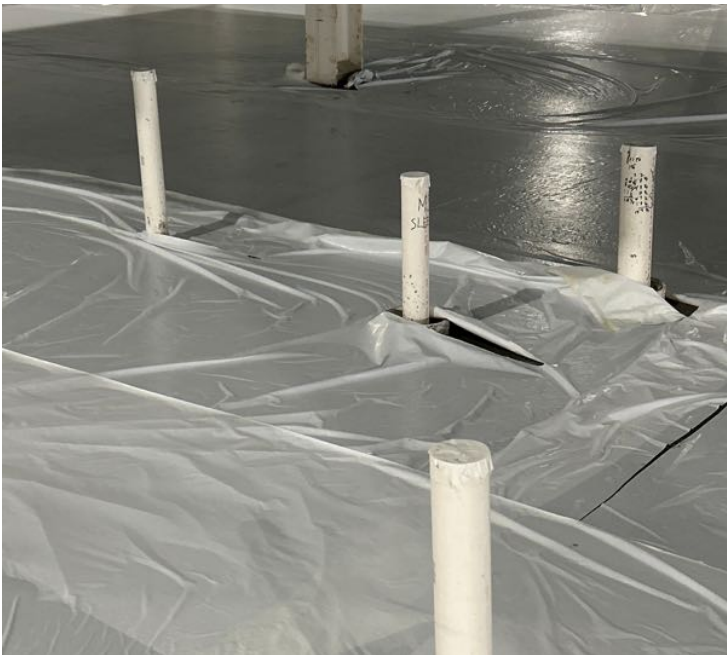
Date	Type	Category	Location	Description
09/26/2024 02:41 PM EDT	Positive	Quality - FME (Foreign Material Exclusion)	GM - Project A	All plumbing is covered with tape.

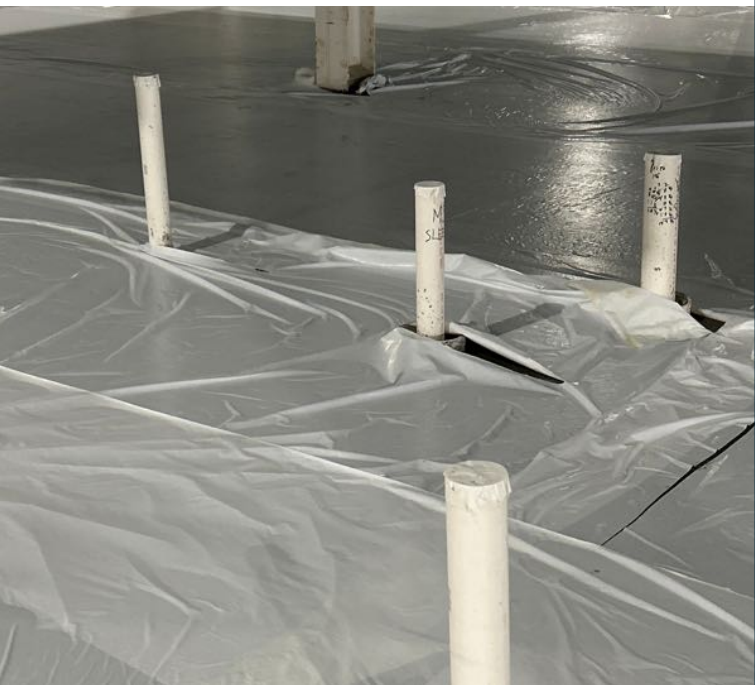
Quality Observation: 382527

Category		Status	
Quality - FME (Foreign Material Exclusion)		Closed	
Description			
All plumbing is covered with tape.

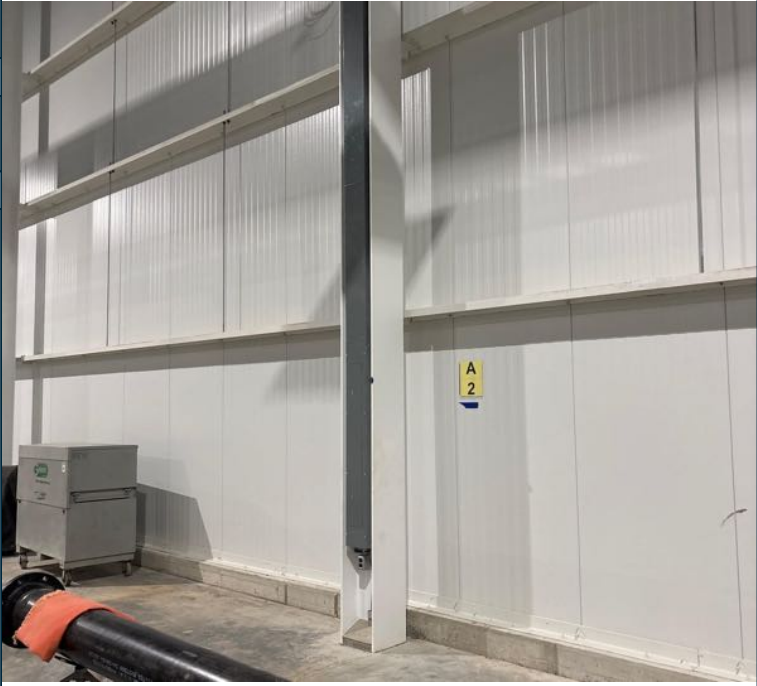
Quality Observation: 380869

Category		Status	
Quality - Code/Spec/Drawing Compliance		Closed	
Description			
Steel touch up paint is white as specified

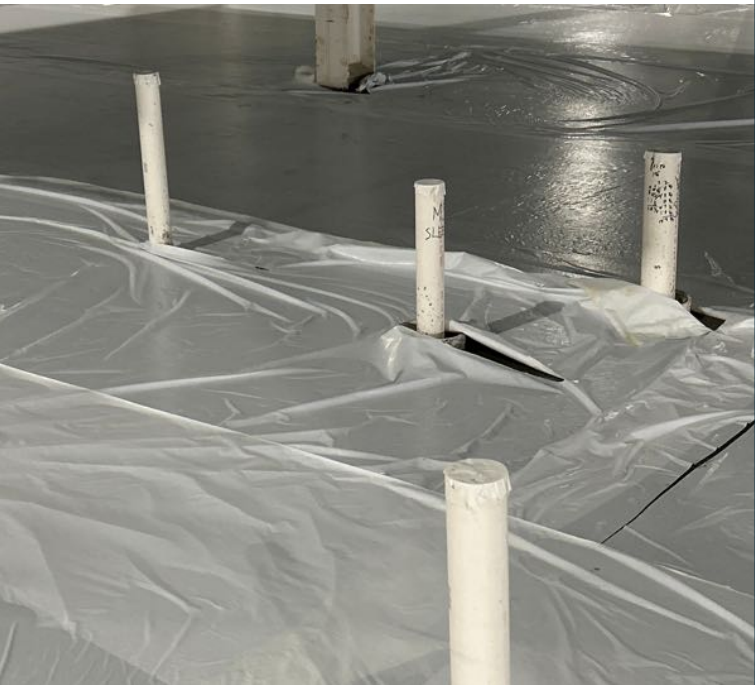
Quality Observation: 382527

Category		Status	
Quality - FME (Foreign Material Exclusion)		Closed	
Description			
All plumbing is covered with tape.
