Site Visit Report

Project:	Test
Report Number:	#1
Subject:	Testing report before deployment

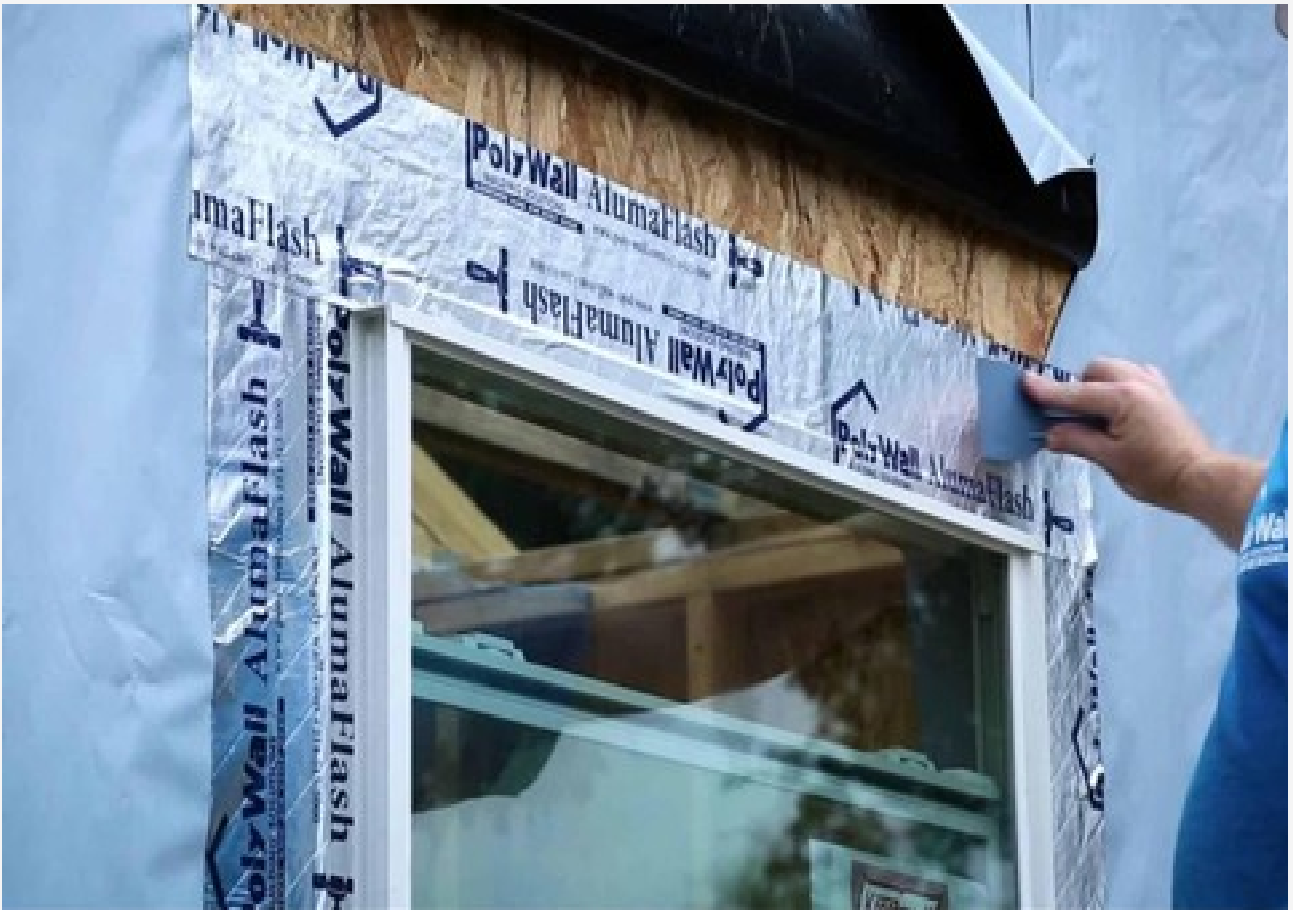
Photo 1

The observations collectively point to several building envelope integrity concerns that could compromise the weather-resistant barrier (WRB) system. The PolyWall AlumaFlash installation around the window opening represents a critical waterproofing detail, as window-wall interfaces are common points of water intrusion. While the caption indicates the installation is in progress, the effectiveness of this detail will depend on proper integration with the WRB and exterior cladding systems.

Installation of a window flashing system showing PolyWall AlumaFlash self-adhered flashing membrane being applied around a window opening with OSB sheathing visible above, creating a weather-resistant barrier to prevent water infiltration at the fenestration perimeter.

2. Conduct a comprehensive review of all window flashing installations to ensure proper shingling of materials, adequate integration with the WRB system, and appropriate end dams to direct water away from the building assembly.

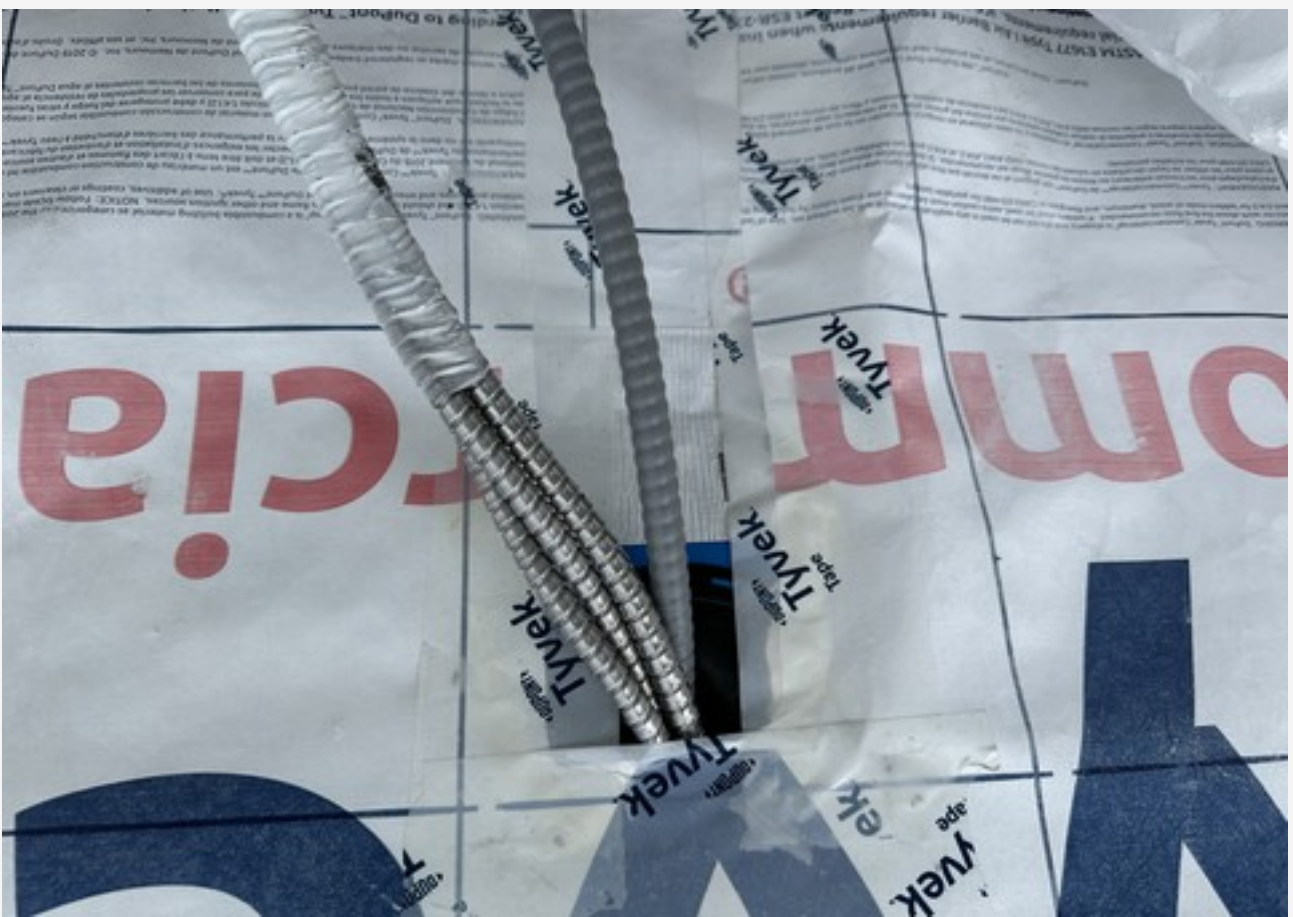
Photo 2

Of significant concern is the electrical conduit penetration through the Tyvek WRB. The rough, unsealed penetration creates a direct pathway for water, air, and vapor migration into the building assembly. Such breaches in the continuous air barrier can lead to moisture-related issues including mold growth, reduced insulation effectiveness, deterioration of sheathing and framing members, and potential indoor air quality problems. Penetrations that are not properly sealed also compromise the building's energy efficiency by allowing air leakage.

Electrical conduit (likely MC cable) penetrating through DuPont Tyvek weather-resistant barrier (WRB), showing a rough penetration opening that requires proper sealing to maintain the building envelope's weather protection integrity.

1. Implement immediate inspection of all building envelope penetrations, focusing on sealing electrical, mechanical, and plumbing penetrations through the WRB using manufacturer-approved methods and materials. Require photographic documentation of corrections.

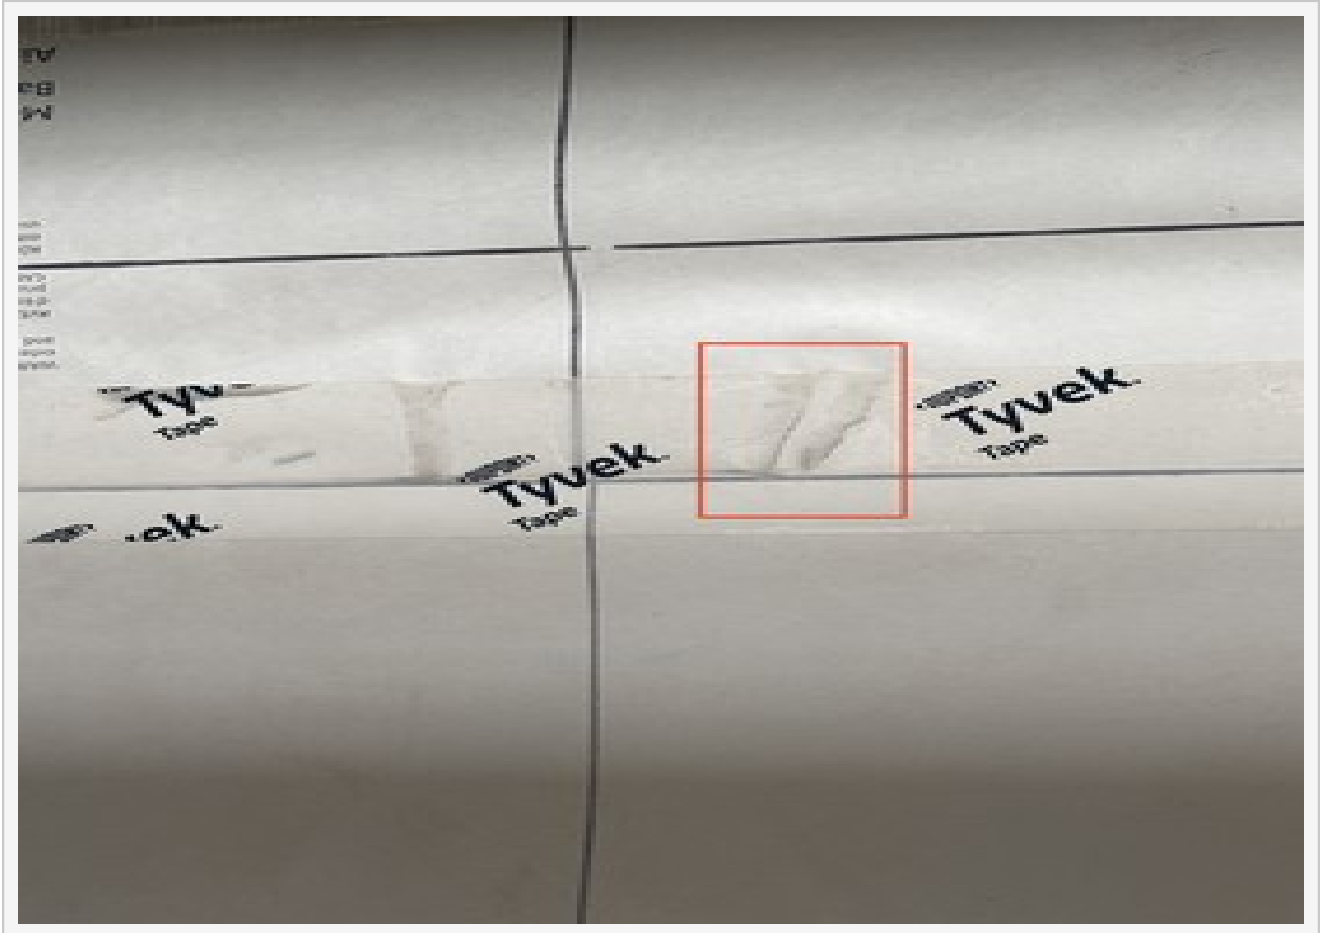
Photo 3

The wrinkled or improperly adhered Tyvek Tape at the WRB seam represents another vulnerability. Proper seam treatment is essential for maintaining continuity of the air and water barrier. Wrinkles, gaps, or poor adhesion at seams can create channels for water intrusion and air leakage. Over time, these deficiencies may worsen due to building movement, thermal cycling, and UV exposure, potentially leading to more significant failures.

DuPont(TM) Tyvek(R) Tape installation showing a seam with a highlighted area of wrinkling or improper adhesion where two sections of commercial weather barrier meet.

3. Re-examine all WRB seam taping for proper installation per manufacturer specifications, ensuring adequate surface preparation, proper overlapping, and sufficient pressure application during installation to prevent wrinkles and ensure full adhesion.
