An Investigation of the Therac-25 Accidents

Nancy G. Leveson, University of Washington

Clark S. Turner, University of California, Irvine

A thorough account of the Therac-25 medical electron accelerator accidents reveals previously unknown details and suggests ways to reduce risk in the future.

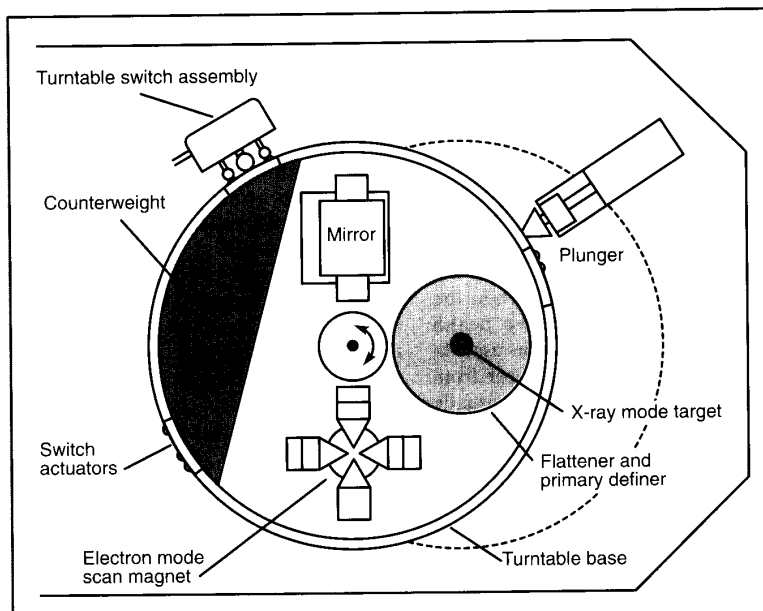
Figure B. Upper turntable assembly.

Manufacturer response. AECL could not reproduce the malfunction that had occurred, but suspected a transient failure in the microswitch used to determine turntable position. During the investigation of the accident, AECL hardwired the error conditions they assumed were necessary for the malfunction and, as a result, found some design weaknesses and potential mechanical problems involving the turntable positioning.

crossswitch codes (which could be caused by a single open-circuit fault on the switch lines) could produce an ambiguous position message for the computer.

hazard of dual-mode machines: If the turntable is in the wrong position, the beam flattener will not be in place.

No accelerator beam is expected in the field-light position. A stainless steel mirror is placed in the beam path and a light simulates the beam. This lets the operator see precisely where the beam will strike the patient and make necessary adjustments before treatment starts. There is no ion chamber in place at this turntable position, since no beam is expected.

cate turntable position that tolerated a 1-bit error: The code would still unambiguously reveal correct position with any one microswitch failure.

The modifications recommended in the Symonds report included redesigning the microswitch and changing the way the computer handled malfunction conditions. In particular, treatment was to be terminated in the event of a dose-rate malfunction, giving a treatment "suspend." This would have removed the option to proceed simply by pressing the "P" key. The report also made recommendations regarding collimator test procedures and message and command formats. A November 8, 1985 letter signed by Ernest Létourneau, M.D., director of the CRPB, asked that AECL make changes to the Therac-25 based on the Symonds report "to be in compliance with the RED Act."

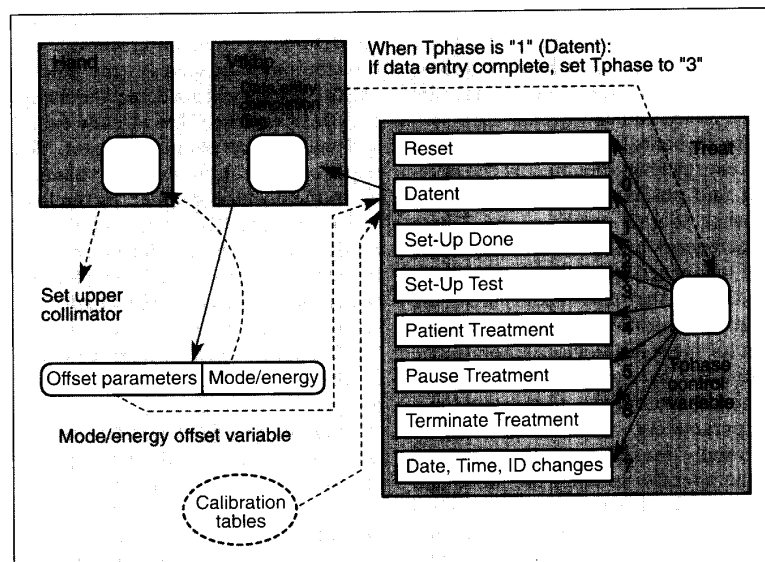
Figure 2. Tasks and subroutines in the code blamed for the Tyler accidents.

As described in the sidebar on Therac-25 software development and design, the treatment monitor task (Treat) controls the various phases of treatment by executing its eight subroutines (see Figure 2). The treatment phase indicator variable (Tphase) is used to determine which subroutine should be executed. Following the execution of a particular subroutine, Treat reschedules itself.

One of Treat's subroutines, called Datent (data entry), communicates with the keyboard handler task (a task that runs concurrently with Treat) via a

shared variable (Data-entry completion flag) to determine whether the prescription data has been entered. The keyboard handler recognizes the completion of data entry and changes the Data-entry completion variable to denote this. Once the Data-entry completion variable is set, the Datent subroutine detects the variable's change in status and changes the value of Tphase from 1 (Data Entry) to 3 (Set-Up Test). In this case, the Datent subroutine exits back to the Treat subroutine, which will reschedule itself and begin execution of the Set-Up Test subroutine. If the Data-entry completion variable has not been set, Datent leaves the value of Tphase unchanged and exits back to Treat's main line. Treat will then reschedule itself, essentially rescheduling the Datent subroutine.

Upon exit from the Magnet subroutine, the data-entry subroutine (Datent) checks the data-entry completion variable. If it indicates that data entry is complete, Datent sets Tphase to 3 and Datent is not entered again. If it is not set, Datent leaves Tphase unchanged, which means it will eventually be rescheduled. But the data-entry completion variable only indicates that the cursor has been down to the command line, not that it is still there. A potential race condition is set up. To fix this, AECL introduced another shared variable controlled by the keyboard handler task that indicates the cursor is not positioned on the command line. If this variable is set, then prescription entry is still in progress and the value of Tphase is left unchanged.

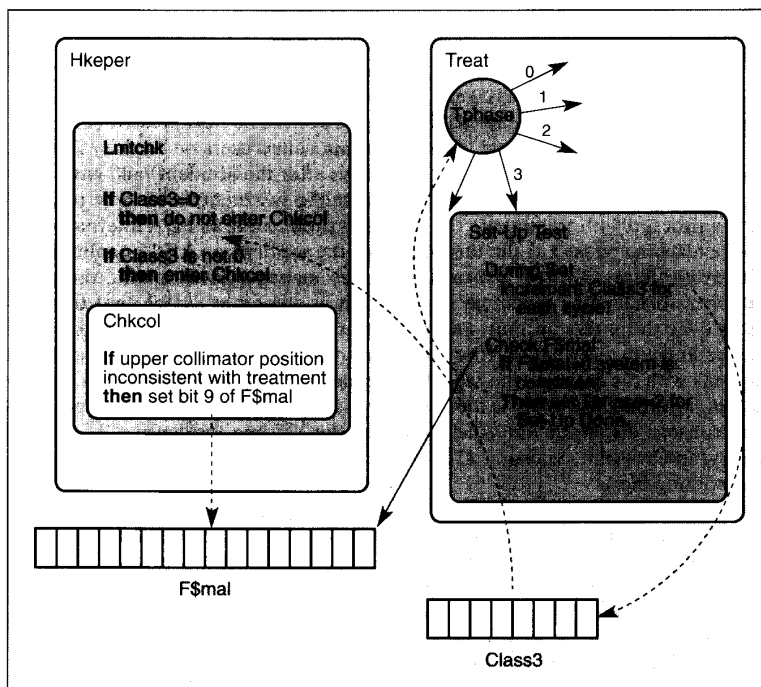
Figure 4. Yakima software flaw.

The second Yakima accident was again attributed to a type of race condition in the software — this one allowed the device to be activated in an error setting (a "failure" of a software interlock). The Tyler accidents were related to prob-

lems in the data-entry routines that allowed the code to proceed to Set-Up Test before the full prescription had been entered and acted upon. The Yakima accident involves problems encountered later in the logic after the treatment monitor Treat reaches Set-Up Test.
