Defect Record Sheet

Defect Ref No: SW2-MAS3-EXT-WK004-047

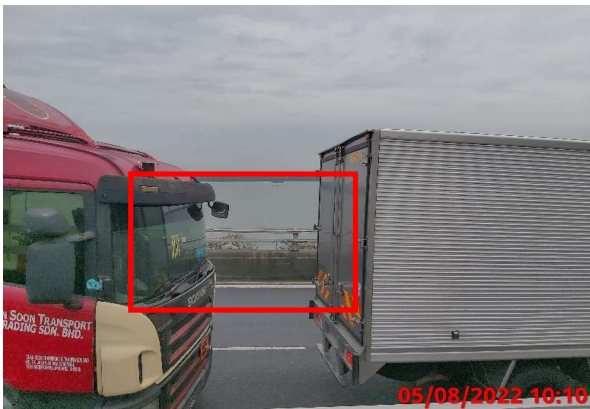
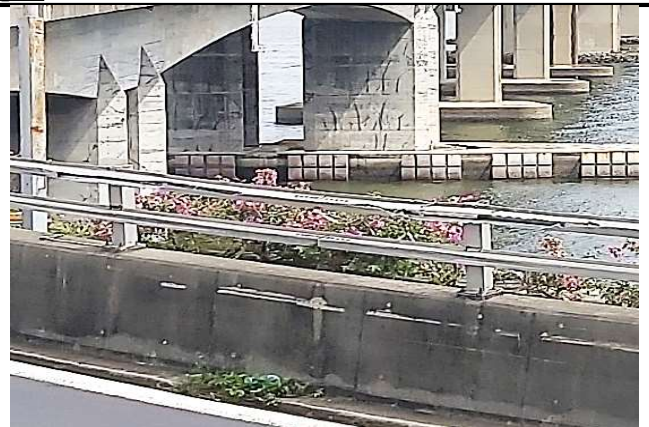
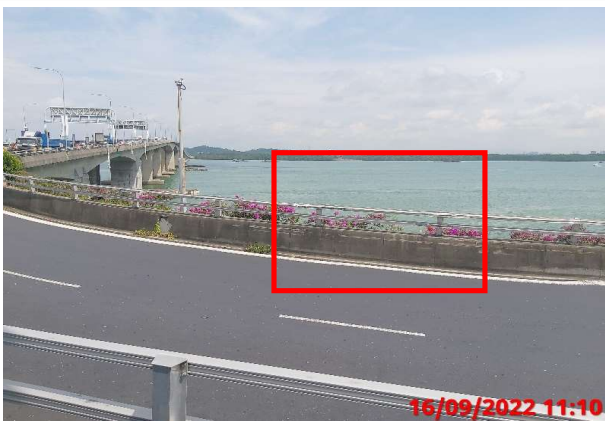
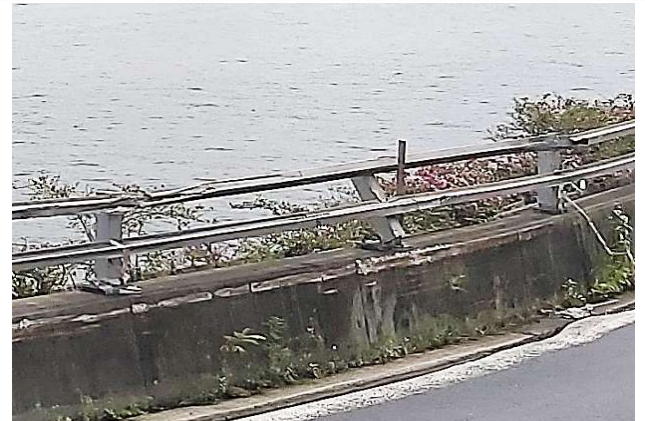
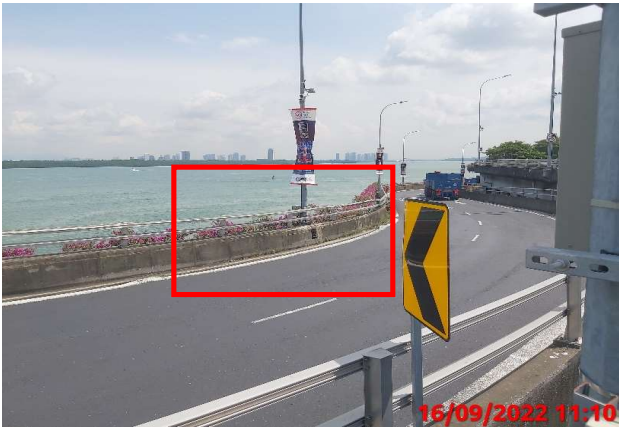
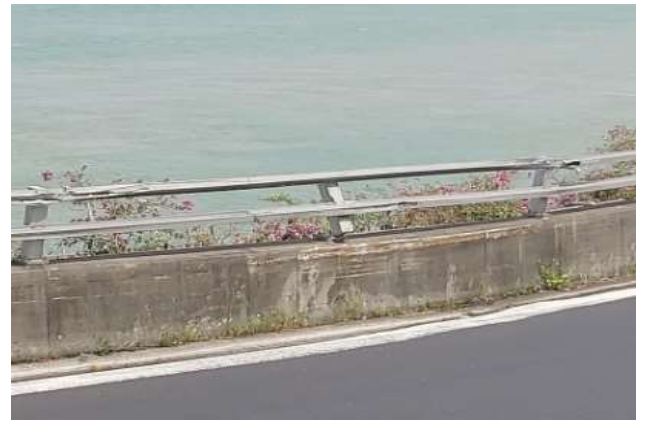
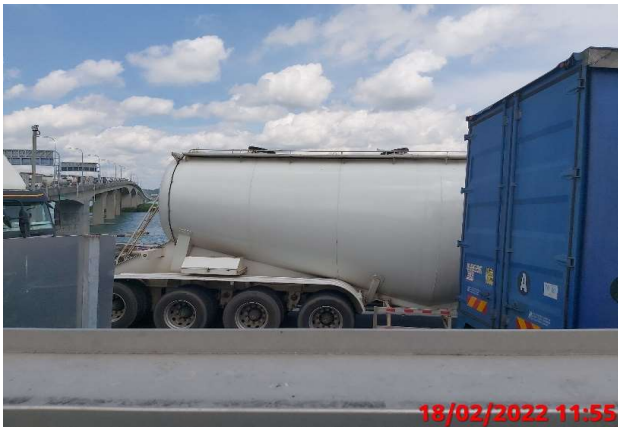
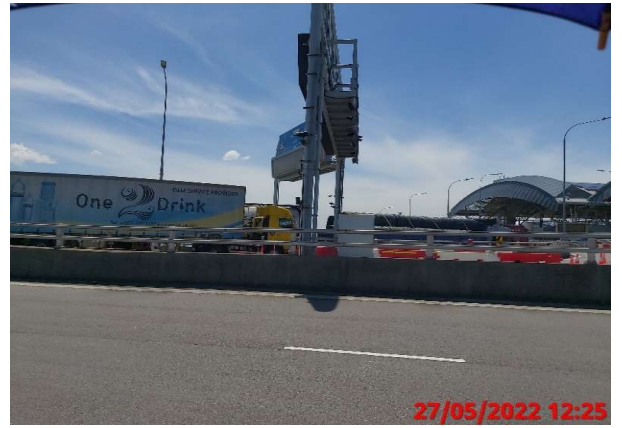
- A** Railing-Damaged
● LP 25F
