Defect Record Sheet

Defect Ref No: SW2-MAS3-EXT-WK004-047

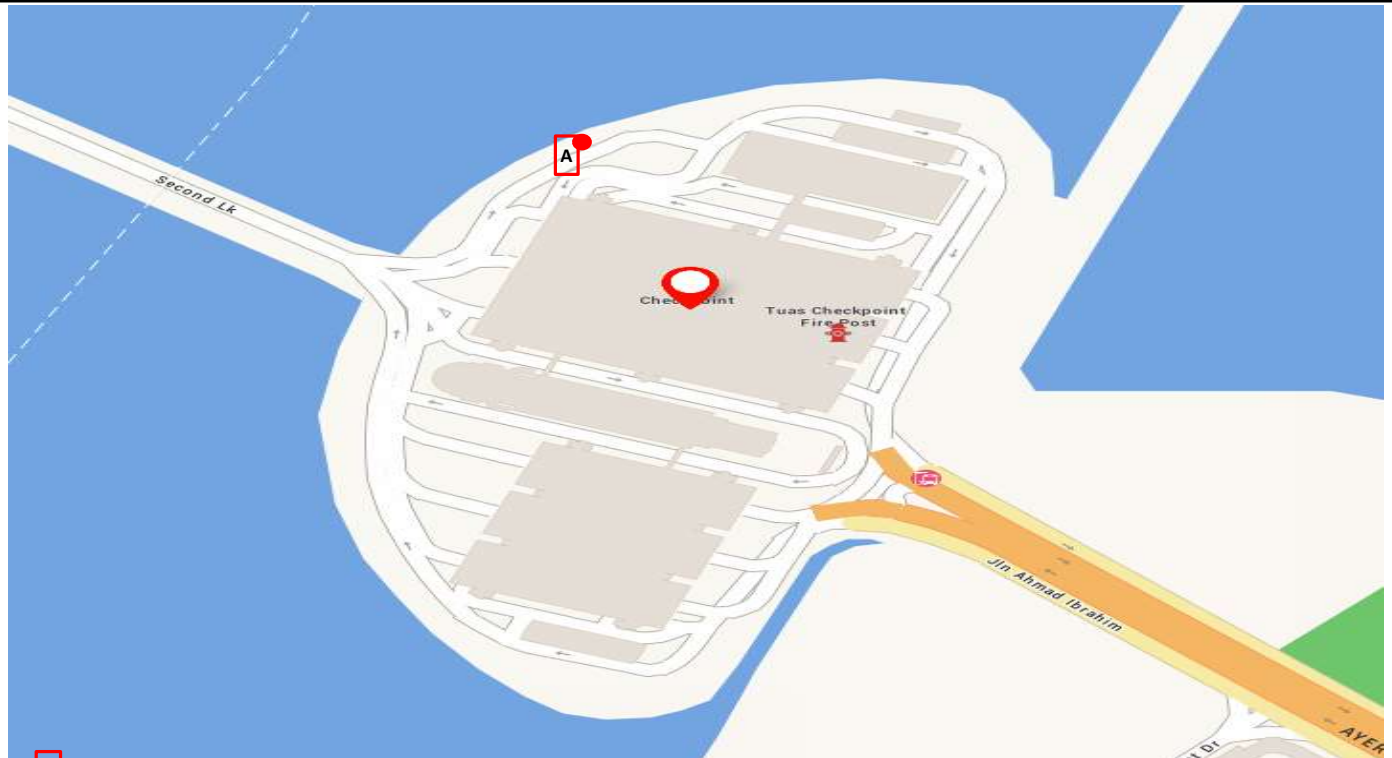
- A** Railing-Damaged
● LP 25F
