Defect Record Sheet

Defect Ref No: SW2-MAS3-EXT-WK004-047

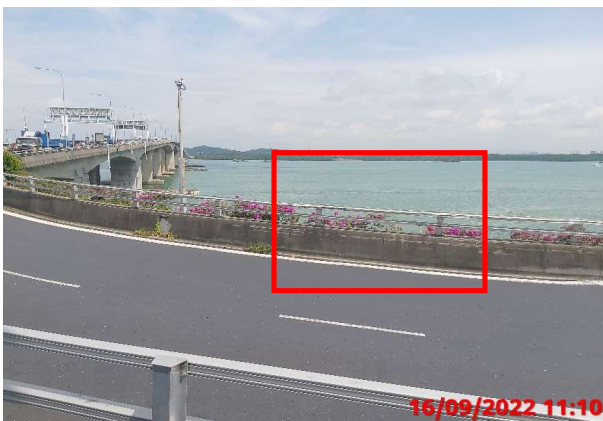
Photographs

A	Defect Ref No : SW2-MAS3-EXT-WK004-047		Date / Time : 16/9/2022	
	Repeated defect: (Yes/ No) Yes			
	Type of Road /Footpath/Facilities : Major			
	Location / Landmark: Tuas Checkpoint		TP 25F	
	Type of Asset: Railing			
	Description: Railing-Damaged			
	Quantity: 5			
	Measurement: 2m x 3.5m			
	Cause of Defect: Ht By Vehicle			
	Recommendation: To Replace			
Inspected By :	XXX	Signature		
Supervised By :	XXX	Signature		
<p>Defects reported to DRC / RARL / RIA / other agencies on:</p> <p>Reported via: Method / Agency / Date / Time: XXX</p> <p>Acknowledgement: Method / Date / Time: XXX</p>				
B	(For LTA Use)			
	Defects Verified by :	Name Signature Date		
	Instructions:			
	WSO No.:			
C	(For contractor's acknowledgement)			
	Acknowledged and received by:	Name Signature Date		
TR322
