Intel[®] Ethernet Controller I210

Specification Update

January 2020

Revision 2.7
332763-011

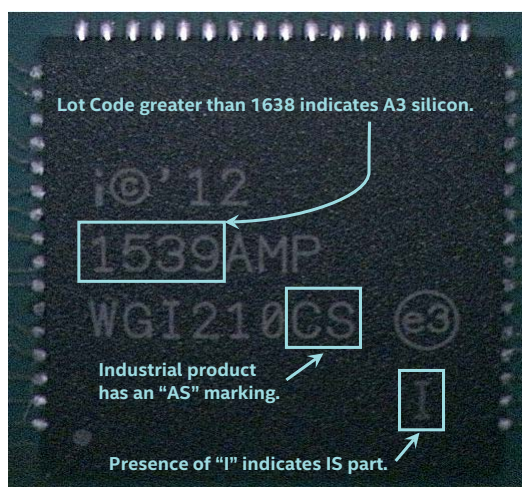
Figure 1-1. Explanation of Top Markings for A3 Stepping

The A3 stepping only applies to the Fiber (IS/CS/CL) products. The A3 stepping can be identified by the Fab Lot Trace Code marking on the package or by the INVM contents.

- Fab Lot Trace Codes starting with 1638 or greater are A3 devices.
- Bit 1 of INVM_DATA[61] (0x12214) is 1b on A3 devices.
