Aviation Safety

Maintainer

Issue 2/2004

Cross-Wired Side-Stick Almost Brings Down Airbus A320

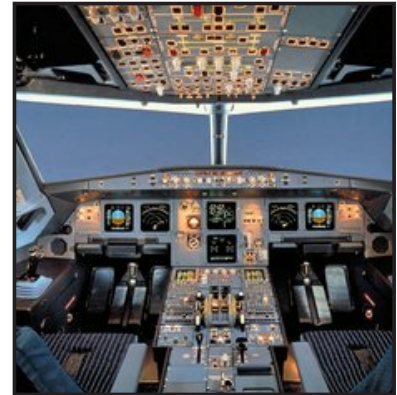
Investigation of the incident revealed that as the technicians were troubleshooting and repairing the elevator and aileron computer (ELAC) system, they found a damaged pin on one segment of the four connector segments, with 140 pins each, on the rack side of the ELAC mount. The repair work performed by various technicians over several shifts involved a complete rewiring upstream of the connector pins. During this process, the polarity was inadvertently reversed on four wires in one connector segment. Two of the wires were for the roll control input and two were for the associated channel outputs. It is believed that the technicians correctly followed the wiring list but that this list can vary by aircraft serial number. Extreme care must be taken to match up the correct wiring list by tail-number (aircraft-affectivity). Since the ELACs are interchangeable from one aircraft to the other, it is thought that the issue of crossed-wiring has at its source the colour coding scheme of the wiring on the backside of the connectors on the rack to which the ELAC is mated.

electronic centralized aircraft monitoring system (ECAM). The flight control check was limited to the F/O's side-stick. The fault got by at least two safety filters, as it was neither detected by maintenance nor at the pre-flight check.
