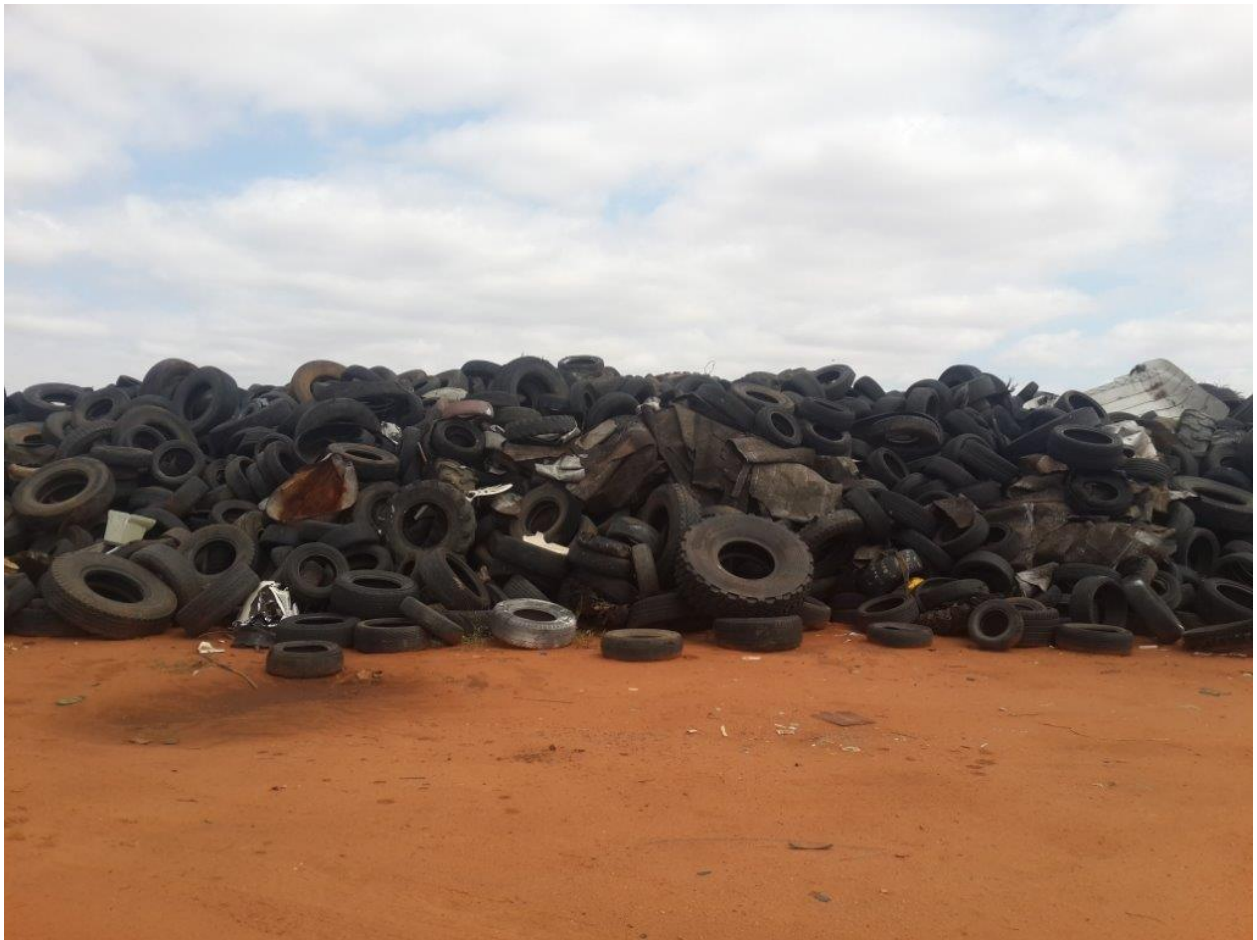
Moreover, they could also contribute to surface instability and present a fire risk with the potential for excessive black smoke.<sup>39</sup>

**Figure 10: Tyres at the Gamodubu Landfill**

- **Expedite the reclamation project to enable management of the accumulation of tyres within the landfill, in order to reduce instances of surface instability that may represent fire risks.**
