USB72x6/USB7252 Silicon Errata and Data Sheet Clarification

This document describes known silicon errata for the following USB72x6/USB7252 devices:

- USB7206
- USB7216
- USB7252

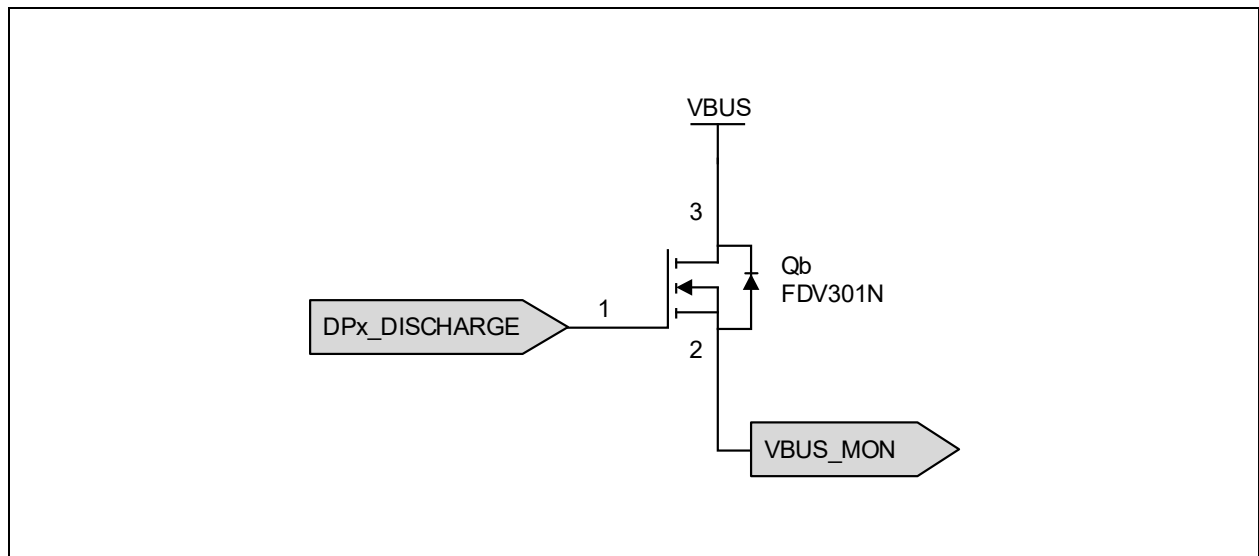
FIGURE 2: TYPE-C DISCHARGE WORKAROUND FOR MODULE 3

Frequently, these ports will be implemented with electrolytic VBUS load capacitors, which retain a small residual charge that is released slowly compared to the timing of the discharge. In such cases, as energy is released from the capacitor the voltage can drift upward slightly after the discharge, which can cross the VBUS_DET threshold for detecting VBUS high. In the sequence of the Port Power On/Off test, this can inhibit subsequent turning on of VBUS in response to commands from the test host and the test fails.

Type C ports that have a large electrolytic capacitor may require this workaround to pass the HUBCV Port Power On/Off test.

In reference designs for USB7216 and USB7252 devices, an N-channel MOSFET with a V_{GS} less than 1.0V is connected between VBUS and VBUS_MON, with gate control from the DISCHARGE signal. This additional component creates an additional current path as the discharge is monitored by VBUS_MON, which biases VBUS_MON higher. This results in discharge to a lower voltage than what is otherwise achieved, and compensates for any residual energy that the capacitor releases after the discharge. At times other than the discharge, the MOSFET is turned off and does not influence VBUS.

No components of the reference design need to be removed; only the MOSFET is added.
