Killer Bug. Therac-25: Quick-and-Dirty

Oct 10 2016

Author: Aleksey Statsenko

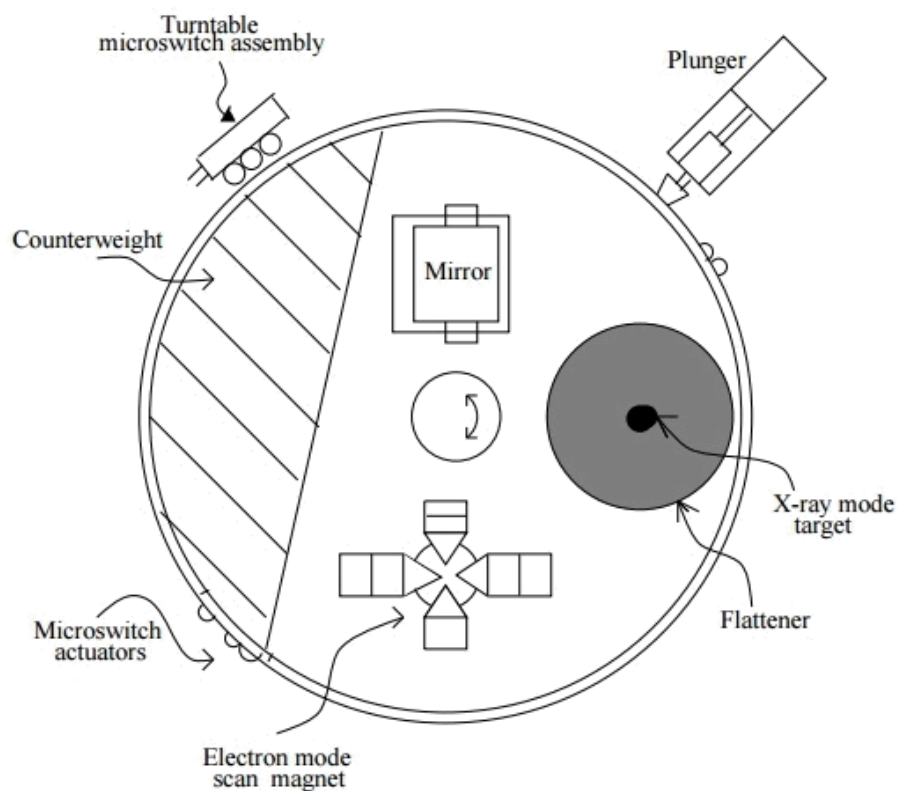
Figure 1: Upper turntable assembly.

In electron mode, scanning magnets would be used to spread the beam out to cover a larger area. In X-ray mode, a target was placed in the electron beam with electrons striking the target to produce X-ray photons directed at the patient. Finally, a mirror could be placed in the beam. The electron beam would never switch on while the mirror was in place. The mirror would reflect a light which would help the radiotherapy technician to precisely aim the machine.

On the Therac-6 and 20, hardware locks prevented the operator from doing something dangerous, say selecting a high power electron beam without the x-ray target in place.
