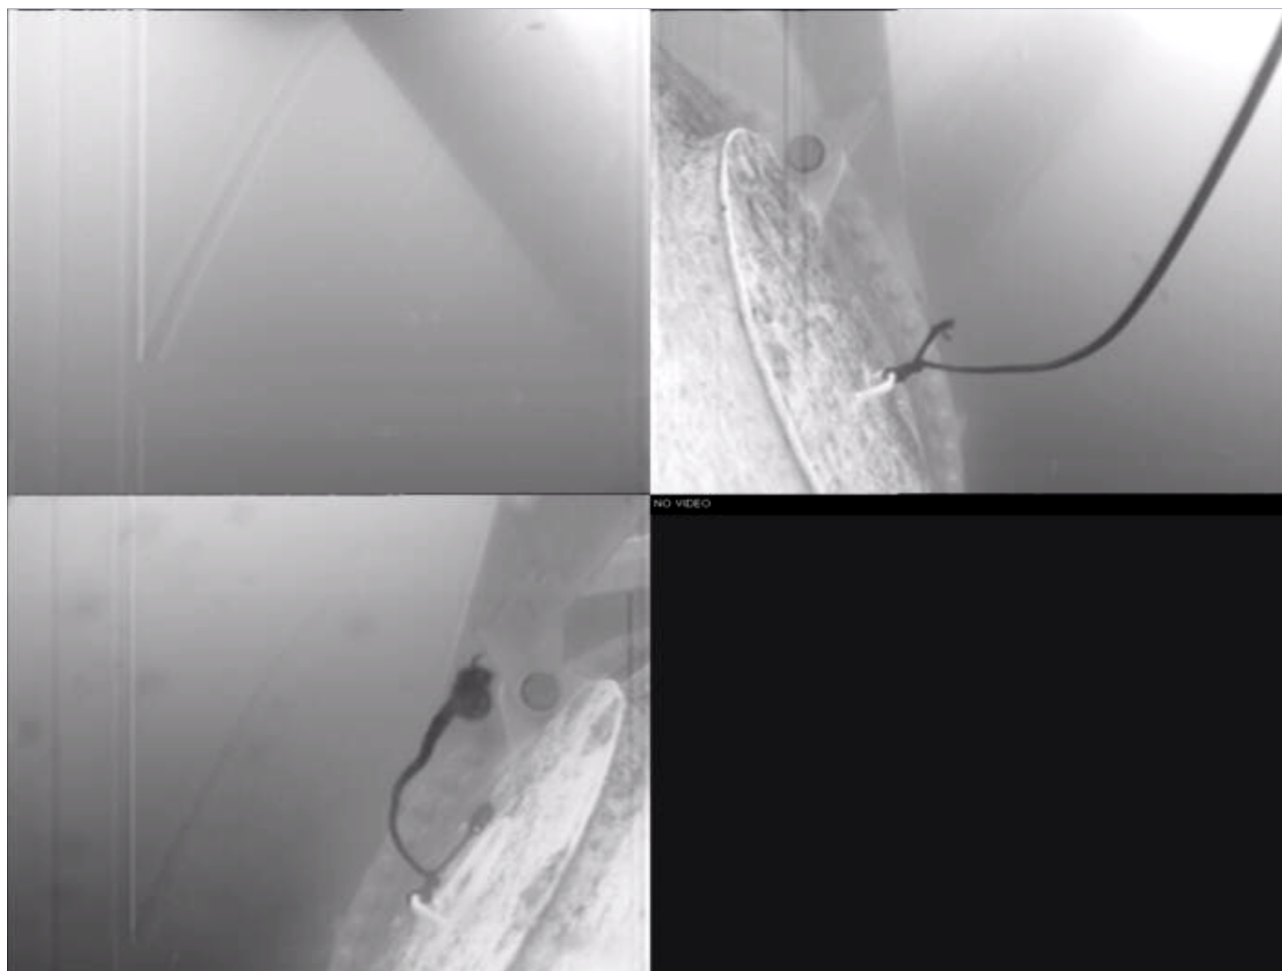
Figure 1.3 Field-of-view from cameras (camera 1 on monopile - top left, camera 2 on nacelle - top right and camera 3 on nacelle - bottom left). Video still is from May when biofouling coverage was at its minimum.

Initially, all three cameras provided clear images of the turbine rotors both when the turbine was at standstill and when it was in operation (see Figure 1.3). Some level of interference was visible on all cameras in the form of vertical lines constantly moving horizontally across the screen. Towards the end of May (approximately two weeks after deployment), biofouling began to appear on the lens of Camera 3. Two small dark areas appeared on the top of the lens of Camera 3 around 21 June. It is thought that these were barnacles, as an alternating patch of light and dark grey in their centre is consistent with the opening and closing of the shell plates which occurs during the feeding behaviour of barnacles. This biofouling got progressively worse until nothing could be seen from Camera 3 by mid-June. Biofouling began to appear on Camera 1 on 24 June, which got progressively worse; however biofouling on this camera did not appear to occur as quickly or severely as it did on Camera 3 and a relatively clear image is still visible by 13 July (see Figure 1.4). Camera 2 stayed free of biofouling and a clear image is available throughout the data gathering period.
