Electrical Infrared & Thermal Imaging Inspection **Nova Centre IR Scan 2023**

Report Title	Nova Centre IR Scan 2023
Company Name	Page Property Management
Phone	902-579-2686
Email	cthomas@pagepm.ca
Site Name	Nova Centre, Halifax
Site Location	1650 Grafton St, Halifax, NS B3J 0E8
Thermographer	Patrick Miller
ITC Certification No.	Level II Thermographer (221112-1)

On May 17, 18, 19, 2023, Dynamic Thermal Imaging conducted a thermal inspection of the electrical assets at The Nova Centre in Halifax, Nova Scotia.

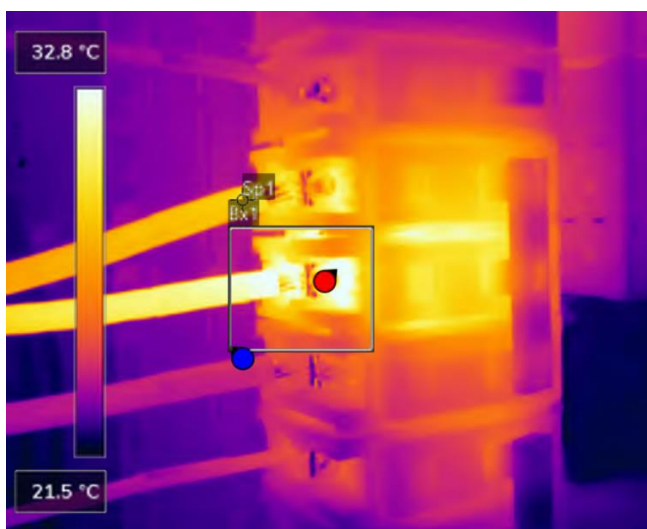
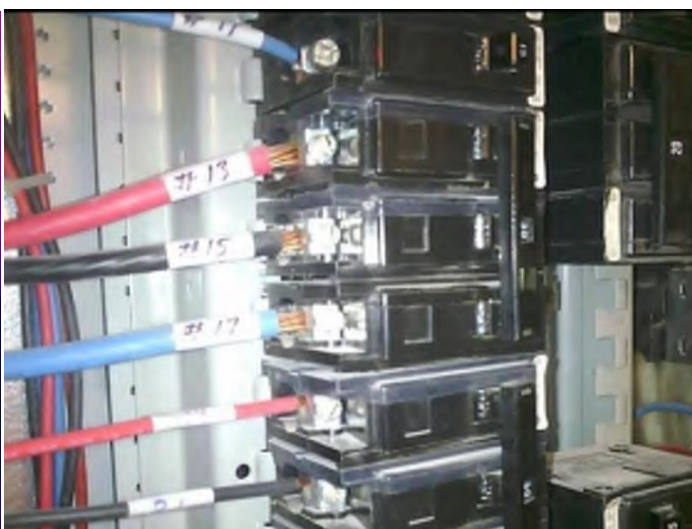
DTI Infrared No. **222125**

Fault Rating: **Potential Problem**

Equipment Summary		Measurements		Parameters	
DTI Infrared No.	222125	Sp1	29.3 °C	Emissivity	0.95
Location	Mechanical Room 676	Bx1		Distance	0.24m
Label	E6P2A cct 15,17,19	Max	35.8 °C	Atmospheric temp.	20.0 °C
Equipment Type/Description	Breaker	Avg	28.1 °C	Relative humidity	50.0%
Rating	208V 30A	Min	23.2 °C	Ext. optics temp.	20.0 °C
Problem	Current exceeds 80% of the breaker rating.	Dt1(公式)		Reference temp.	0.0 °C
Recommendation	Replace breaker.	Bx1.Max-Sp1	6.5 °C		
Action	Repair Required	Delta			
		Value			
Amperage Reading:	31.2200 A

High temperature connection found on 3p30A breaker CCT 13,15,17, feeding Emergency Panel E6LP2D. Current readings are: PhA 22A, PHB

31A, PhC 7A. This emergency panel shows an unbalanced load which should be investigated further. Unbalanced loads may be caused by too many loaded circuits on one phase, or time of day use. Balancing a panel can be particularly difficult due to different loads being energized at different times.

Current readings exceed the rating of the breaker. Wire appears to be #6awg copper, which can safely be put under a 3p60A breaker. Recommend upsizing this breaker to avoid unwanted

downtime of emergency panel.
