## Accident investigation

*Fire in container for battery energy storage,  
Gothenburg 2023-04-26*

Fire in container for battery energy storage

2023-04-26

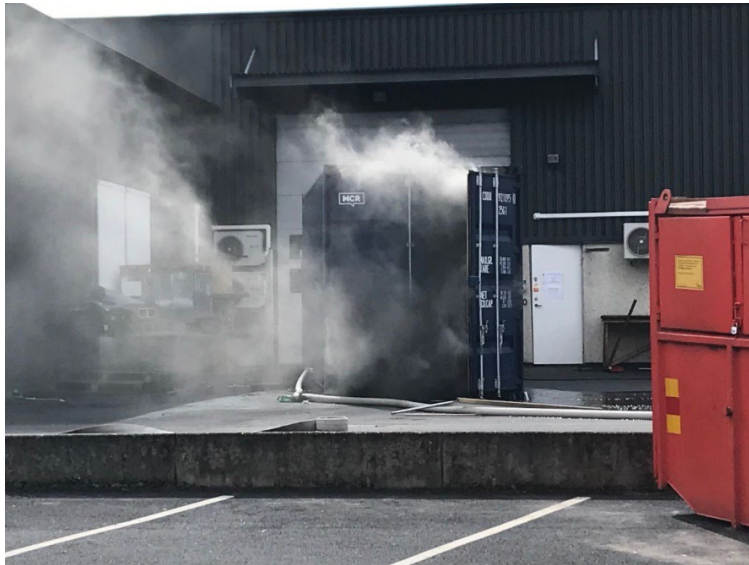
*Picture 2 shows the container early in the operation. Source RSG*

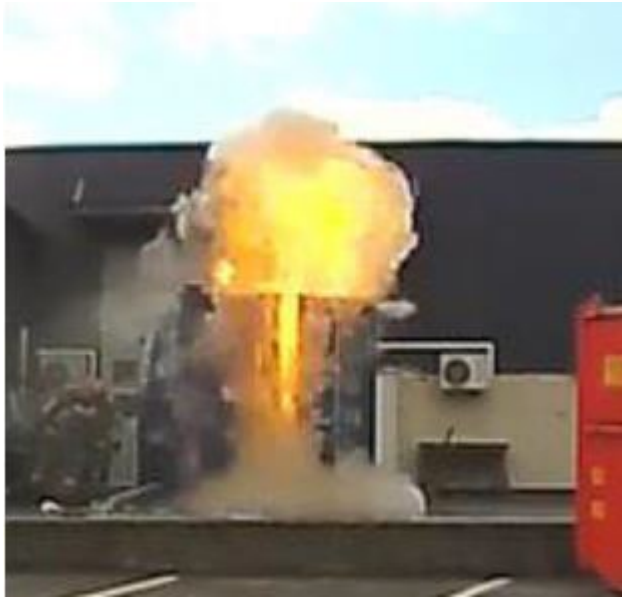
about 4 – 5 minutes after cooling with cutting extinguishers started, a strong explosion occurred which deformed the container and where the doors on one short side of the container flew open.

*Image 3 shows a clip from a film that captured the explosion. Source current company*

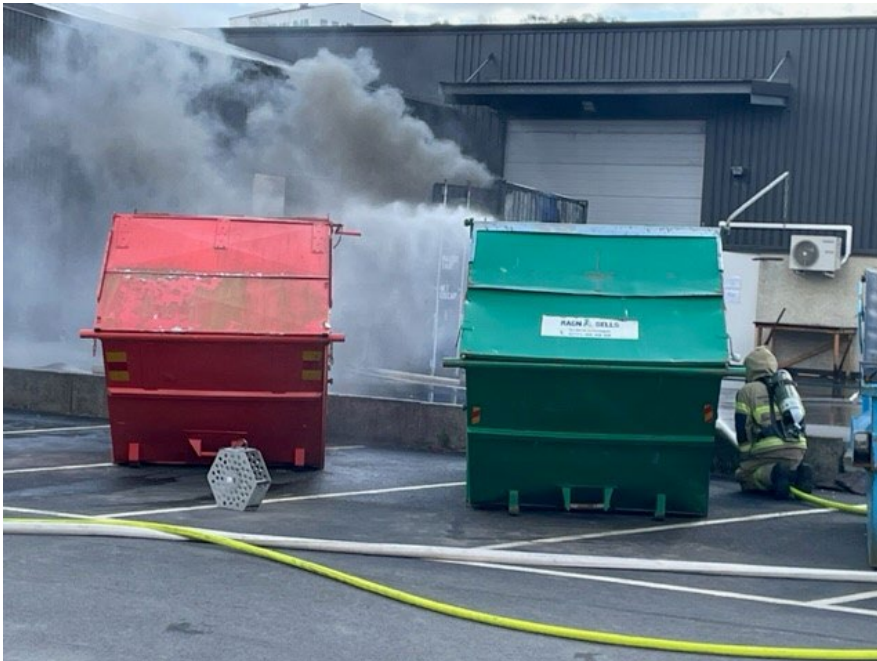
*Figure 4 shows smoke development and work from a protected position. Source RSG*

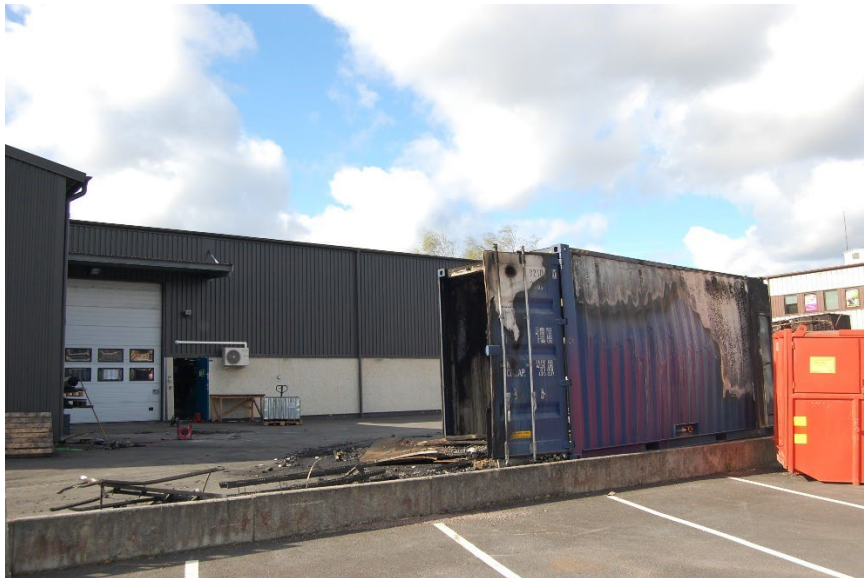
*Picture 5 shows the new location of the container. Source RSG*

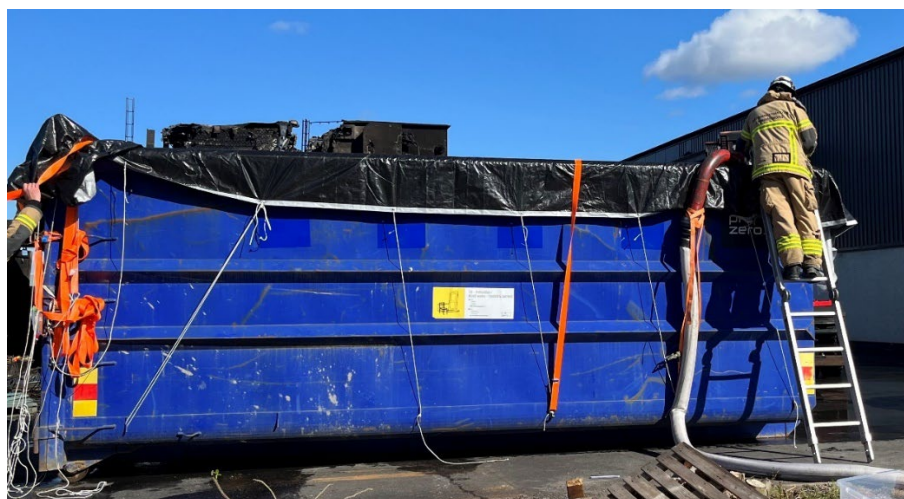
After just over 1.5 hours after the end of the rescue operation, a new 112 call was received, where it emerged that smoke had once again started to come from the batteries. RSG started a new rescue effort where initially a risk distance of 50 m was kept and the plan was once again to get a container that could be filled with water and then submerged in the batteries. They had contact with expertise that meant that in itself is there any additional danger with this type of reboot other than just continuing to cool. A few hours later, the company had produced a container that was coated on the inside with pressing and then filled with water. With the help of a crane truck, the battery was then lowered in its entirety for cooling.

*Picture 6 shows the battery immersed in a water bath. Source RSG*

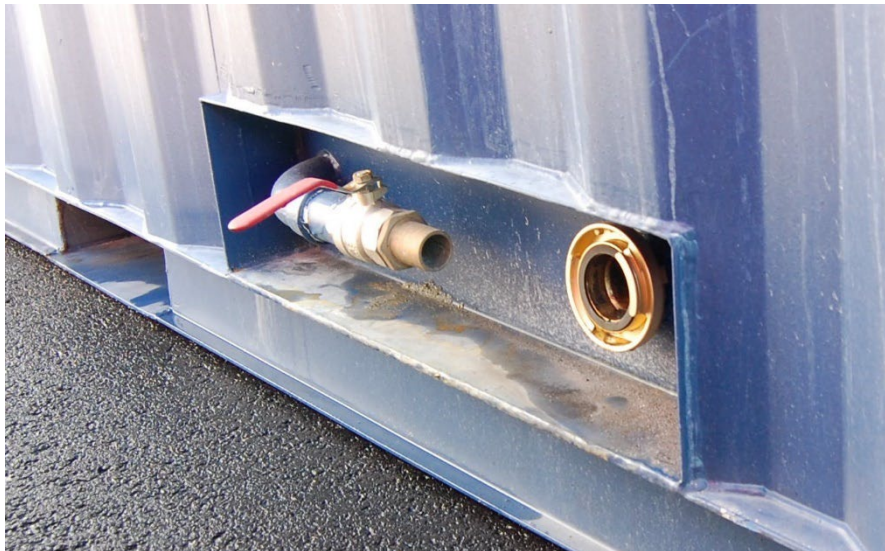
*Picture 8 Shows the connection for the introduction of water on the right and emptying on the left. Source RSG*

This inlet was connected with hose from RE early in the operation but water application was not started. The company's representative announced in connection with the information about the introduction that "using this method destroys all batteries". That information together with other assessments led RL to decide at the time to start the operation with the method of containing, inerting and cooling the fire gases using the cutting extinguisher described above. When the explosion resulted in the container being deformed, cooling via introduction was no longer relevant.

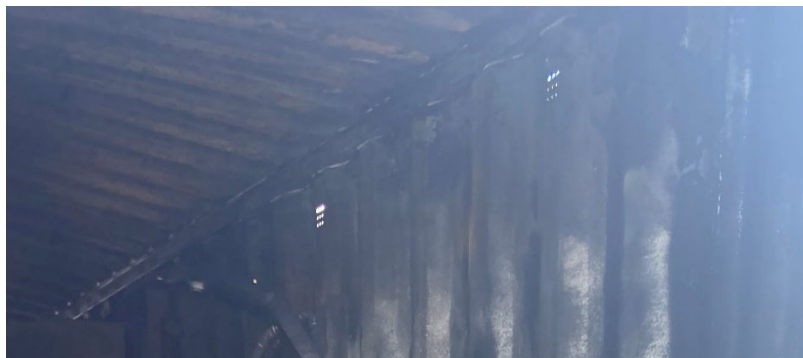
in the current case, the investigator was able to find ventilation in the container. However, it is unknown how large a volume of air can pass through this ventilation and at what rate.

*Picture 9 shows two of eight ventilation openings. Source RSG*

It also requires that the water be applied to the top of the container so that rising water pressure does not affect the filling. According to the description, the pipe must have been constructed in this way. The deformation of the container in connection with the explosion suggests that pressure relief hatches for sudden pressure increase were missing.
