**Objet:** Flash info Technique : Etiquettes bornier à l'envers sur sirènes NEXUS

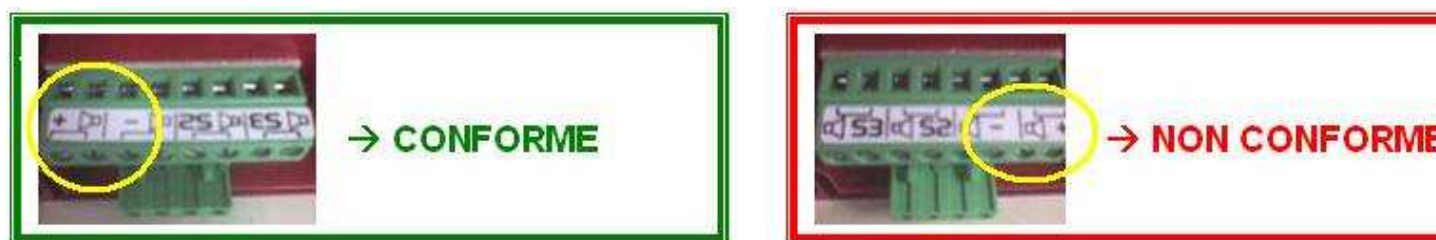
Suite à quelques remontées d'informations d'agences, il s'avère que sur certaines sirènes NEXUS livrées de Cergy depuis le 01/01/2011, des étiquettes borniers sont collées à l'envers : de ce fait, le raccordement de l'alimentation peut se trouver inversé et ainsi, les sirènes ne fonctionnent pas lorsqu'elles sont sollicitées (voir schéma ci-dessous)

Les codes produits concernées sont : 640 200 025, 640 200 026, 640 200 027, 640 200 028, 640 200 029 et 640 200 030
