Stewardship for Lone Hickory

Lead Steward: Dominic

2023-12-18

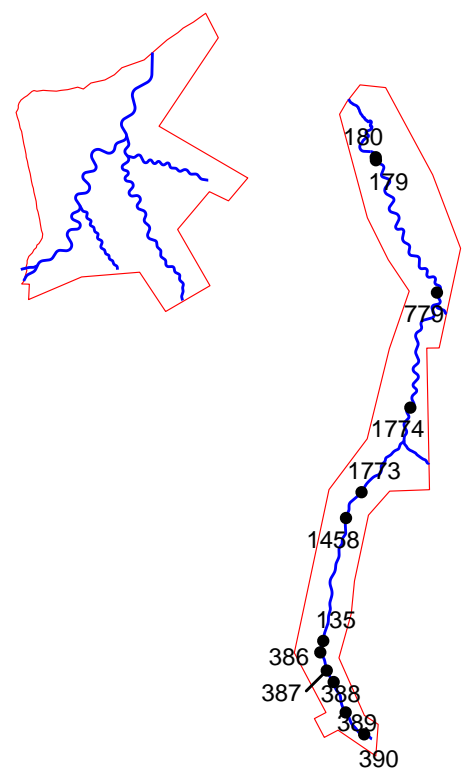
Channel Issues (points)

OBJECTID	Year	Subtype	Issue	Description	Treatment	TreatDate	Resolved
1081	2023	Channel Stability/Erosion	ErosionScour	Minor bed scour previously noted @ XS15; MY5 bank height ratio is 1.1 so therefore area seems to be improving			Yes
1054	2023	Channel Stability/Erosion	ErosionScour				No
1080	2023	Channel Stability/Erosion	ErosionScour	Bed scour @ XS10; MY5 bank height ratio is 1.4			No
1082	2023	Channel Stability/Erosion	ErosionScour	Bed Scour @ XS28; MY5 bank height ratio is 1.3			No
1458	2023	Failed Structure	Piping	Log at tail of riffle piping/goes temp. subsurface. No visible erosion. Subsurface flow/scour on right bank 11/6/2023			No
1773	2023	Failed Structure	Piping	See its higher flow			No
1774	2023	Failed Structure	Piping	Hole around structure			No
786	2022	Needs Livestakes			live staked silky willow, dogwood, black willow	01/2023	Yes
732	2022	Needs Livestakes		Needs livestakes on eroding banks.			No

733	2022	Channel Stability/Erosion	ErosionScour	Undercutting banks on both sides; more severe on left bank			No
734	2022	Needs Livestakes		Needs livestakes both sides			No
735	2022	Channel Stability/Erosion	ErosionScour	Undercutting banks; minor with woody stems present on banks; 11/5/2023 just minor bowling out, keep eye on			No
736	2022	Needs Livestakes					No
737	2022	Needs Livestakes					No
784	2022	Channel Stability/Erosion	AggradationDeposition	Aggradation			No
386	2022	Failed Structure	Piping	Piping around or under log sills. J hook?; does not seem to be actively scoring 7/24/2023			No
387	2022	Failed Structure	Piping	Water flowing under log sill. Somewhat stable. No scour visible.; no piping 11/6/2023			No
388	2022	Failed Structure	Piping	Riprap repair did not fix log sill piping. Subsurface under rip rap but at least it's holding grade, deep hole on right side of channel 7/24/2023			No
389	2022	Failed Structure	Piping	Piping under chunky riffle and rock sill. Somewhat stable.			No

390	2022	Failed Structure	Piping	Piping under and/or around rock sill			No
779	2022	Failed Structure		Part of brush toe maybe dislodged but bank is intact, minor concern			No
520	2021	Channel Stability/Erosion	ErosionScour	Erosion around rocks; repair looks good	stream bank repair with geolift and live stakes	11/2022	Yes
519	2021	Channel Stability/Erosion	ErosionScour	Mid channel bar with streambank erosion			Yes
179	2021	Failed Structure	Piping	Piping around left side of log; not piping 02/2023	No treatment made. Water flowing over sill now.	03/2022	Yes
556	2021	Needs Livestakes		Live stakes needed on left bank			No
180	2021	Failed Structure	Piping	Piping under log sill. Pointing in photos where water is flowing. Also undercutting banks immediately after sill.	sill material replaced and bank stabilized	11/2022	No
135	2021	Failed Structure	Piping	Failed log sill; water piping around; not piping 02/23; minor scour on LBK above 2 boulder 7/24/2023			No

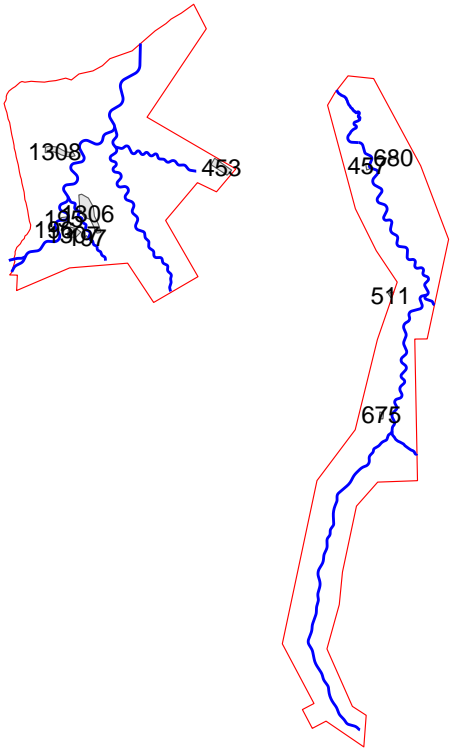
Vegetation Issues (polygons)

OBJECTID	Year	Issue	Description	Treatment	TreatDate	Resolved
1306	2023	Low Stem Vigor/Height	Obvious area of low stem height represented by VP16 and VP17	soil amendments added	06/2023	No
1308	2023	Low Stem Vigor/Height and Density	Small area of low stem height partially represented by VP23 and MP6 (MY5)	soil amendments added	06/2023	No
1307	2023	Low Stem Vigor/Height	Small Area of low height represented by VP21, trees appear healthy just slightly stunted	soil amendments added	06/2023	No
675	2022	Bare Areas and Low Stem Density	Gullies and bare areas			No
680	2022	Bare Areas, Low Stem Vigor/Height and Density				No
453	2021	Bare Areas, Low Stem Vigor/Height and Density		Smoothed rilling, temp seeded, spread biochar, tackifier, water, matting/straw. Installed bare roots around BMP with most going in on repair side.	02/2022	Yes
195	2021	Bare Areas, Low Stem Vigor/Height and Density	Bare area along floodplain	soil amendments and microbes	08/2022	No

196	2021	Bare Areas, Low Stem Vigor/Height and Density	Bare area along floodplain	Soil amendments and microbial spray	08/2022	No
197	2021	Bare Areas and Low Stem Vigor/Height	Bare area along floodplain			No
457	2021	Bare Areas and Low Stem Density				No
511	2021		Area to be seeded			No

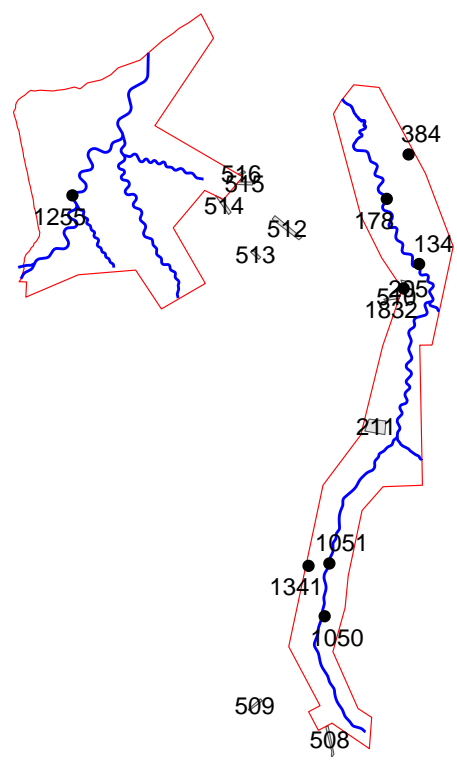
Miscellaneous Issues

OBJECTID	Year	Subtype	Description	LocationOrFeature	Treatment	TreatDate	Resolved
1832	2023	Misc	Coir log placed above gulley				Yes
520	2023	Beaver Dam	Still present on 2/8/2023, new dam present on 6/29/2023		Raked by staff	08/2022	No
995	2023	Beaver Dam					No
1050	2023	Misc	Debris in channel; Water flowing under, does not seem to be causing issues				No
1051	2023	Misc	Debris in channel				No
1116	2023	Beaver Dam					No
1255	2023	Misc	Tire in stream				No
1341	2023	Misc	tires / debris				No
521	2022	Beaver Dam			Raked by staff	08/2022	No
522	2022	Beaver Dam			Raked by staff	08/2022	No
384	2022	Misc	Small pine grove				No
761	2022	Beaver Dam					No
775	2022	Beaver Dam					No
177	2021	Beaver Dam			Staff removal by hand (successful)	11/2021	Yes
508	2021	Misc	WLC to put down matting				No
509	2021	Misc	WLC to add matting? At least anchor straw bales in places as check dams and area needs to be re-worked.				No

510	2021	Misc	WLC to install matting and grass seed area adjacent the easement (where hard to reach for farmers). They want to put grass down.				No
512	2021	Misc	Farm road needs work. Gullies carry sediment towards BMP. Additional rock?				No
513	2021	Misc	WLC to install matting below first rock berm.				No
514	2021	Misc	WLC to install matting below last rock berm.				No
515	2021	Misc	WLC to install matting below last rock berm.				No
516	2021	Misc	WLC to install matting below last rock berm.				No
178	2021	Misc	Cattails				No
211	2020	Misc	Gullies healing	Upland	Gully Repair, Seed Amendment	07/2022	No
205	2020	Misc	Historic gullies	Upland			No
134	2020	Misc	Scattered sweet gum saplings				No
