Stewardship for Buckwater

Lead Steward: Neil

2023-12-18

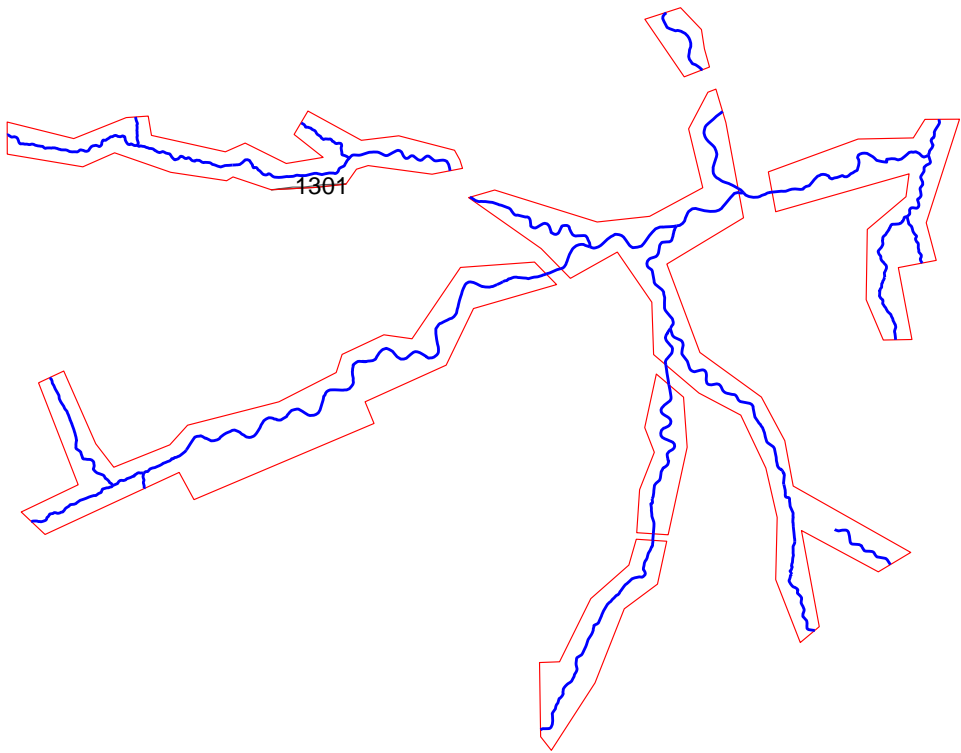
Boundary Issues (polygons)

OBJECTID	Year	Description	Resolved
1301	2023	Powerline easement cutting encroachment	No

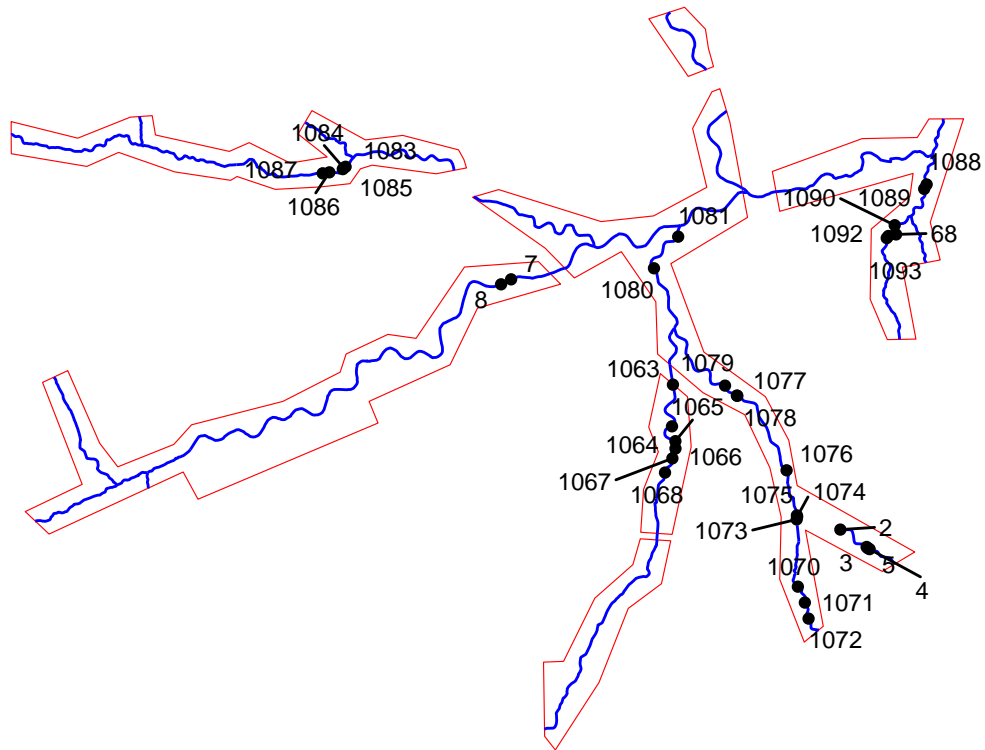
Channel Issues (points)

OBJECTID	Year	Subtype	Issue	Description	Treatment	TreatDate	Resolved
1009	2023	Channel Stability/Erosion		three pipping log sills. probably not keyed in properly. massive hole on last log sill			No
1010	2023	Channel Stability/Erosion		DS rock sill pipping. riffle incised and material washed away. US log sill is pipping. log is rotten, nonfunctioning filter fabric. water stops a foot above the sill			No
1012	2023	Channel Stability/Erosion					No
1013	2023	Channel Stability/Erosion	ErosionScour	left bank scour. riffle incision			No
1014	2023	Channel Stability/Erosion		right bank scour. has been live staked. incision. needs to be watched			No
1015	2023	Channel Stability/Erosion		incision. not enough riffle material			No
1016	2023	Channel Stability/Erosion		riffle material not present. functioning like poll			No
1017	2023	Channel Stability/Erosion		rock sills holding grade but pipping under.			No
1018	2023	Channel Stability/Erosion		incision. no riffle material			No

2	2023	Failed Structure	Failed/Not Functional	4 large non functioning log sills and 1 rock sill.			No
5	2023	Failed Structure		4 failed rock sills. non functioning rock sills. no major grade control issues. no real bank erosion			No
1063	2023	Failed Structure		erosion left side of culvert. small plug fix. maybe need extra rock			No
1064	2023	Failed Structure		left bank starting to erode. could be fixed by hand. maybe with juncus plugs			No
1065	2023	Failed Structure		filter fabric washed over log. pipping under or around in right bank. potential to just remove log?			No
1066	2023	Failed Structure		water going under bank on left side. potential machine repair			No
1067	2023	Failed Structure		log sill not keyed in. right end exposed			No
1068	2023	Failed Structure		water eroding around right rock sill. visible bank exposure but live stakes preventing more erosion			No
1070	2023	Failed Structure		pippping rock sill. still holding grade			No

1071	2023	Failed Structure		pippping but hard to tell where. maybe going under bank on right side.			No
1072	2023	Failed Structure		bank erosion on both sides due to drop. needs some soil and plugs.			No
1073	2023	Failed Structure		non functioning rock sill. pipping around right bank. filter bank is present but not fully covering rock sill			No
1074	2023	Failed Structure		non functioning rock sill causing bank erosion and incision DS			No
1075	2023	Failed Structure		rock sill. water going around edges.			No
1076	2023	Failed Structure		perched culvert			No
1077	2023	Failed Structure		pippping rock sill on left bank. filter fabric is there but washed to the side. holding grade.			No
1078	2023	Failed Structure		water going around rock sill. up against boulder toe. holding grade			No
1079	2023	Failed Structure		channel over widening. can move rock around to protect bank			No
1080	2023	Failed Structure		not keyed in log sill			No

1081	2023	Failed Structure		water going under log vane. need to keep an eye on right bank			No
1083	2023	Failed Structure		pippping under log sill riffles incised. filter fabric is present. not holding grade			No
1084	2023	Failed Structure		piping under log sill. bank erosion upstream of log on right bank			No
1085	2023	Failed Structure		first failing log sill not keyed in. right bank erosion. pipping around. riffle incision			No
1086	2023	Failed Structure		need plugs on right bank to help prevent erosion			No
1087	2023	Failed Structure		left bank exposed but stable.			No
1088	2023	Failed Structure		needs plugs on right bank. log sill leaning into bank			No
1089	2023	Failed Structure		filter fabric present but pipping under log sill. currently holding grade			No
1090	2023	Failed Structure		log sill pipping under. water flows subsurface a foot above log sill			No
1092	2023	Failed Structure		pippping rock sill under. holding grade			No

1093	2023	Failed Structure		pippping rock sill around right bank. holding grade			No
907	2022	Channel Stability/Erosion	ErosionScour	Erosion	Live stakes	01/2022	Yes
908	2022	Channel Stability/Erosion		Sills require fixing	Fixed sills	02/2022	Yes
910	2022	Channel Stability/Erosion		Sills require fixing			Yes
473	2021	Needs Livestakes		No live stakes			Yes
474	2021	Needs Livestakes			Sills fixed	06/2022	No
472	2021	Needs Livestakes		Needs live stakes. Finish polyline			No
475	2021	Needs Livestakes		Some live stakes. In stream veg			No
476	2021	Channel Stability/Erosion		Some erosion on bank. Add some plugs			No
481	2020	Channel Stability/Erosion	ErosionScour	severely eroded outside bend after bedrock drop area. Repaired by WLC on July 14 2021	Machine repair- installed boulder toe	07/2021	Yes
3	2019	Failed Structure					No
4	2019	Failed Structure					No
7	2019	Failed Structure	Failed/Not Functional	Large failed log sill. Piping around right side			No

8	2019	Failed Structure	Piping	Log sill. Piping readily on right side			No
68	2019	Failed Structure		failed log sill. Water flowing under			No

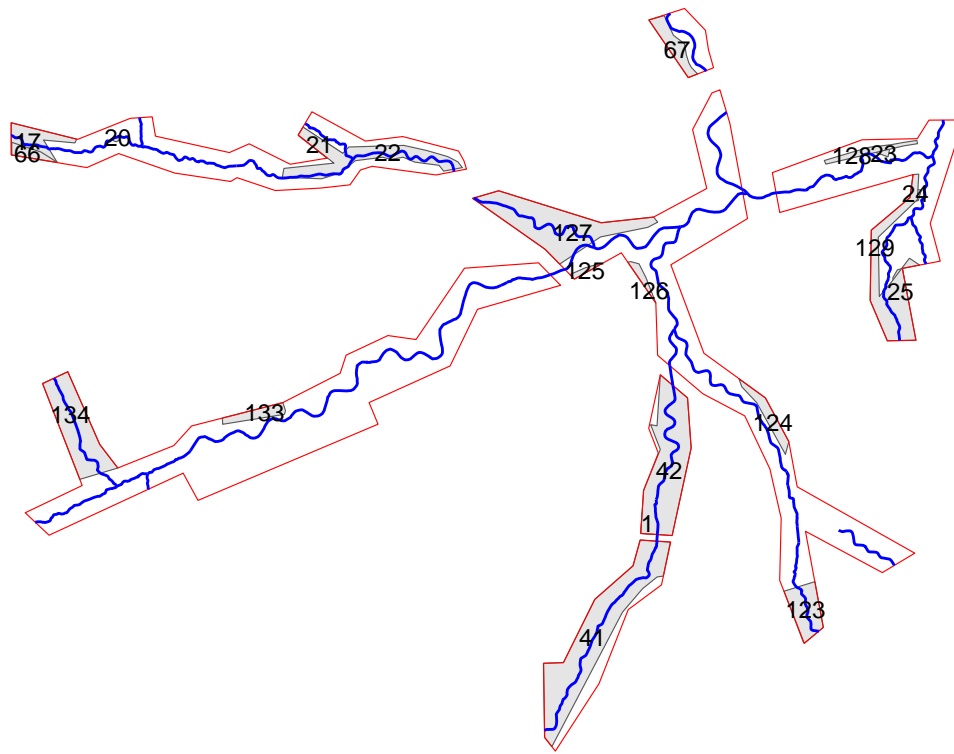
Vegetation Issues (polygons)

OBJECTID	Year	Issue	Description	Treatment	Method	TreatDate	Resolved
22	2021	Bare Areas and Low Stem Density	Continue seeding, amendments, and plant willow poles	heavily seeded bare areas in P2 cuts with millet		08/2021	No
22	2021	Bare Areas and Low Stem Density	Continue seeding, amendments, and plant willow poles	planted 325 new stems. Added soil amendment mix to planting holes for containers		08/2021	No
22	2021	Bare Areas and Low Stem Density	Continue seeding, amendments, and plant willow poles	ring sprays- 2.5 pct glyphosate solution		08/2021	No
22	2021	Bare Areas and Low Stem Density	Continue seeding, amendments, and plant willow poles	Cover crop		06/2022	No
22	2021	Bare Areas and Low Stem Density	Continue seeding, amendments, and plant willow poles	Cover crop		01/2023	No
25	2021	Low Stem Density	Dense tall fescue. Add 30 one gallons and ring spray	ring sprays		03/2021	No
17	2021		Need tree release and some one gallon planting. Plan for planting 50 containers, ring sprays, blackberry release, and amendments	brush cut blackberry.	Backpack Spray	04/2021	No

17	2021		Need tree release and some one gallon planting. Plan for planting 50 containers, ring sprays, blackberry release, and amendments	follow up spray with 2.5 pct triclopyr		06/2021	No
17	2021		Need tree release and some one gallon planting. Plan for planting 50 containers, ring sprays, blackberry release, and amendments	Weedeat blackberry around trees	Mow	04/2022	No
1	2021	Low Stem Density	Needs about 25 more trees and ring sprays.				No
20	2021	Low Stem Density	Old pond. Plant willows, elderberry, mulberry, and cottonwood. 25 stems. Add live stakes along streams				No
21	2021	Low Stem Density	Old field succession. Reduce sweet gum by 40 pct. Plan for blackberry release, 25 one gallons, and ring sprays				No
23	2021	Low Stem Density	Needs 25 one gallons				No
24	2021	Low Stem Vigor/Height and Density	Needs 20 one gallons. Add amendments now. Very few trees in veg plot				No
41	2020	Low Stem Vigor/Height and Density	Replant 200 stems/acre- 640 stems. dense tall fescue needs ring sprays			08/2021	Yes

41	2020	Low Stem Vigor/Height and Density	Replant 200 stems/acre- 640 stems. dense tall fescue needs ring sprays	Ring sprays. All N half. Some S half		04/2020	Yes
41	2020	Low Stem Vigor/Height and Density	Replant 200 stems/acre- 640 stems. dense tall fescue needs ring sprays	Planted 640 stems. Ring sprays		02/2021	Yes
126	2020		replant 250 stems/acre- 25 new stems. treat fescue	tree planting		02/2021	Yes
126	2020		replant 250 stems/acre- 25 new stems. treat fescue	ring sprays		03/2021	Yes
42	2020	Low Stem Vigor/Height and Density	Replant. Needs 150 stems per acre. Needs ring sprays. One round of ring sprays was previously completed in early spring 2020	tree planting		08/2021	Yes
42	2020	Low Stem Vigor/Height and Density	Replant. Needs 150 stems per acre. Needs ring sprays. One round of ring sprays was previously completed in early spring 2020	ring sprays		03/2021	Yes
42	2020	Low Stem Vigor/Height and Density	Replant. Needs 150 stems per acre. Needs ring sprays. One round of ring sprays was previously completed in early spring 2020	Ring sprays		03/2022	Yes

134	2020	Low Stem Vigor/Height and Density	replant 175 stems/acre- 263 stems . treat dense tall fescue	planted 263 new stems		02/2021	Yes
134	2020	Low Stem Vigor/Height and Density	replant 175 stems/acre- 263 stems . treat dense tall fescue	ring sprays		03/2021	Yes
133	2020	Low Stem Vigor/Height and Density	replant 150 stems/acre- 45 new stems. low groundcover. Few trees are low vigor	planted 45 new stems		02/2021	Yes
127	2020	Low Stem Vigor/Height and Density	replant 175 stems/acre- 420 new stems. Poor soils	tree planting and soil amendments on every stem		02/2021	Yes
127	2020	Low Stem Vigor/Height and Density	replant 175 stems/acre- 420 new stems. Poor soils	soil amendments		06/2021	Yes
124	2020	Low Stem Density	replant 250 stems/acre- 75 new stems. treat fescue	tree planting		02/2021	Yes
124	2020	Low Stem Density	replant 250 stems/acre- 75 new stems. treat fescue	ring sprays		03/2021	Yes
123	2020	Low Stem Vigor/Height and Density	Need replant- 150 stems/acre. 105 new stems. old pond- take soil sample	planted 105 new stems		02/2021	Yes

67	2020	Low Stem Density	Needs trees. Dense tall fescue needs ring sprays	Planted 110 new bare roots and 1-gallons		02/2021	Yes
67	2020	Low Stem Density	Needs trees. Dense tall fescue needs ring sprays	ring sprays		03/2021	Yes
125	2020		replant 250 stems/acre- 25 new stems. treat fescue	planted 25 stems		02/2021	Yes
125	2020		replant 250 stems/acre- 25 new stems. treat fescue	ring sprays		03/2021	Yes
129	2020	Low Stem Vigor/Height and Density	replant 175 stems/acre- 298 new stems. Need ring sprays	tree planting		02/2021	Yes
128	2020	Low Stem Vigor/Height and Density	replant 150 stems/acre- 45 new stems. old haul road. trees damaged during repair				Yes
66	2020		Old field succession dominating area. Low planted stem density persists after tree plantings in early 2021	40 new bare root and 1-gallon containers planted- 300 stem/acre rate		02/2021	No
66	2020		Old field succession dominating area. Low planted stem density persists after tree plantings in early 2021	ring sprays- 2.5 pct glyphosate		03/2021	No

66	2020		Old field succession dominating area. Low planted stem density persists after tree plantings in early 2021	Cleared blackberry heavily competing with trees		04/2021	No

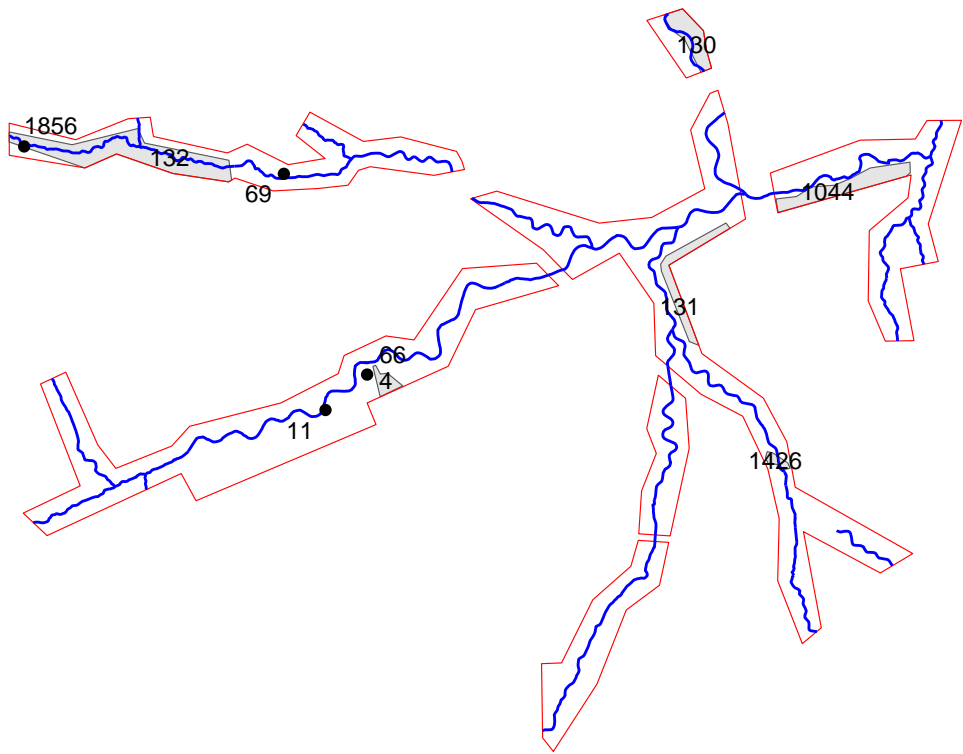
Weed Issues – Chinese Privet

OBJECTID	Year	Species1	Species2	Issue	Treatment	Method	TreatDate	Resolved
1044	2023	Chinese Privet	Japanese Honeysuckle	Privet	Privet Tx by contractor	Cut Stump	03/2023	No
1426	2023	Chinese Privet		Dense pocket of privet and LOJA				No
1856	2023	Chinese Privet		Privet chainsaw size				No
1061	2023	English Ivy		cut stump contained English ivy				No
1084	2023	Japanese Honeysuckle		fairly dense honeysuckle.				No
1069	2023	OTHER		raked out near culvert. ring sprays				No
1091	2023	OTHER		small in stream veg				No
1809	2023	Tree Of Heaven		2 large, several root suckers				No
1011	2023			rake out debris. would need brush cutters to remove blackberry. little flow through channel.				No
14	2021	Blackberry		Cut in April 2021. Spray in early spring 2022				No
131	2021	Chinese Privet		large stems	Cut stump	Cut Stump	02/2021	Yes
131	2021	Chinese Privet		large stems	Privet Tx by contractor	Cut Stump	03/2023	Yes
132	2021	Chinese Privet		some small. some resprouting previously treated large stems	Cutstump privet	Cut Stump	12/2023	Yes

4	2021	Chinese Privet		Scattered privet. Some treated previously in 2019				No
16	2021	Johnson Grass		Dense. Flowering in July 2021	Brush cut mature Johnson grass to the ground. Will spray once it regrows this fall	Mow	08/2021	No
16	2021	Johnson Grass		Dense. Flowering in July 2021				
18	2021	Multiflora Rose		Treated in spring 2021. Few shoots survive. Treat in September 2021	sprayed out		04/2021	No
135	2021	Multiflora Rose		in trees- maybe cut stump				No
15	2021	Sweet Gum		Reduce by 50 pct	Thinned and treated sweet gum	Cut Stump	01/2023	No
2	2021	Sweet Gum		Dense sweet gum. Reduce by 50 pct				No
3	2021	Sweet Gum		Dense sweet gum. Reduce by 50 pct				No
5	2021	Tree Of Heaven		Several trees. Stem inject	Cut stump and stem injection. Some resprouts may occur in future. Need to check next year.	Stem Injection	09/2021	Yes
19	2021	Tree Of Heaven		Sapling and pole sized. Mostly off CE				Yes
130	2020	Chinese Privet		scattered little stems	stem injection and cut stump. Neil hand pull	Stem Injection	10/2021	Yes

11	2019	Chinese Privet		Small patch	Privet removal along both sides of reach 4 including all points and polygons	Hand Pull	02/2021	Yes
								No
66	2019	Chinese Privet		cut stump				No
69	2019	Chinese Privet	Japanese Honeysuckle	cut stump (LISI)and foliar (LOJA)				No
65	2019	Japanese Honeysuckle						No
24	2019	Multiflora Rose		Large clump. Treated spring 2021. Few shoots survive				No
67	2019	Multiflora Rose		one large clump				No
1	2019	Tree Of Heaven		One large tree half dead. Treated last two years	stem injection. previously treated	Stem Injection	09/2021	Yes
9	2019	Tree Of Heaven		One half dead large tree	stem injection. Was previously treated	Stem Injection	09/2021	Yes
6	2019	Tree Of Heaven		2 large trees	stem injection. Two large stems	Stem Injection	09/2021	Yes
25	2019	Tree Of Heaven		10 saplings. Cut stump	Neil	Cut Stump	10/2021	Yes
10	2019	Tree Of Heaven		Some large some sapling	stem injection	Stem Injection	09/2021	No

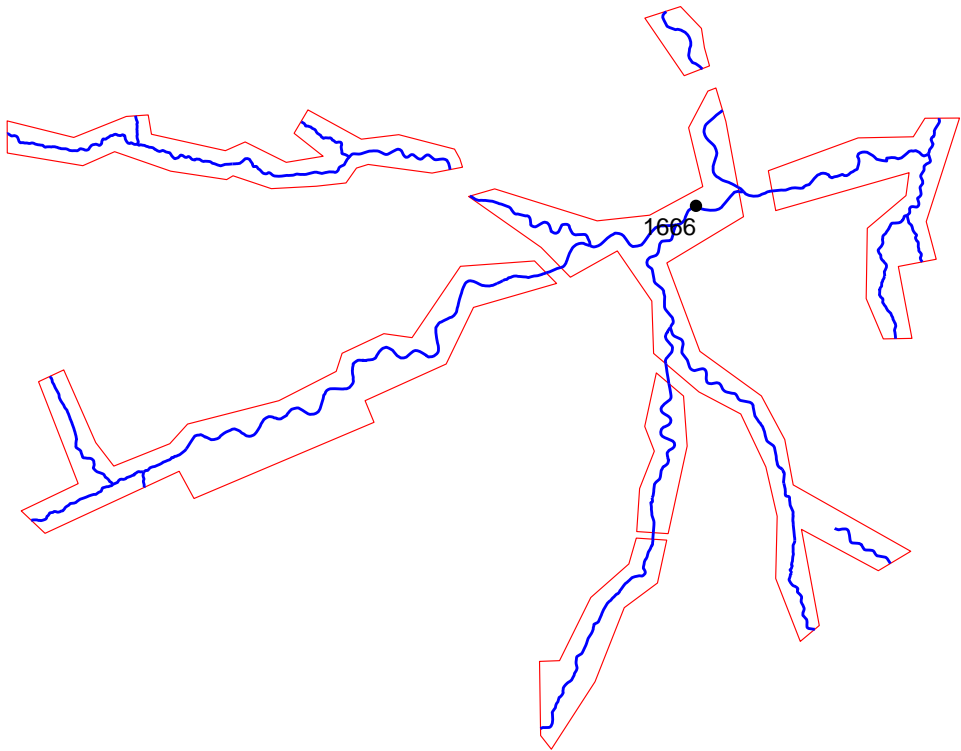
Miscellaneous – Beaver Dam

OBJECTID	Year	Subtype	Description	Resolved
1274	2023	Misc	Repair area 1 LOD	No
1275	2023	Misc	Repair LOD 2	No
1276	2023	Misc	Repair area 3 LOD	No
1277	2023	Misc	Repair area 4 LOD	No
1082	2023	Misc	need live staking	No
1666	2023	Beaver Dam		No
849	2022	Soil Sample	BUC3B	
850	2022	Soil Sample	BUC3A	
31	2019	Soil Sample	BW-B	
32	2019	Soil Sample	BW-B	
33	2019	Soil Sample	BW-A	
34	2019	Soil Sample	BW-C	
35	2019	Soil Sample	BW-C
