SHAMS POWER COMPANY
ENGINEERING DIVISION
INSPECTION & CORROSION SECTION
SHAMS 1

CERTIFICATE OF INSPECTION

ITEM : Steam drum 2

TYPE OF INSPECTION : Major

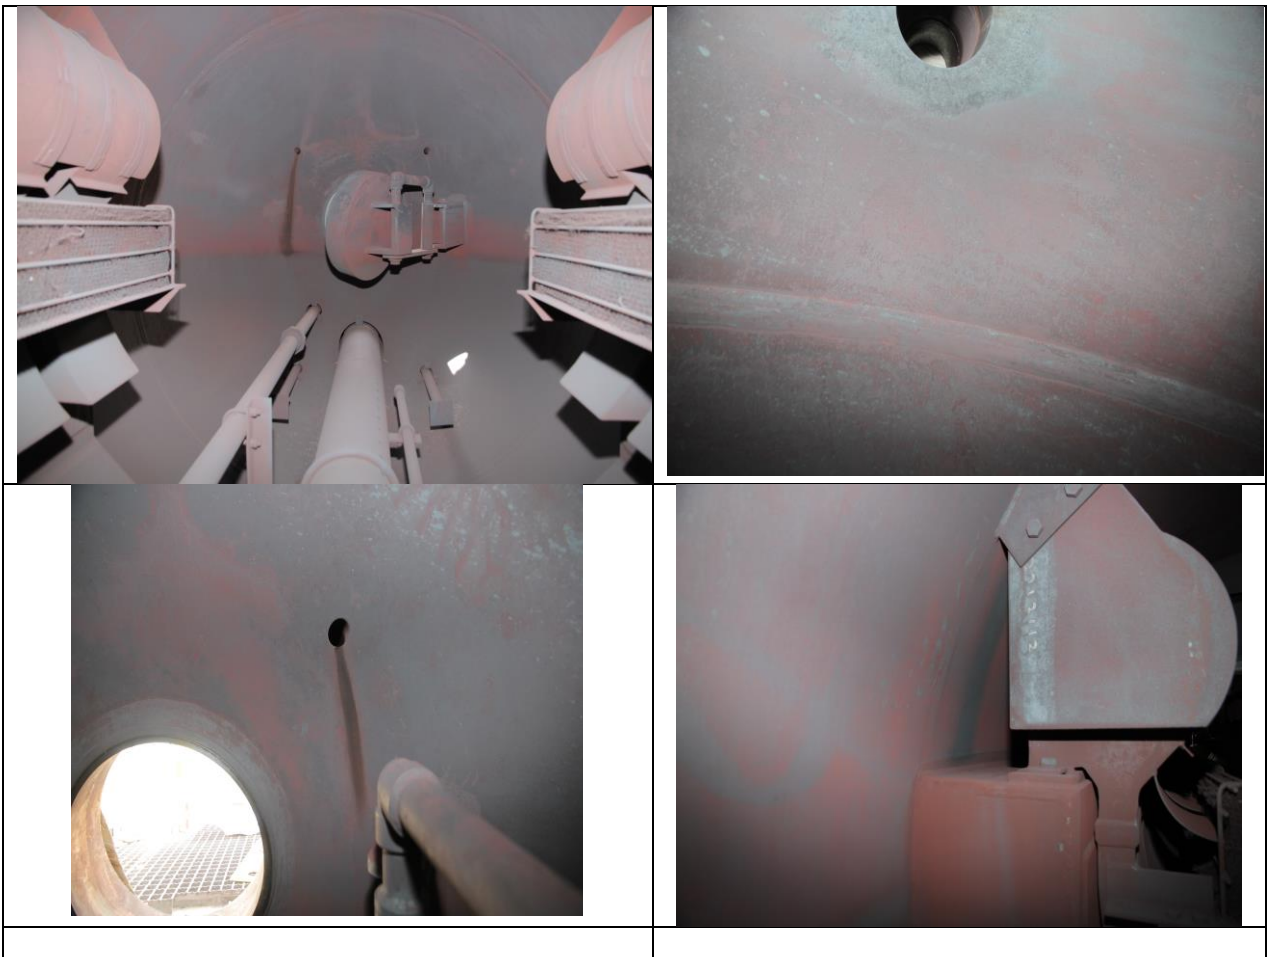
5.2.1 All internals found in satisfactory condition without evidence of fallen down, damage or corrosion. It found with black magnetite layer in the lower half of the drum apart from hematite layer in the upper half of the drum

5.2.2 All internal surfaces of shell and heads found in satisfactory condition with black magnetite layer in the lower half of the drum apart from hematite layer in the upper half of the drum

5.2.3 All welds of shell and heads found in satisfactory condition without evidence of heavy.

Shell surfaces ,welds and Internals

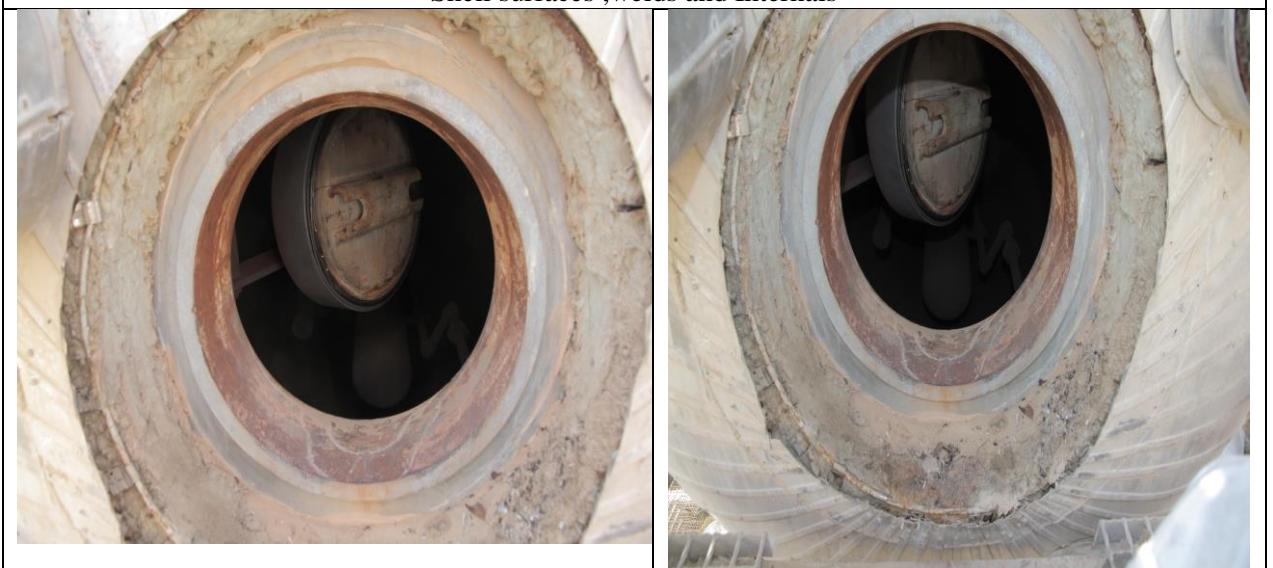
5.2.6 Manways, nozzle, cover and lock bolts found in satisfactory condition.

Manways

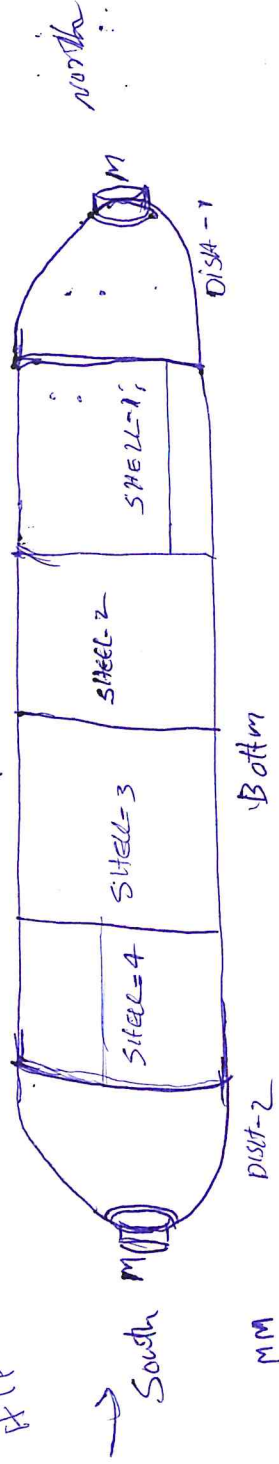
STEAM DRAM-2

Dish North Side

Top = 111.40

E = 112.0

Bottom = 111.41

W = 112.0

Dish-2 South Side

Top = 114.6

E = 112.10

Bottom = 114.4

W = 113.4

SHELL-1	SHELL-2	SHELL-3	SHELL-4
Top = 96.73 E = 97.02 Bottom = 96.97 W = 96.40	Top = 96.94 W = 96.81 E = 96.96 Bottom = N/A	Top = 96.12 W = 95.74 Bottom = 96.10 E = 95.90	Top = 96.12 W = 95.74 Bottom = 96.10 E = 95.90
