SHAMS POWER COMPANY
ENGINEERING DIVISION
INSPECTION & CORROSION SECTION
SHAMS 1

LOCATION : R1HAE11BB010
KKS : R1HAE11BB010

CERTIFICATE OF INSPECTION

ITEM : Steam drum 1

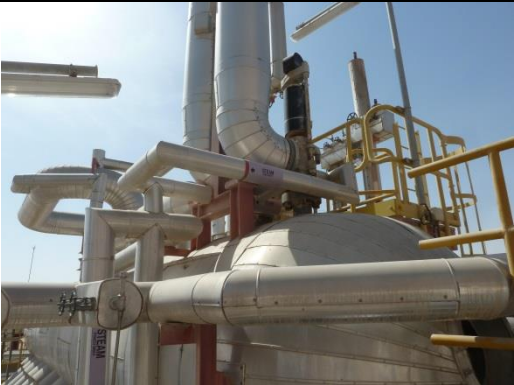
<p>Steam drum general view</p>	<p>Ladder, stairways and handrail</p>

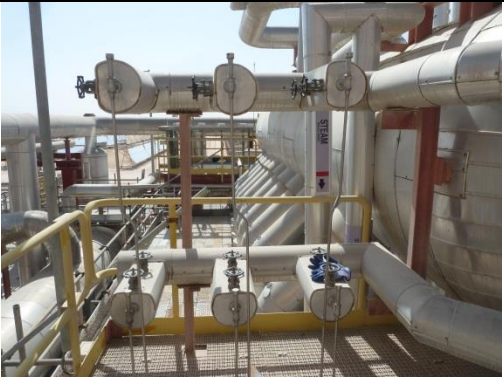
5.1.3 All ladders, stairways and handrails found in satisfactory condition.

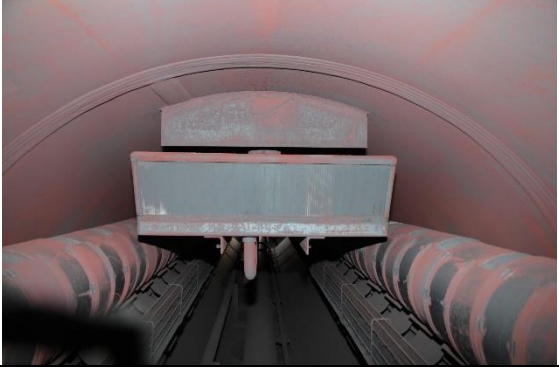
5.2.2 All internal surfaces of shell and heads found in satisfactory condition with black magnetite layer in the lower half of the drum apart from hematite layer in the upper half of the drum .

5.2.3 All welds of shell and heads found in satisfactory condition without evidence of corrosion.

<p>Internal & shell surfaces and welds</p>

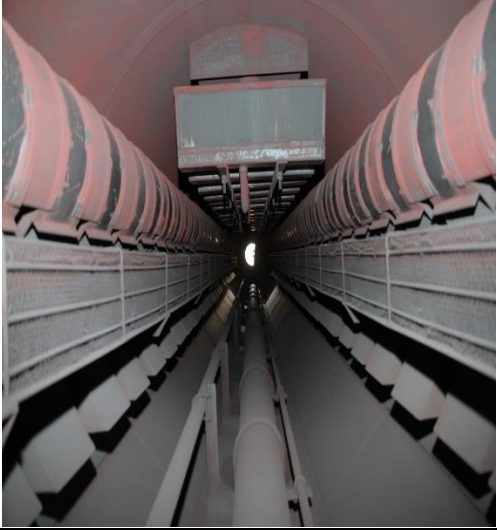
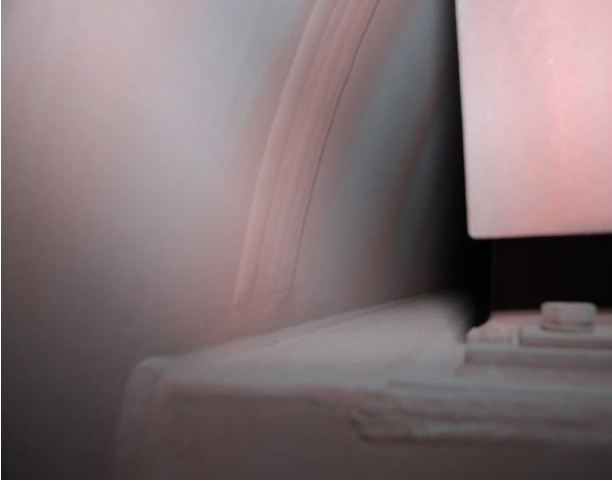
<p>Internal & shell surfaces and welds</p>

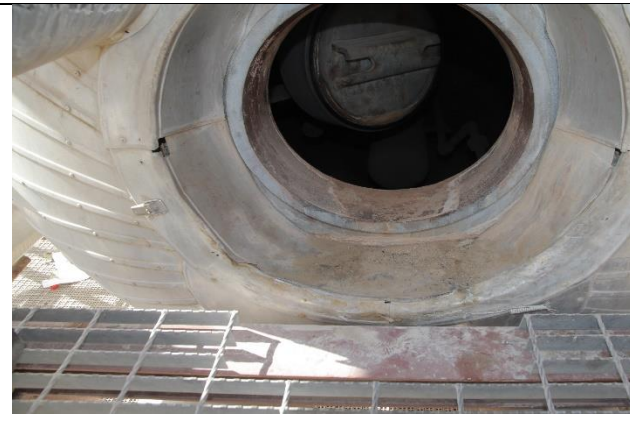
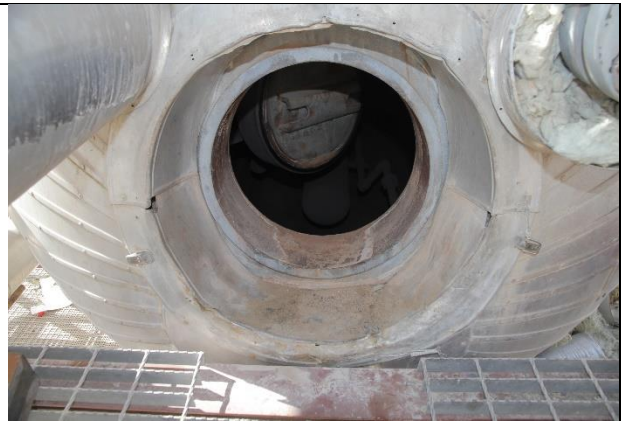
Manways

5.2.6 Manways, nozzle, cover and lock bolts found in satisfactory condition.

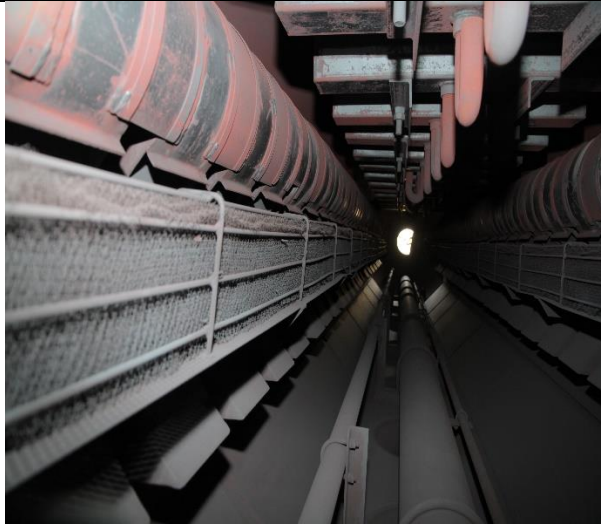
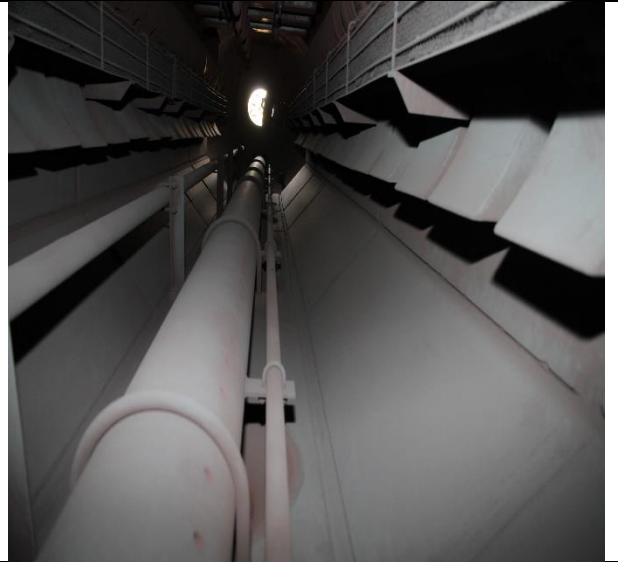
Internals

5.2.1 All internals found in satisfactory condition without evidence of fallen down, damage or corrosion. It found with black magnetite layer in the lower half of the drum apart from hematite layer in the upper half of the drum

- Review BFW deaerating process to assure absence of oxygen and mitigate any oxygen further corrosion.
- It is recommended to open steam drum -1 after 4 years as per SHAMS Code of Practice.

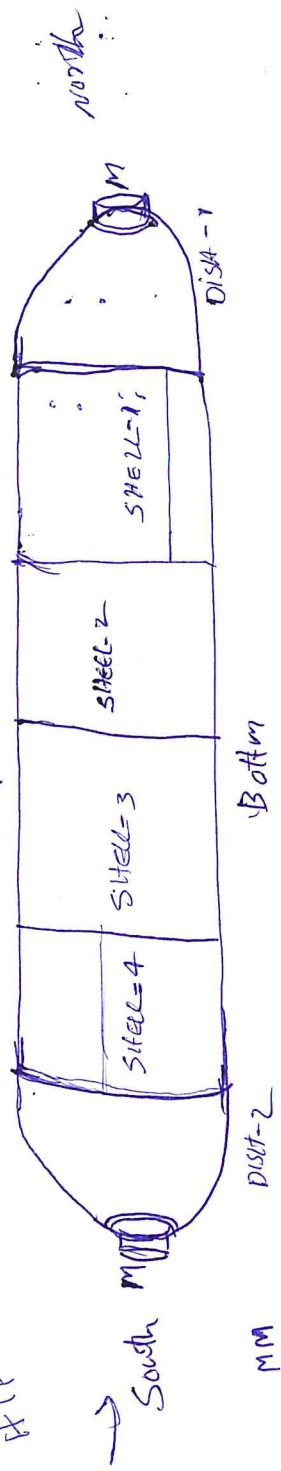
STEAM DRAM-2

Top = 111.40
 E = 112.0
 Bottom = 111.41
 W = 112.0

Top = 96.73
 E = 97.02
 Bottom = 96.97
 W = 96.40

Top = 96.94
 W = 96.81
 E = 96.96
 Bottom = N/A

W = 95.66, 95.95
 E = 95.71, 95.80
 Top = 96.01
 Bottom = N/A

Top = 96.12
 W = 95.74
 Bottom = 96.10
 E = 95.90

Top = 114.6
 E = 112.10
 Bottom = 114.4
 W = 113.4

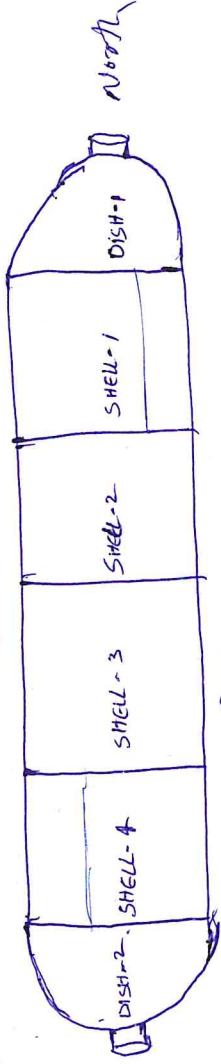
HIF numbers

DISH-1	SHELL-1	SHELL-2	SHELL-3	SHELL-4	DISH-2
Top = 112.7	Top = 95.45	W = 96.30	W = 96.82	Top = 96.20	Top = 112.2
E = 113.2	E = 95.60	E = 96.45	Top = 97.31	W = 96.30	W = 110.9
Bottom = 111.6	Bottom = 95.60	Top = 96.12	E = 96.85	E = 95.75	E = 112.1
W = 113.9	W _{leg} = 95.35	Bottom = N/A	Bottom = N/A	Bottom = 95.28	Bottom = 112.8
