MAJOR OUTAGE REPORT 2020

Message from General Manager

The major outage has a significant importance to the long term strategy of Shams plant and assets. The vast scope includes major overhaul and inspection of critical equipment such as steam turbine, generator, booster heaters, HTF heaters, DCS upgrade and others. These are critical assets and equipment that impact the business of Shams directly, thus it's of paramount importance to ensure its reliability, availability, and efficiency over its lifetime.

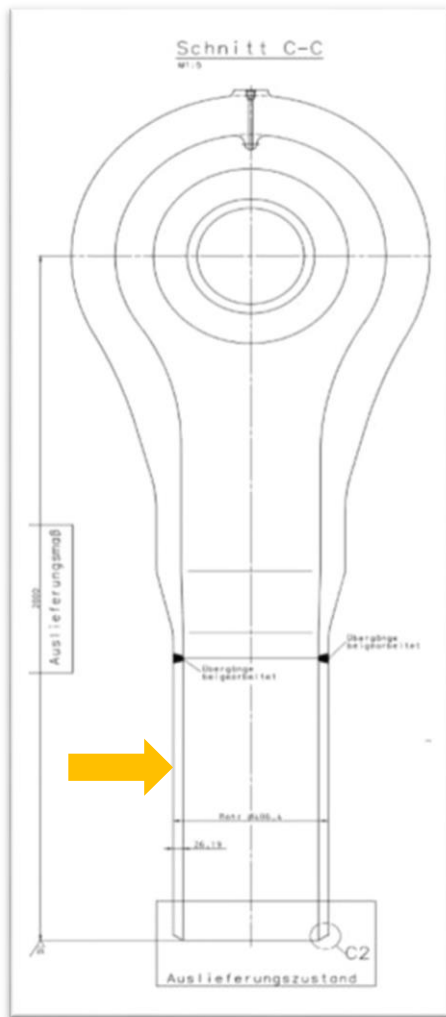
Figure 3.1: Marking point of the pipe cutting on the HP pipe inlet.

The P91 pipe was cut 20 cm above the heat affected zone from the previous weld as shown in Fig. 3.1. A pneumatic profile cutter was used to cut the pipe with the specified welding beveling profile, as shown in Fig. 3.2.

- HP Header material – P91
- ST Nozzle material – P91
- Pipe external Diameter – 406.4mm
- Pipe wall thickness – 26.19mm
- HP below header material – P22

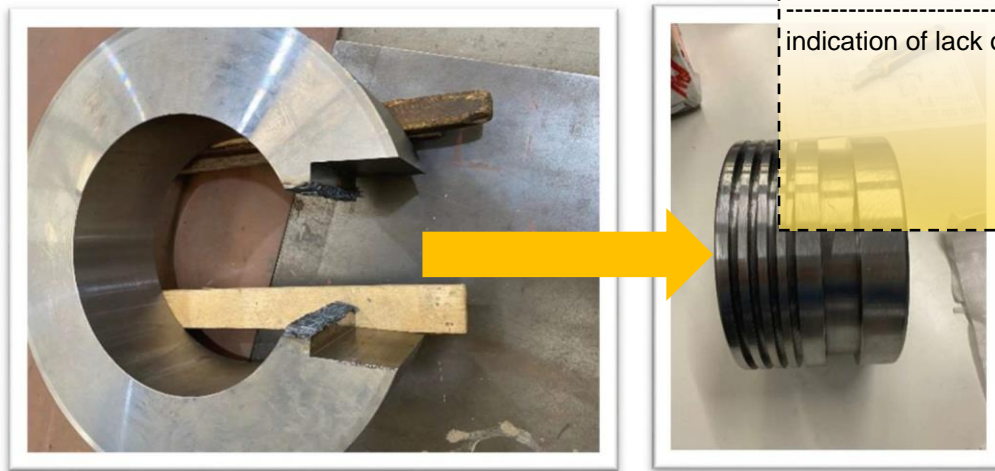
Even though we ordered the recommended spares from the OEM, many spares such as the balance pistons, inner casing horizontal bolts, connection pins between turbine and casing had to be fabricated from raw materials X22 e.g. shown in Fig. 4.

Figure 4: showing a piece cut out & fabricated into spare part indicated by the arrow.

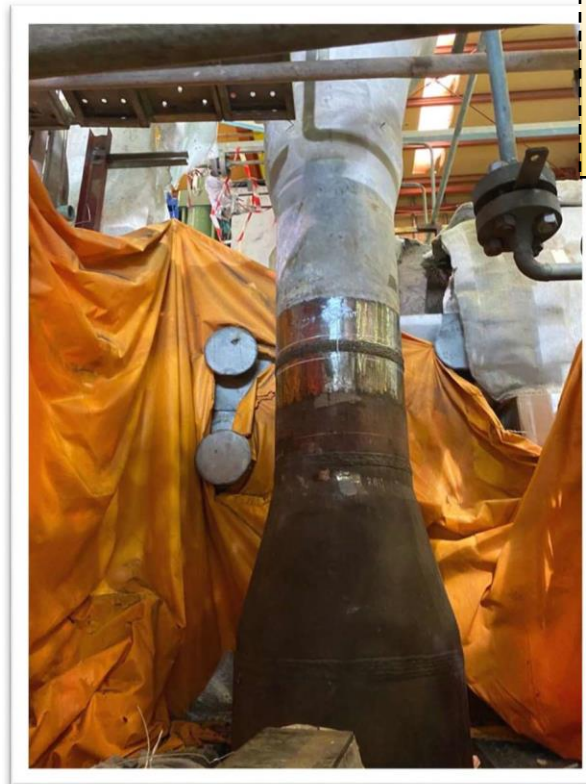
Figure 4.1: Welding, PWHT and final testing of HP pipe.

During the welding of the HP pipe 8 dial gauges installed around the steam turbine to monitor the slightest movement that may result from the welding of the inlet HP pipe. There was no movement identified.

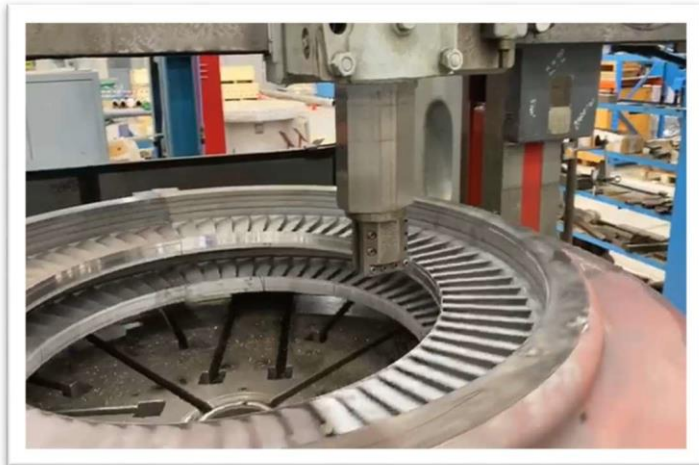
- 1) Bearing housing no. 1 shims deformed from initial position
- 2) Journal bearing scotch marks observed due to foreign material
- 3) Inadequate clearances on the blade carriers and balance piston. Machining carried out at specialist workshops (Fig. 5 & 6)
- 4) Undersized coupling bolt holes of the new rotor.
- 5) New governor valve actuator was not functional.
- 6) Turning gear incident damaged Turning gear and Rotor gear wheel. New gear wheel installed (Fig. 7 & 8) and old turning gear reused.
- 7) Instrumentation cables found burnt and replaced with high temperature resistant materials.
- 8) Foreign material found inside the lube oil tank. The Lube oil tank cleaned and refilled.
- 9) Minor traces of varnish found inside the tank indicated by the level mark. The oil heater also covered with varnish particles.

Figure 5: Machining of blade carriers.

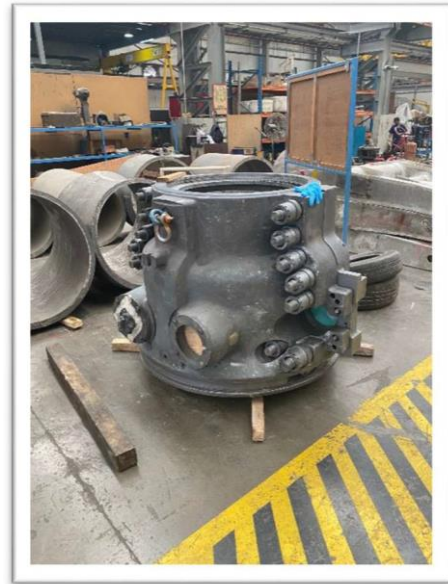
Figure 6: Machining of balance piston

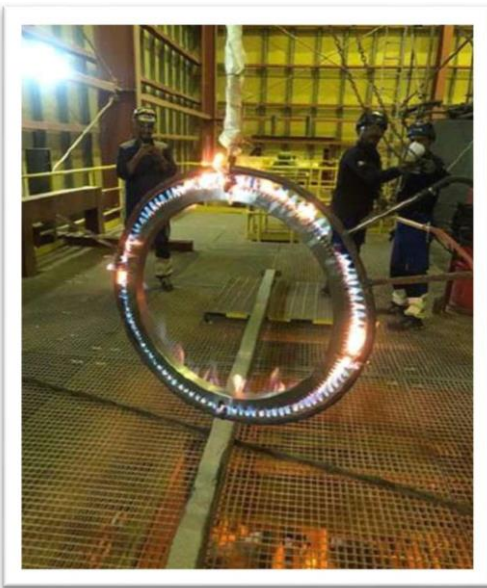
Figure 7: New Gear ring heating for installation as per procedure.

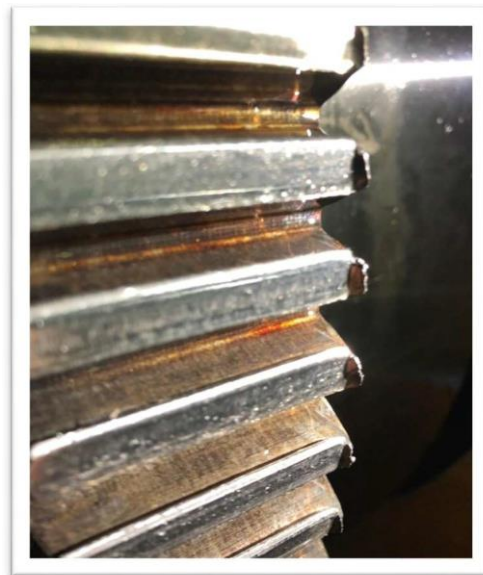
The new turning gear was inspected after the incident and found the gear wheel on the new rotor was damage (we had one spare available) as well as the new turning gear had to be replaced with the old one. After these components replaced, the Steam Turbine was successfully commissioned along with the physical Overspeed test (please see Fig 4.2 and ref. Annexure 3 for detailed MAN report, page 130) and handed over back to operation on 4th April 2020.

Figure 8: Damage Gear wheel seen on the corners.

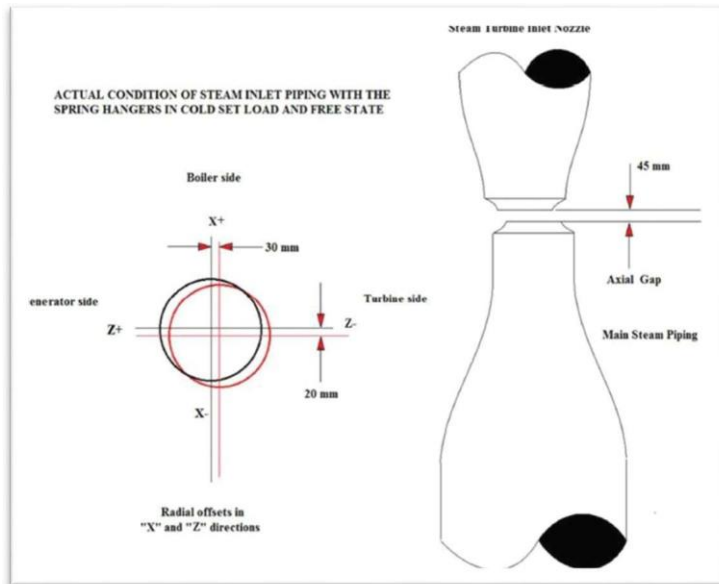
- a. Stress impact of HP Pipe on the ST casing and Front Bearing Housing. (Fig. 9)
- b. HP header supports found damaged, deformed and installed incorrectly. (Fig. 10)

Figure 9: Diagram showing displacement of the HP pipe to the casing inlet pipe.

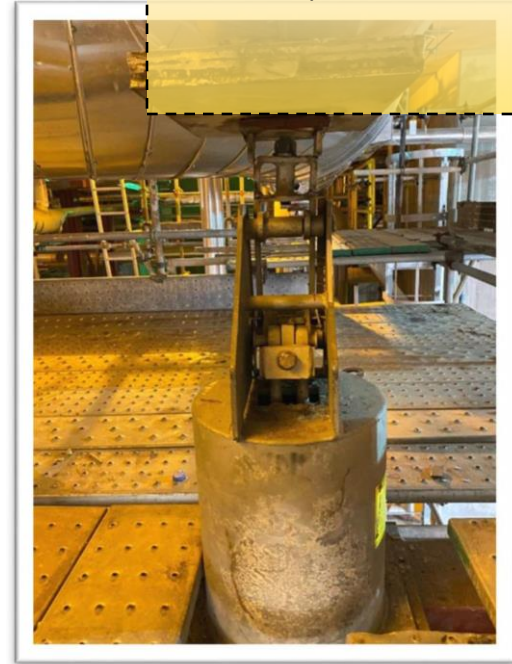
We also identified the HP piping support were damaged and d Shams then assigned Ansaldo Energia who specialize in this area (for detailed Ansaldo report) and rectify these issues. The HP head no stress induced on the Steam Turbine casing.

Figure 10: HP Header support damage.

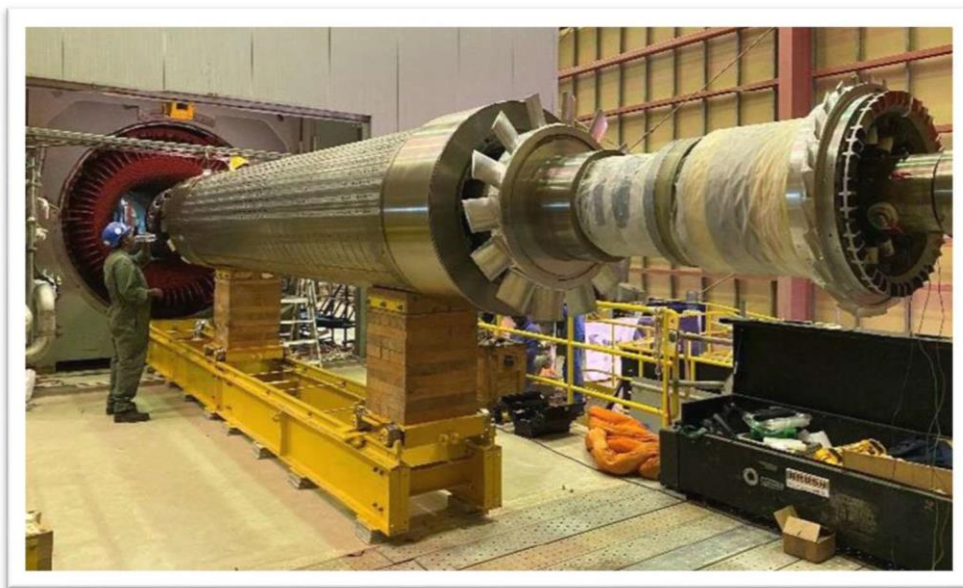
Figure 11: Generator rotor slide out for inspection and testing.

During the inspection phase, both the DE and NDE bearings were found with light scoring marks, the NDE was replaced with spare and the DE bearing was installed after its refurbishment. Also, the rotor inter-slot wedges showed signs of migration, they were re-peened into position.

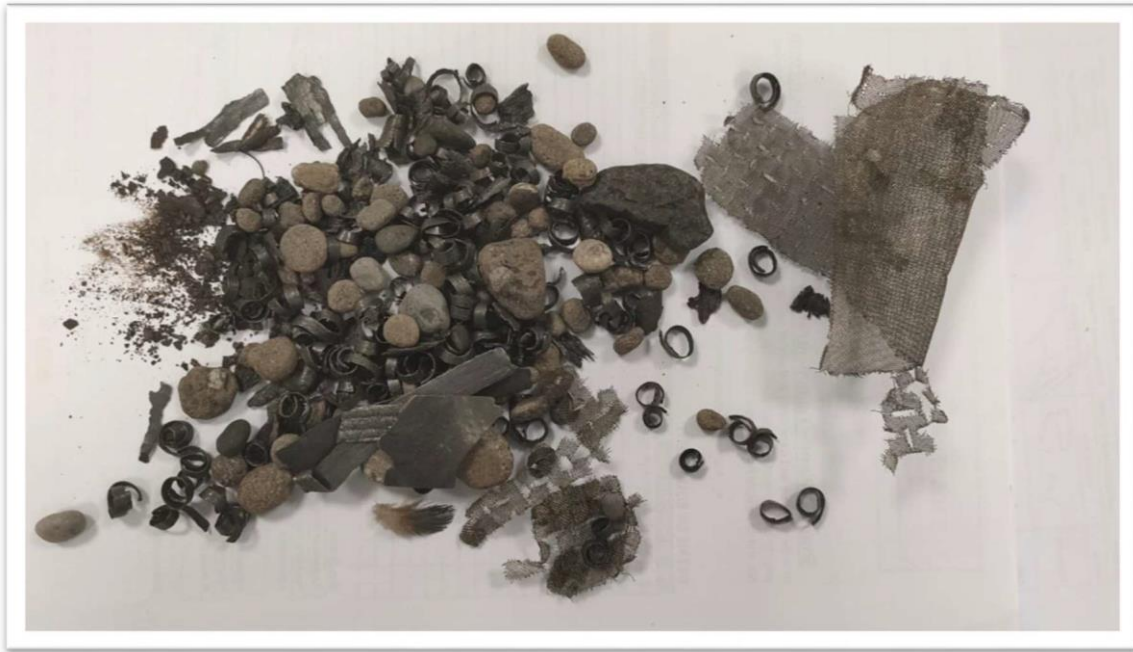
- a. Excessive foreign materials found in system e.g. welding rods, stones, nuts and bolts, etc. this can lead to valve passing issues. Please see Fig 11.1.

Figure 11.1: Debris found after removing valve.

- a. HTF system to be cleaned during the next major outage.

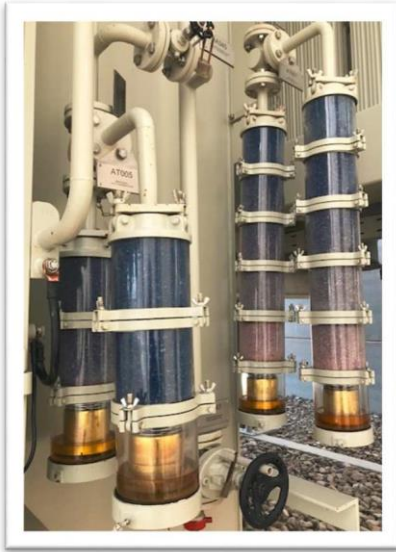
Figure 12: Silica Gel before replacement.

Cooling fans were cleaned, silica gel for dehydrating breather replaced and touch-up painting done on unpainted welded joints along Conservator tank piping.

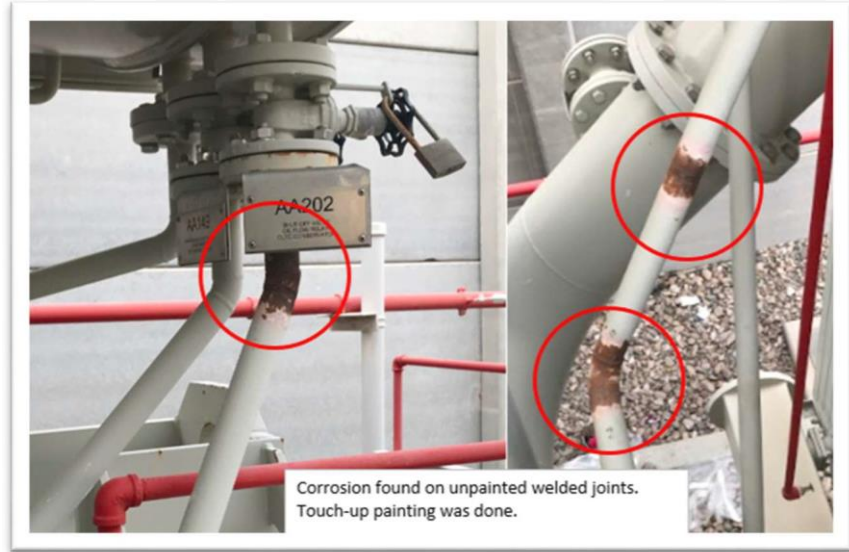
Figure 13: Corrosion found welding joints.

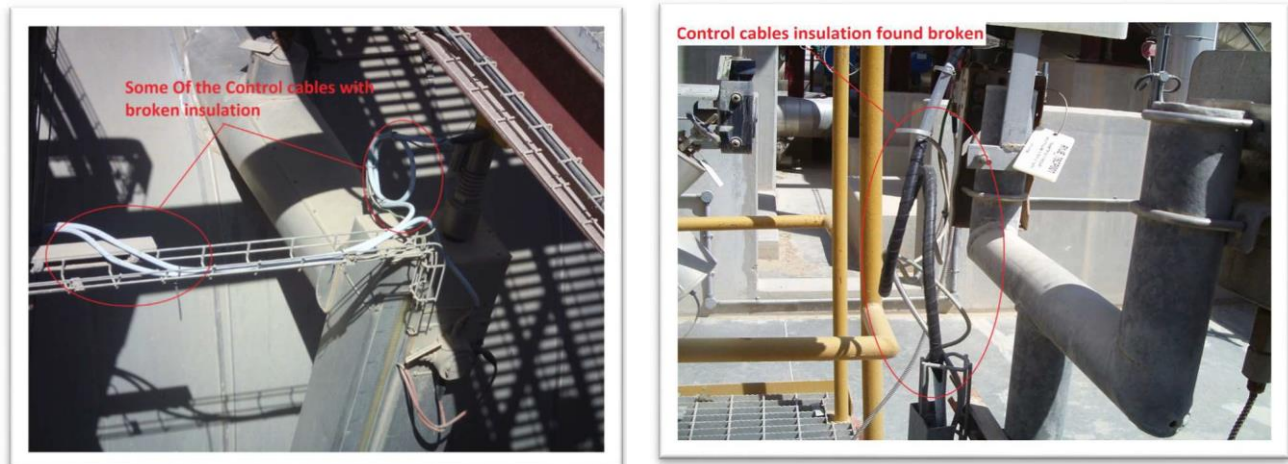
- 1) Many control cables insulation and trays found broken and in bad condition. Please see Fig. 14.1.
- 2) Steam and Water sampling stations needs to be recommissioned in the next major outage as many instruments keeps failing due to ambient temperature and direct sunlight. Please see Fig. 14.3.
- 3) Many instruments found without proper shade to protect them from direct sunlight. Please see Fig. 14.2

Figure 14.1: Broken insulation control cables.

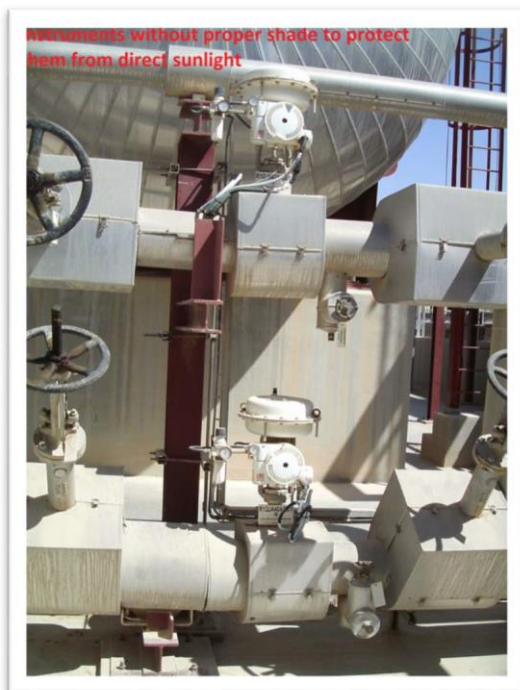
Figure 14.2: No Shade to protect from sunlight.

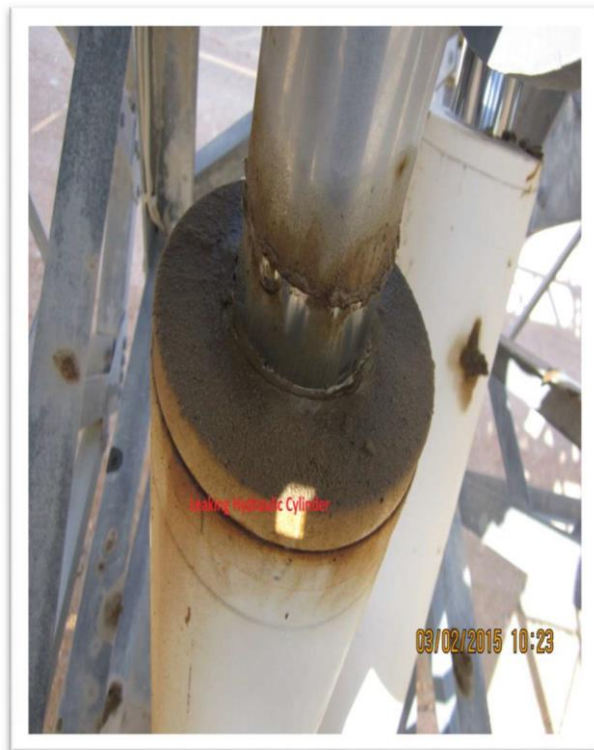
Figure 19: Leaking Hydraulic Cylinder.

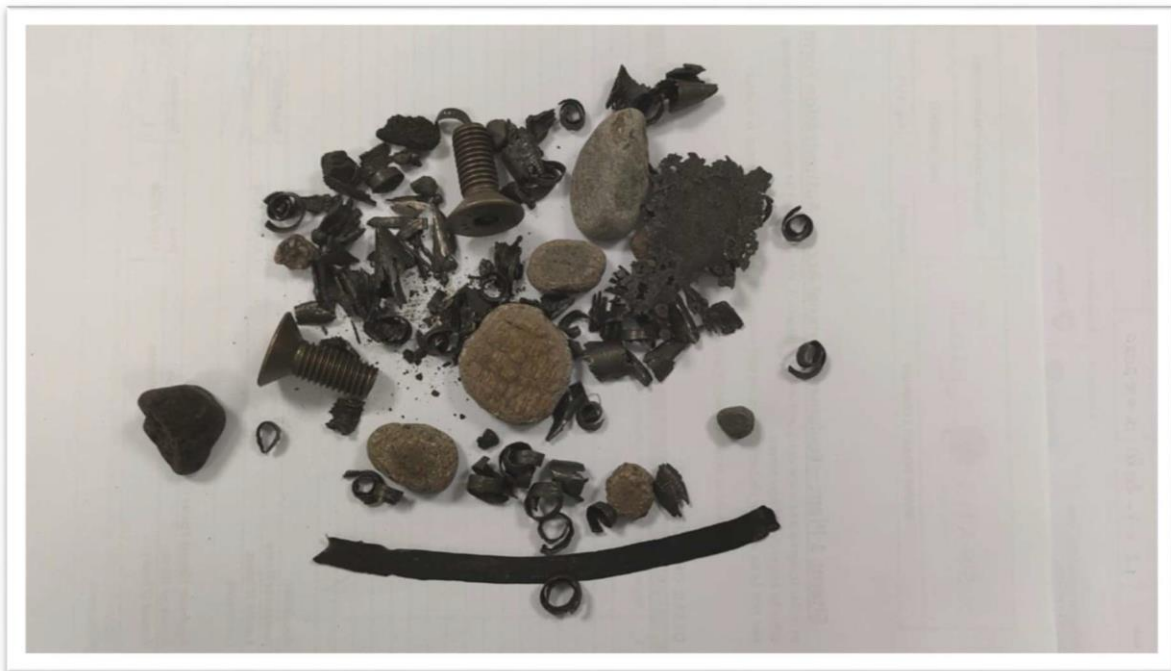
- 1) Excessive foreign materials found, e.g. welding rods, stones, nuts and bolts, etc. after bonnet of the valve, R2JB_GH09910010AA501 was replaced. Please see Fig. 20.1

Figure 20.1: Debris found in the valve seat.

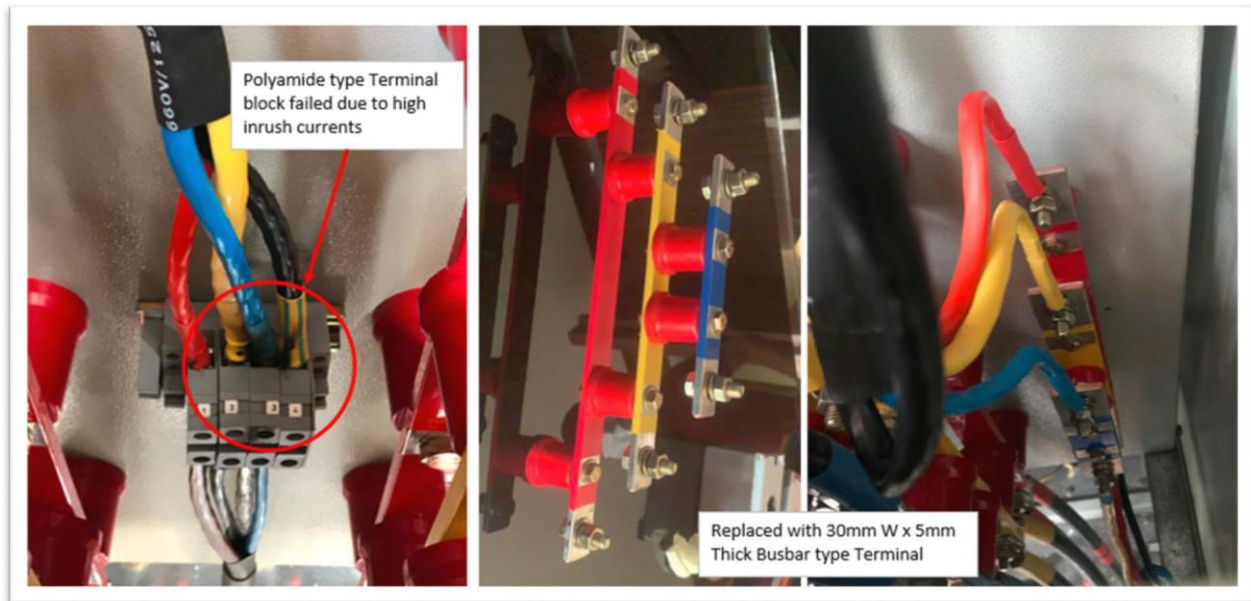
After few days of keeping the fans in service, there were failures observed on some terminal blocks due to overheating. All similar terminal block types were replaced with bus-bar type terminal and no overheating was observed.

Figure 18: New cable terminations.
