# Global RME Jam Program

## MAD7 Jam Analysis Jan 1 – Jan 31 (2025)

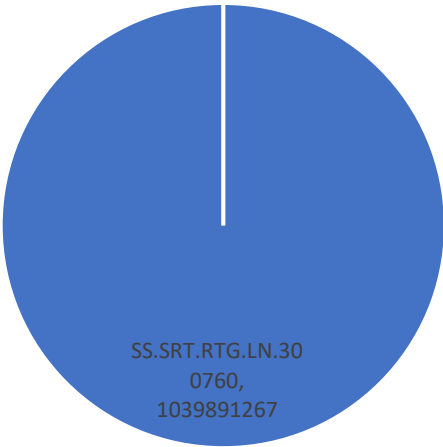
Top Equipment	SEV/HIE Events
Slat Shoe Sorter / AFE Routing	1

WO	Area	Equipment	What happened?	How did it happen?	What was the fix?
1039891267	Slat Shoe Sorter / AFE Routing	SS.SRT.RTG.L N.300760	On 27/01/2025 at 14:58h during normal operation time, SL2 (Routing sorter) suffered a breakdown due to 2 consecutive broken pins. Resulting in two stops , first one of 34 minutes and the second one of 50 minutes.	After the SL2 stopped at 14:58, RME team began reviewing alarms in Flexsort and detected a broken pin on slat 107 in UDC04. The SRMET and the AE proceeded to inspect the issue (PICTURE 1).Two RMET began removing covers to inspect the SL2 section between UDC03 and UDC04. Slat 107's pin and shoe cap was found between UDC03 and UDC04 (PICTURE 2), so	RME team installs the new shoe and starts the SL2 after inspecting the entire surrounding area at 15:29 h. The root cause of the jam is a tray with a damaged flap that gets caught in the takeaway narrow (PICTURE 5).SL2 restarted again at 16:45 h without further incident.
