Global Jam Program Audit

Organization	SYR1	Object	SYR1
Object Description	SYR1 FC - Clay		
Contractor			
Scheduled Date	2024-Oct-18	Date Completed

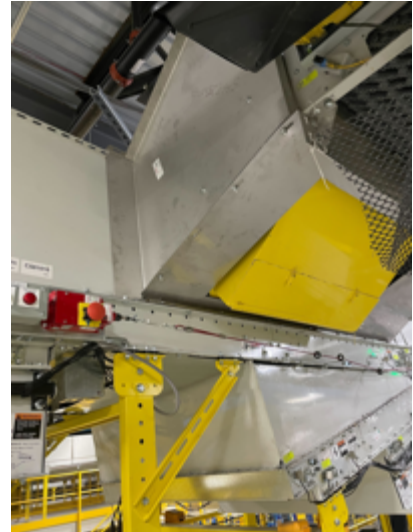
Sequence 340
Label
Check (1.1) Applicable JAM Incident correction by RME
Document 11415654

(1.1) Applicable JAM Incident correction by RME	GOOD	MHE Incident Corrections are properly completed, as required by Network. The RME team identified that the reported injury was not related to the MHE operations.
