INFRASTRUCTURE DIRECTORATE

MONTHLY REPORT – AUGUST 2019

MATJHABENG MUNICIPALITY

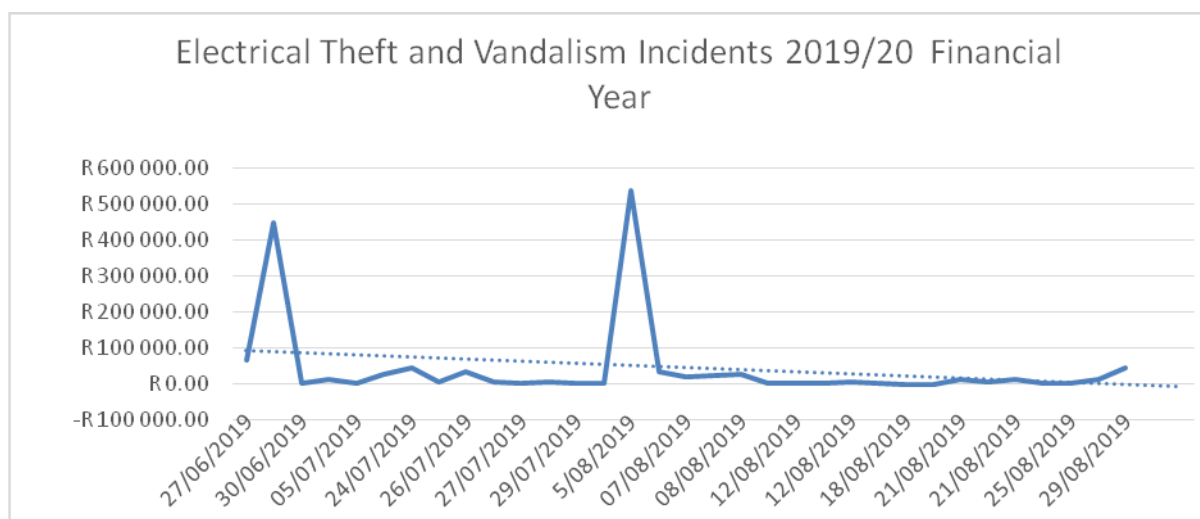
Location	Unit	Incident	Financial year	Date of incident	Approximate loss	Comments
62 Erasmus Street	Odendaalsrus	50 meters overhead power lines stolen	2019-20	25/08/2019	R 5 000.00	No preventative action implemented by the PSTD.
Mini Substation Dresden	Riebeeckstad	14 meters cable 95mm ² x4 core 1Kv SWA stolen	2019-20	28/08/2019	R 16 900.00	No preventative action implemented by the PSTD.
Theronia purification Works	Welkom	30 meter x150mm x 3 Core Pile cable damaged and Wooden Tar Electrical Poles	2019-20	29/08/2019	R 49 080.00	No preventative action implemented by the PSTD.
Total		25			R 877 810.00	
Average cost		R 35 112.40

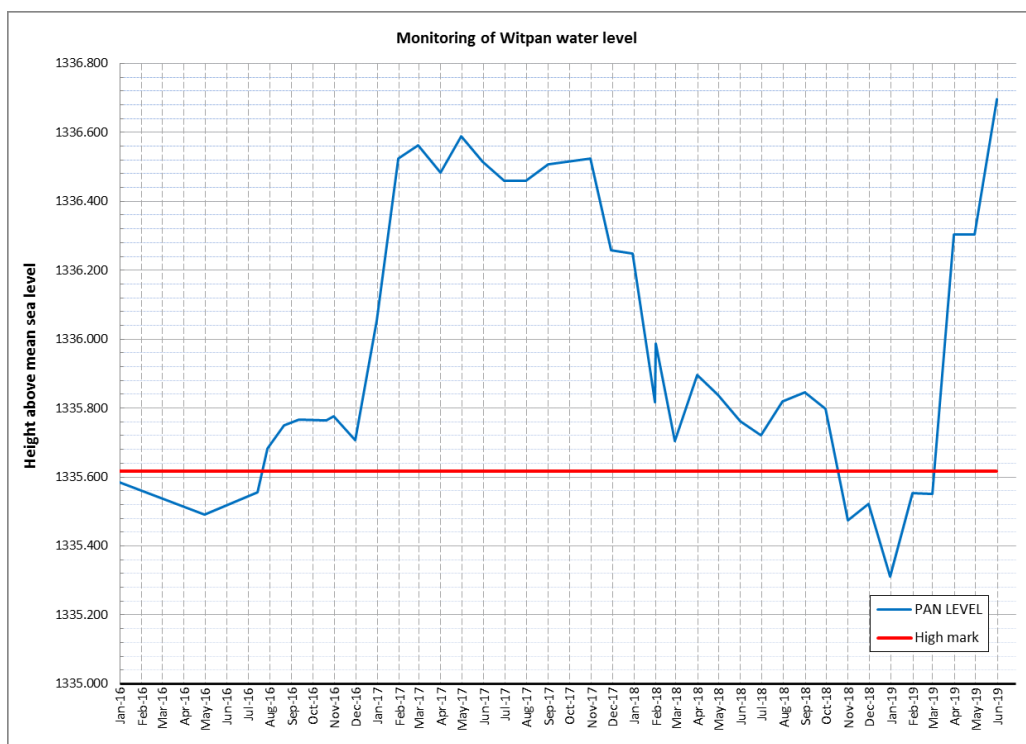
WITPAN

The pan's level has risen by almost 400mm during the past two months. It is far above our critical level (Klippan Road) and must urgently be reduced. The road to the pump station is flooded. It is critical that the pump station be made more effective.

The Municipality is also required by Law to manage and keep the levels of Stormwater Evaporation Pans to an acceptable level. The level of Witpan is continuously increasing due to underground water leakages flowing through the stormwater systems to the lakes. Currently untreated sewer are also diverted to Witpan lake.

- Upgrading Thabong WWTW through the Regional Bulk Infrastructure Bulk (RBIG) by the Department of Water and Sanitation (DWS) which is currently on feasibility stage.
- Formalizing and upgrading of the Mostert Canal, funded from internal capital funds, which is currently at design stage. However, the appointed Professional Service Provider have recommended on emergency Tender to instantly reduce the level of the pan.

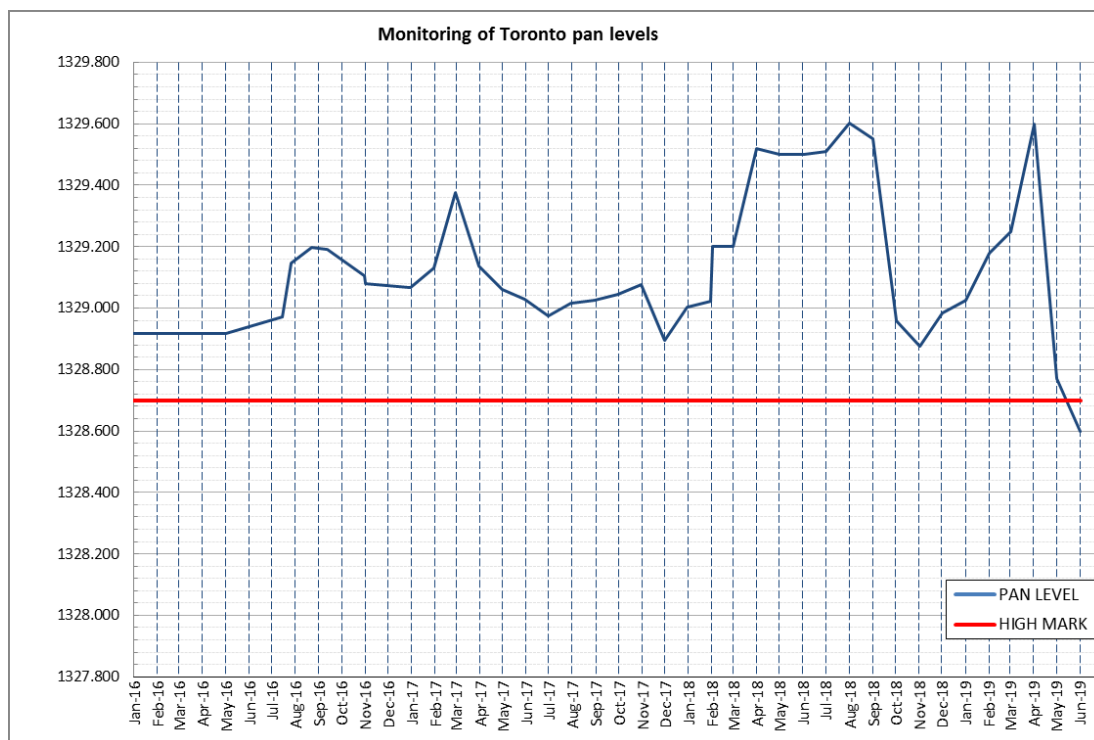
TORONTO PAN

The pan's level has dropped during the past month and no immediate problems are foreseen. The upgrading of the Geelwortel Channel is urgently required.

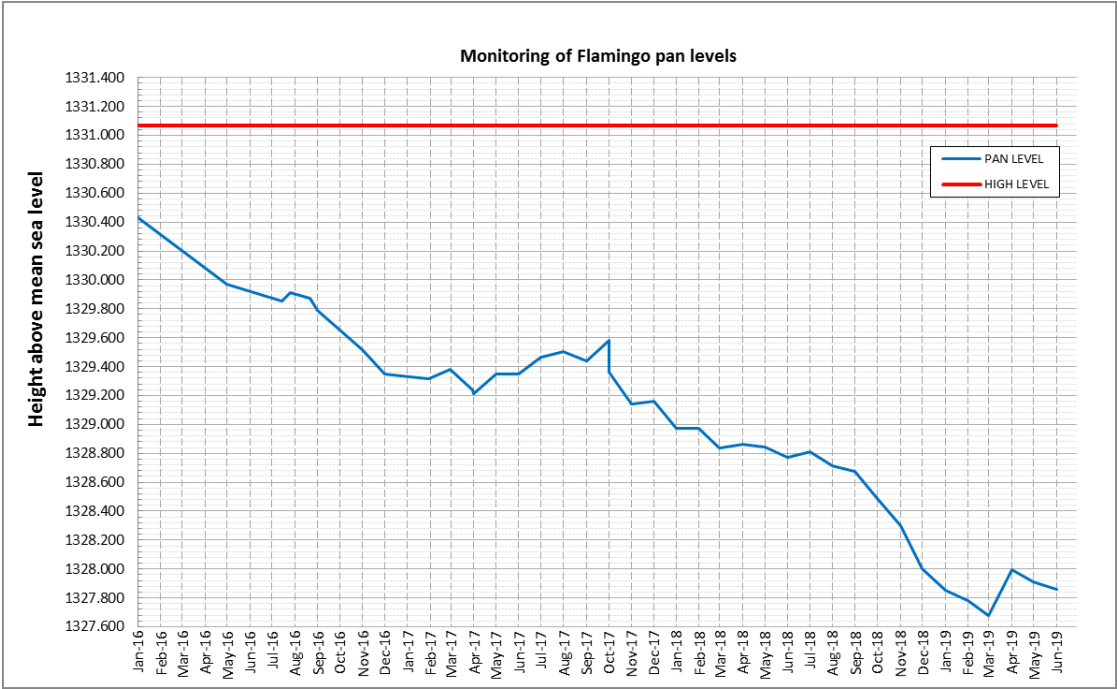
FLAMINGO PAN

This pan’s level has been fairly stable during the past month. It is recommended that the purified irrigation system urgently be made operational again to ensure long term management of the level.

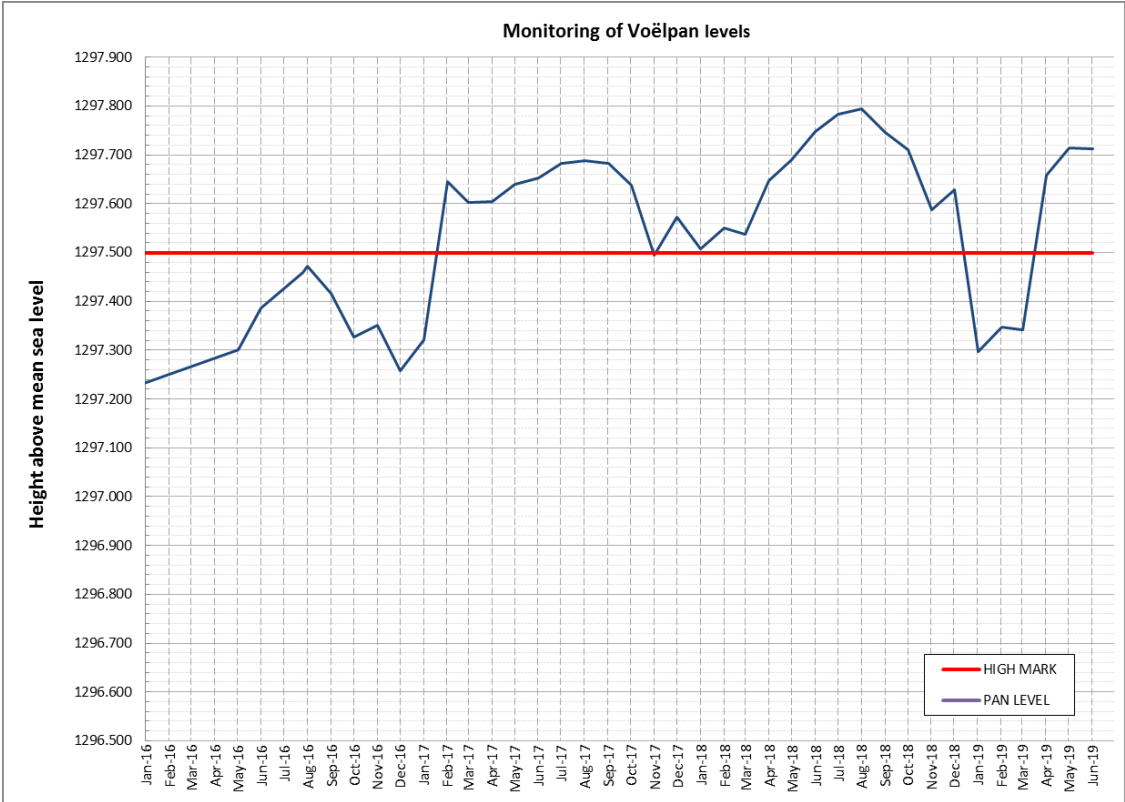
VOËLPAN (ALLANRIDGE)

This pan’s level has been fairly stable during the past few months. No immediately problem is foreseen.
